Public Works and Government Services Canada

# **Giant Mine Roaster Complex Deconstruction Waste Audit Report-FINAL**

003-DISO Roaster Demo-DISO-RPT-0004-Rev1\_20121128-FINAL

November 28, 2012

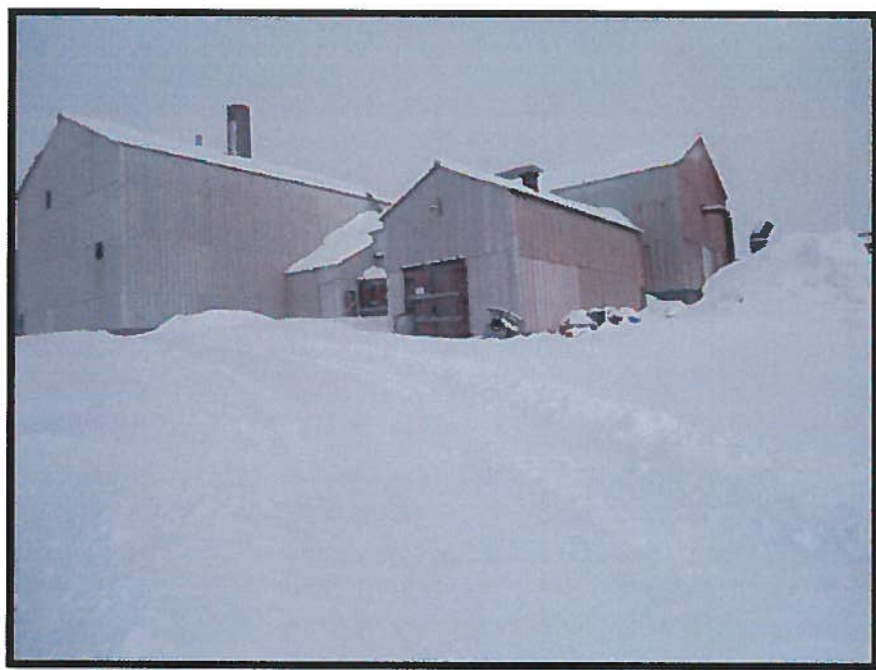
*Photograph 1: Calcine Building (Three Visible Phases/Buildings). Asbestos-Containing Exterior Siding and Roofing is Visible.*

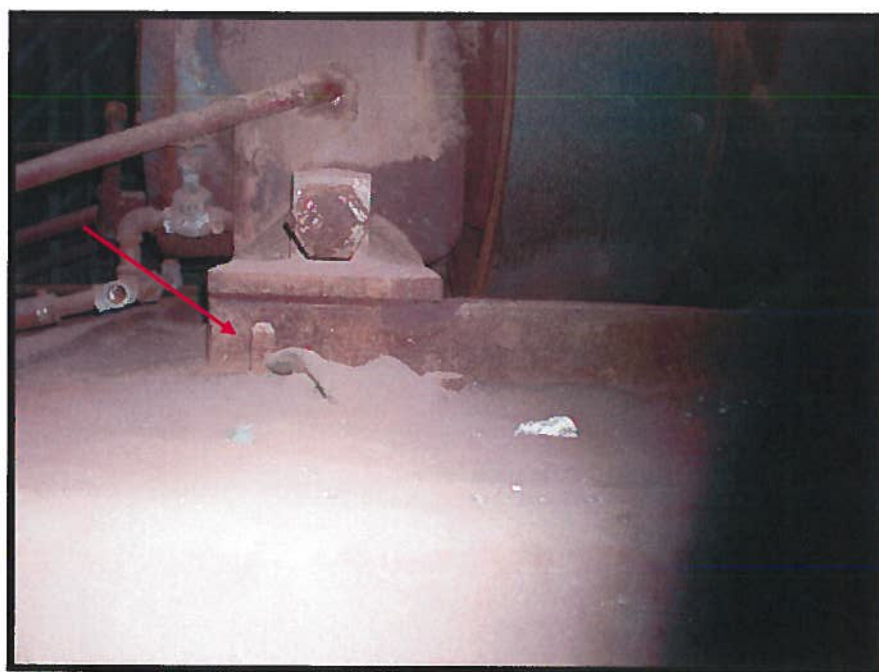
*Photograph 2: Dust Sample Location – Middle Platform Kiln Furnace (Sample 06-D).*

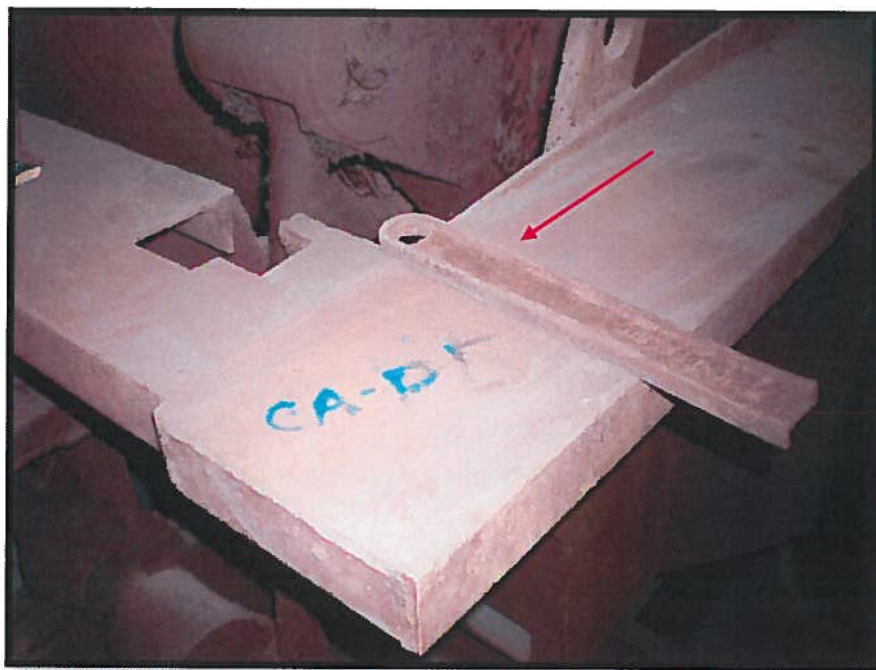
*Photograph 7: Dust Sample Location – Second Level Calcine Drum (Sample 11-D).*

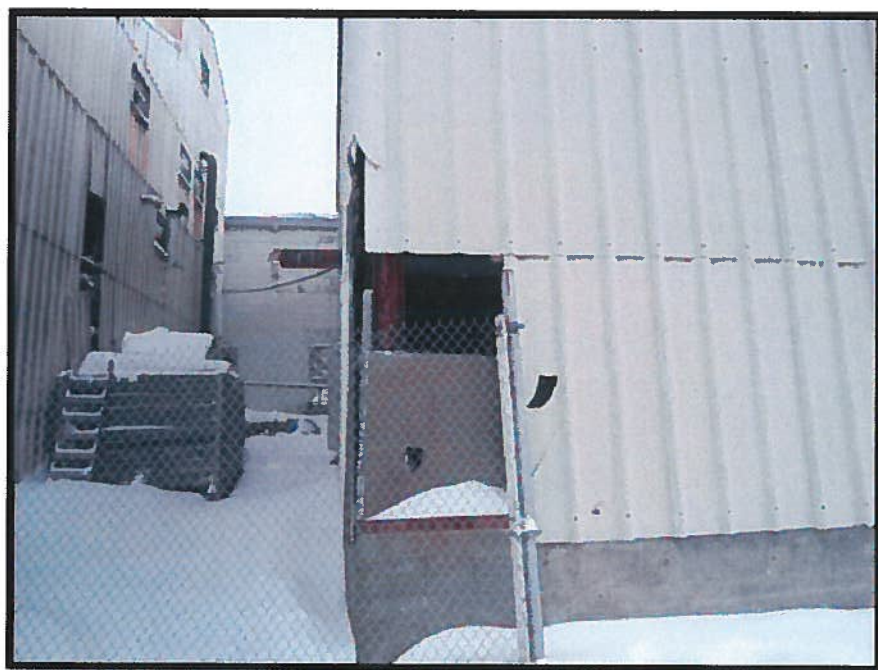
*Photograph 8: Asbestos-Containing Exterior Wall Panels (Sample 21).*

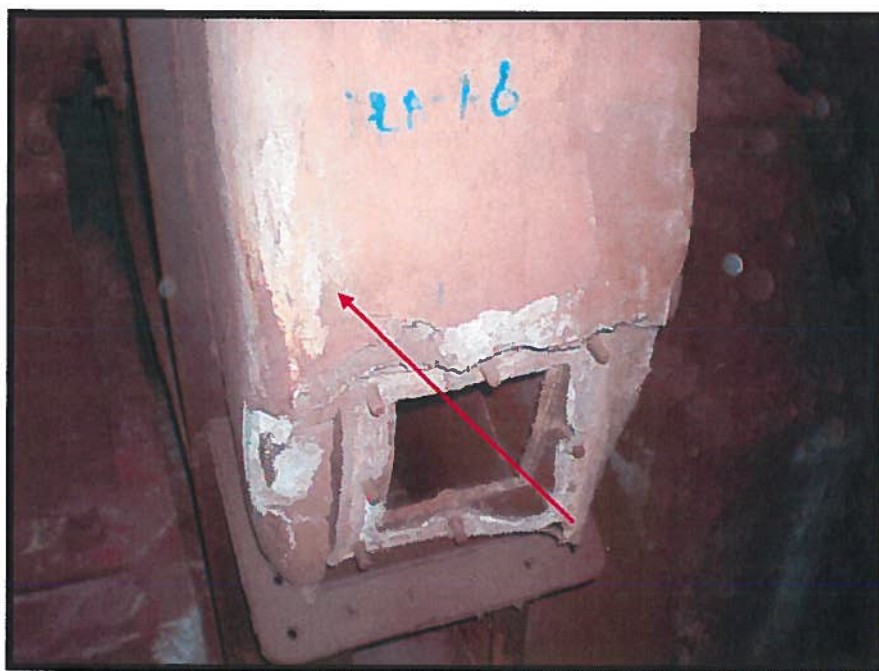
*Photograph 10: Asbestos-Containing Mechanical Insulation on Equipment on Fan/Blower Unit North End (Sample 10) with suspect Asbestos-Containing Gasket Materials.*

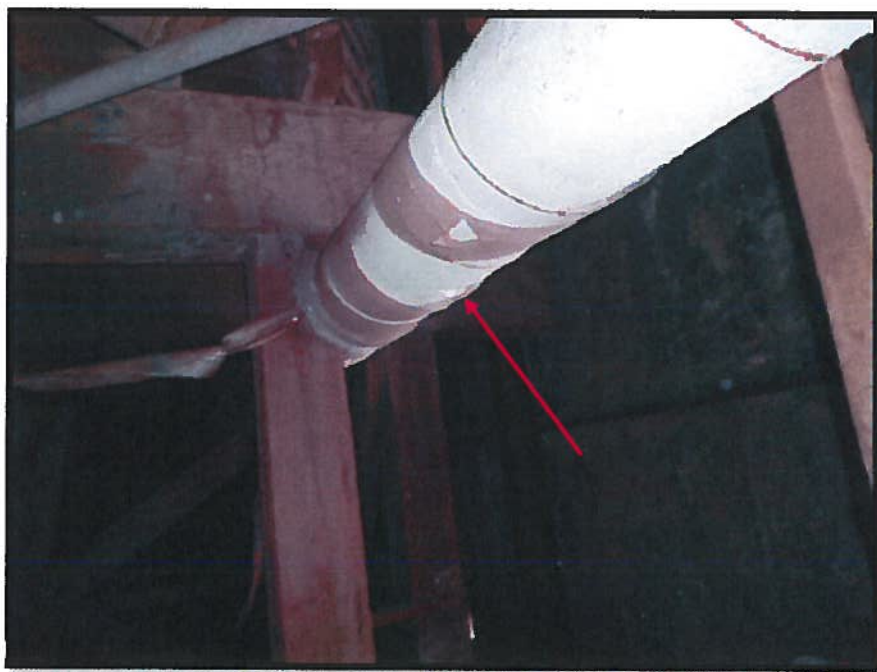
*Photograph 16: Asbestos-Containing Pipe-Insulation (Sample 30).*

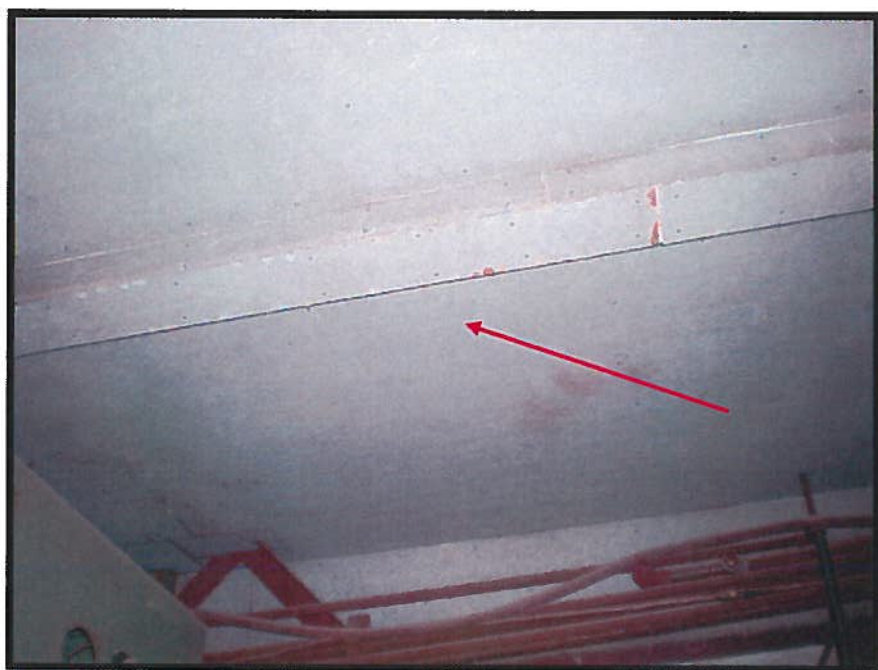
*Photograph 18: Asbestos-Containing Cement Board Paneling on Asbestos Paper (Visually Referenced).*

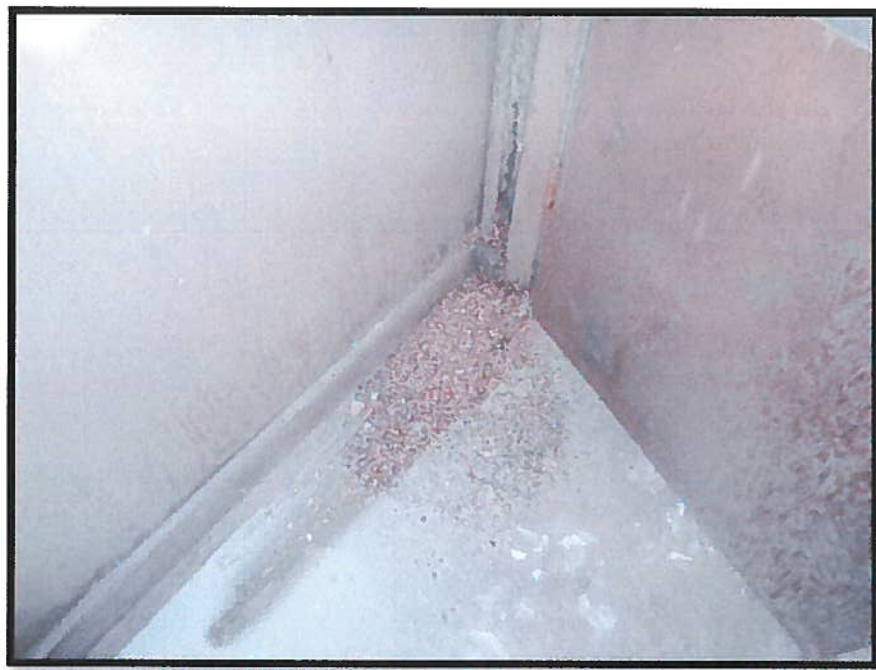
*Photograph 19: Suspect Asbestos-Containing Vermiculite (not Sampled, Assumed to be contaminated with Asbestos).*

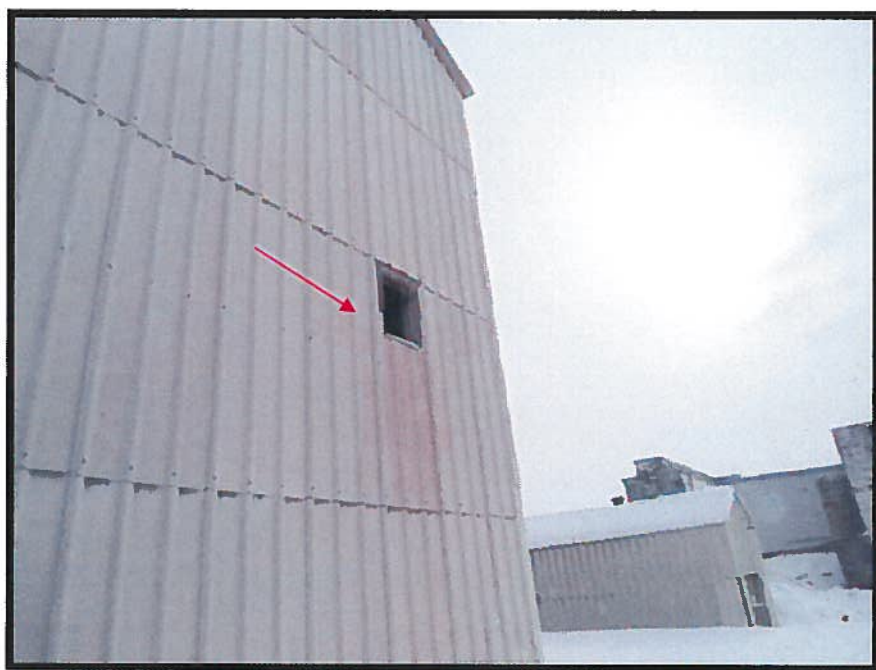
*Photograph 20: Lead Sheetting Located on Building Windows and Openings.*

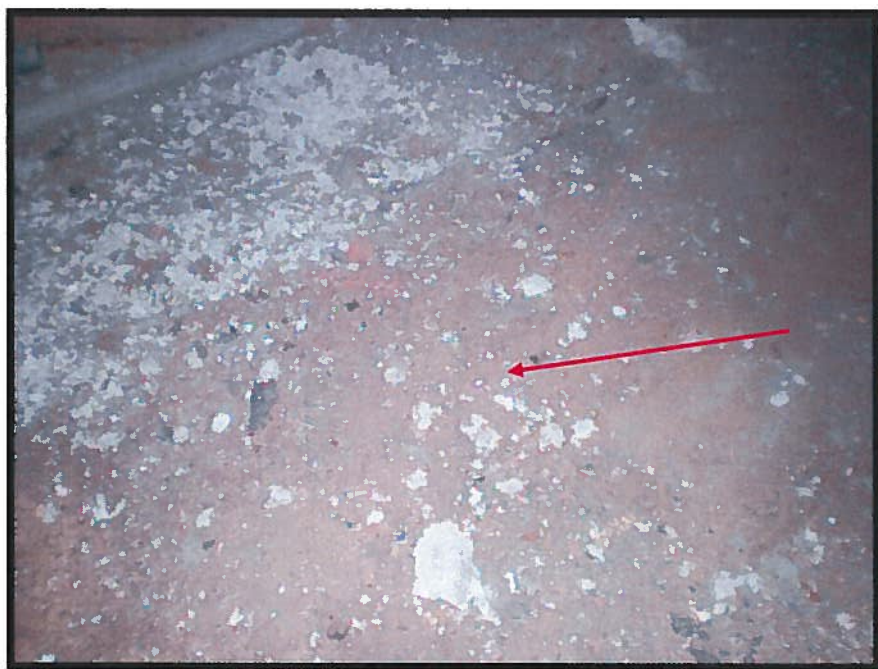
*Photograph 6: Non-Asbestos Insulation Debris on Basement Level, Suspected to be From the Ceiling (Sample 40).*

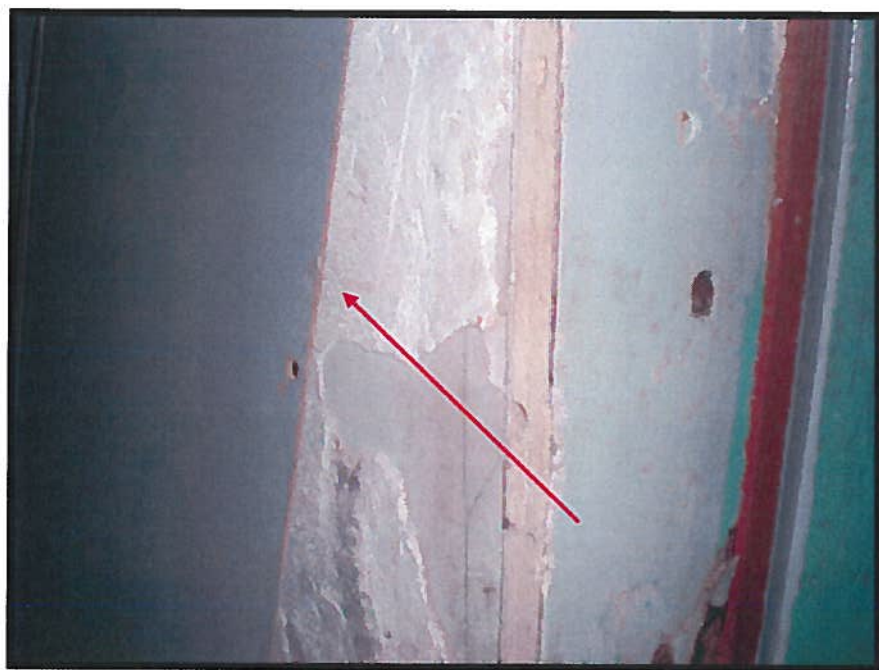
*Photograph 8: Asbestos-Containing Wall located within Electrical Room Behind Control Room (Sample 08).*

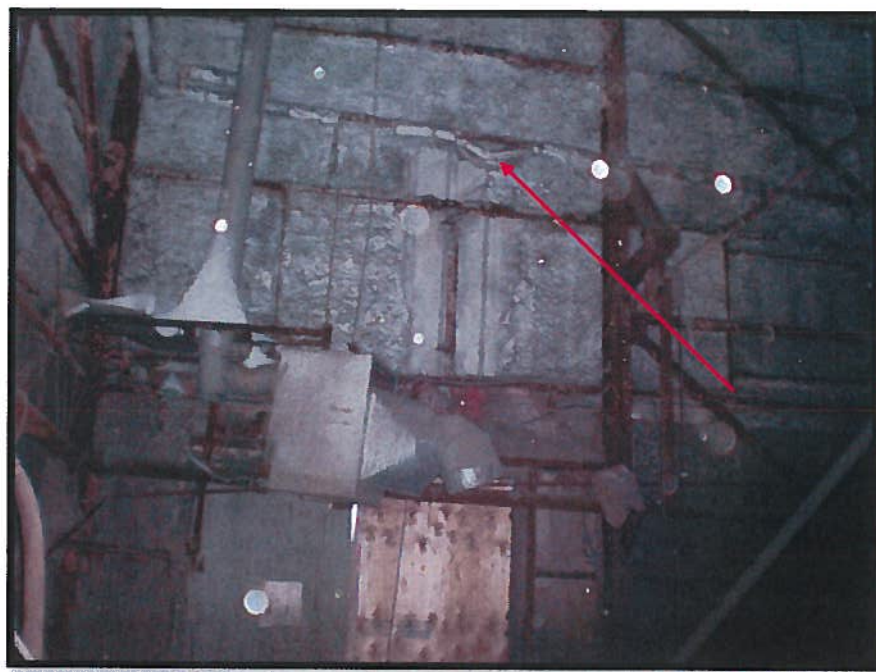
*Photograph 9: Typical Asbestos-Containing Spray-Applied Wall Insulation and Asbestos Containing Pipe Insulation on the West Perimeter Wall (Red Arrow).*

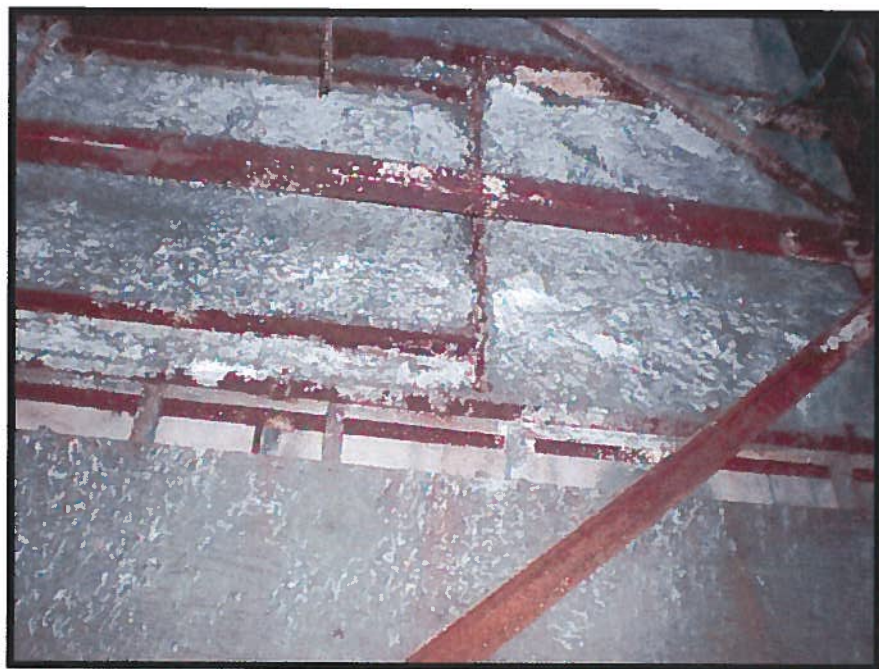
*Photograph 10: Typical Asbestos-Containing Spray-Applied Wall Insulation.*

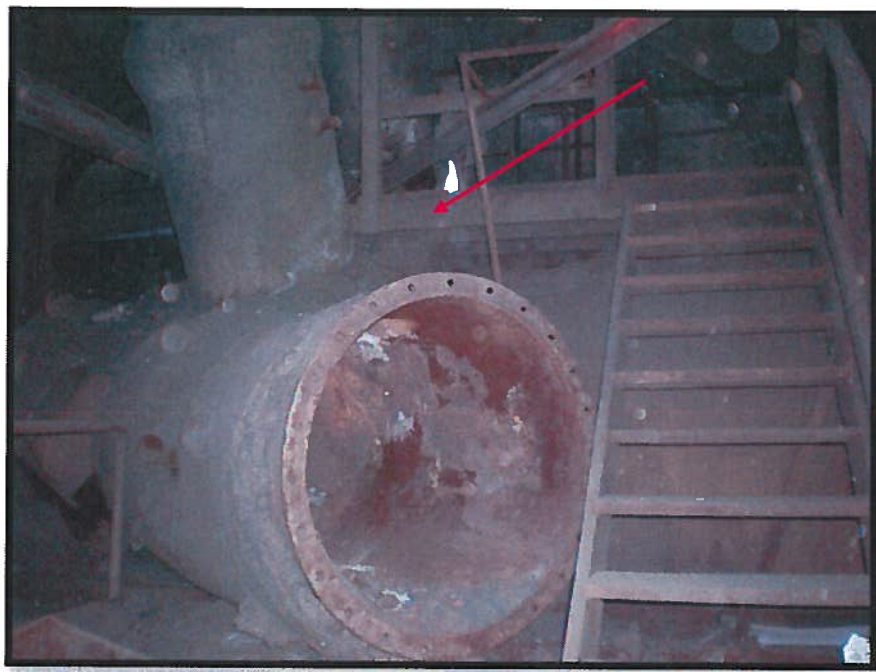
*Photograph 10: Asbestos-Containing Insulation on Flue Piping located Throughout the Building (Sample 43).*

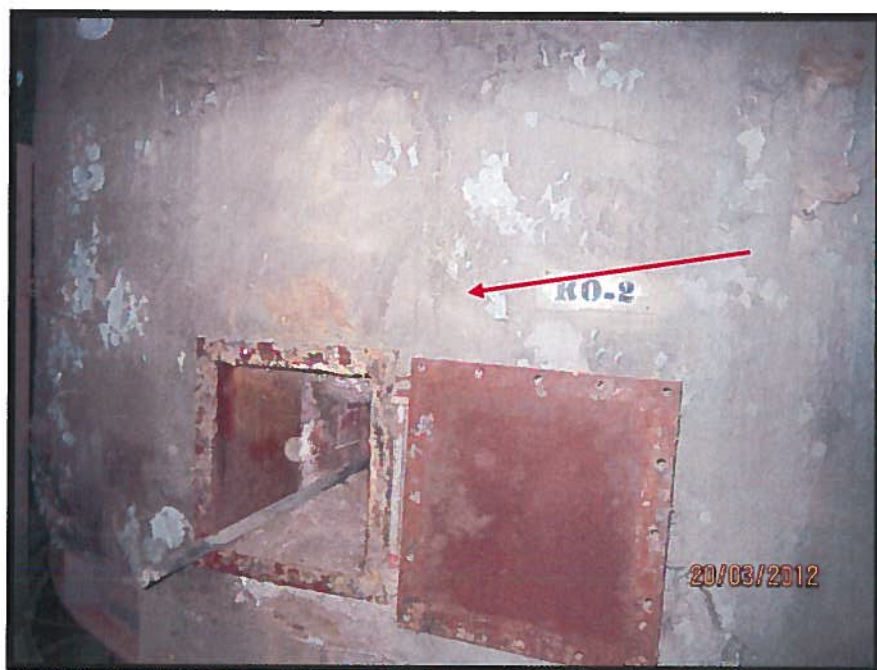
*Photograph 12: Asbestos-Containing Insulation on Roaster #02 (Sample 44).*

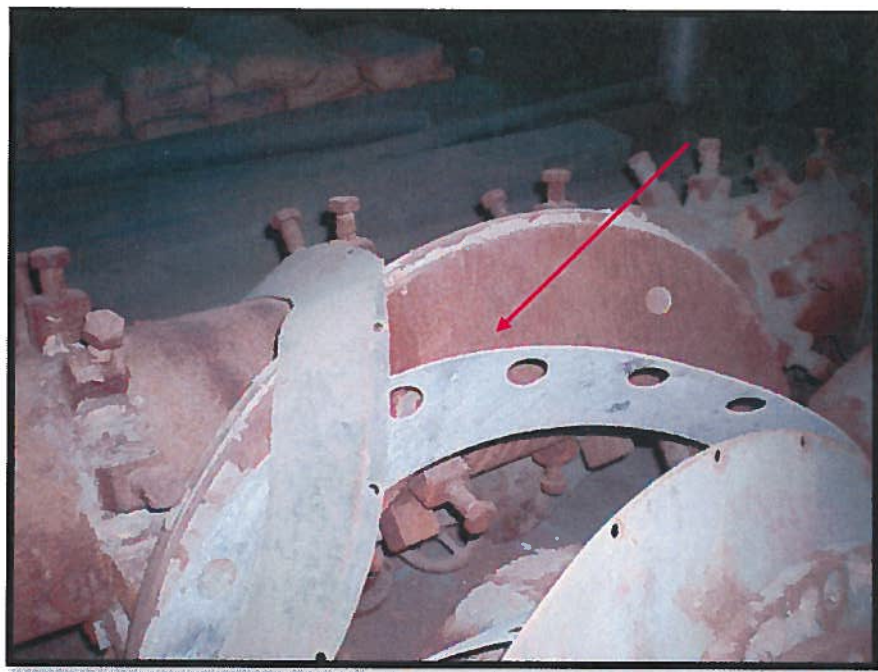
*Photograph 13: Asbestos-Containing Gasket Materials, Loose and Located on Piping throughout the Building (Sample 46).*

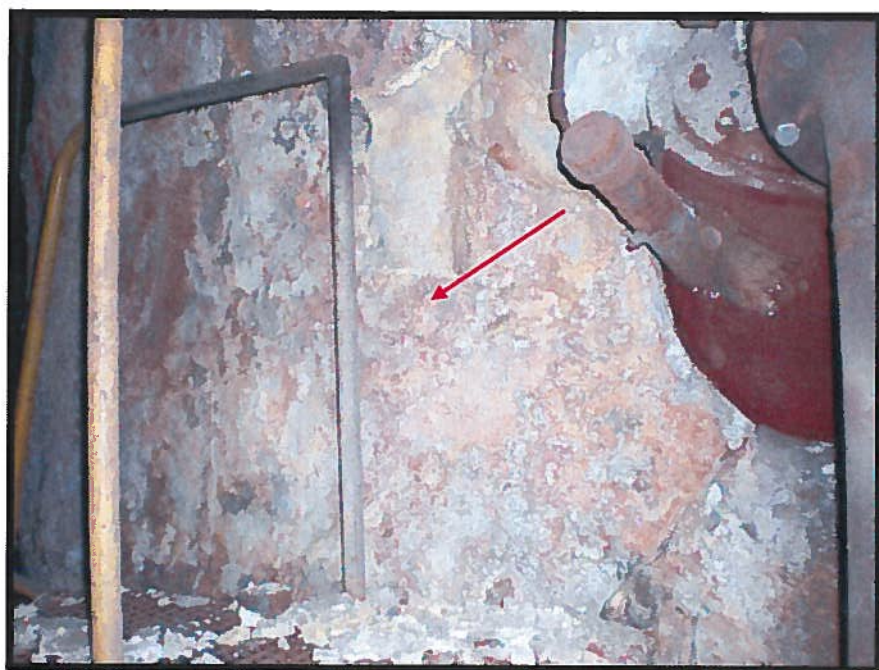
*Photograph 14: Asbestos-Containing Insulation Roaster #01 (Sample 47).*

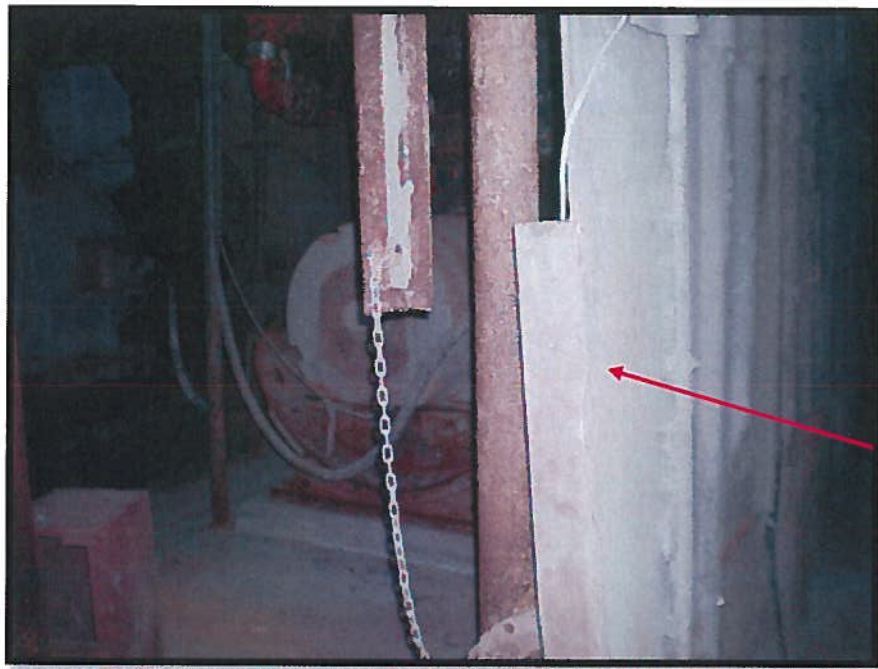
*Photograph 15: Asbestos-Containing Cement Board, Basement Level Pump Room (Sample 50).*

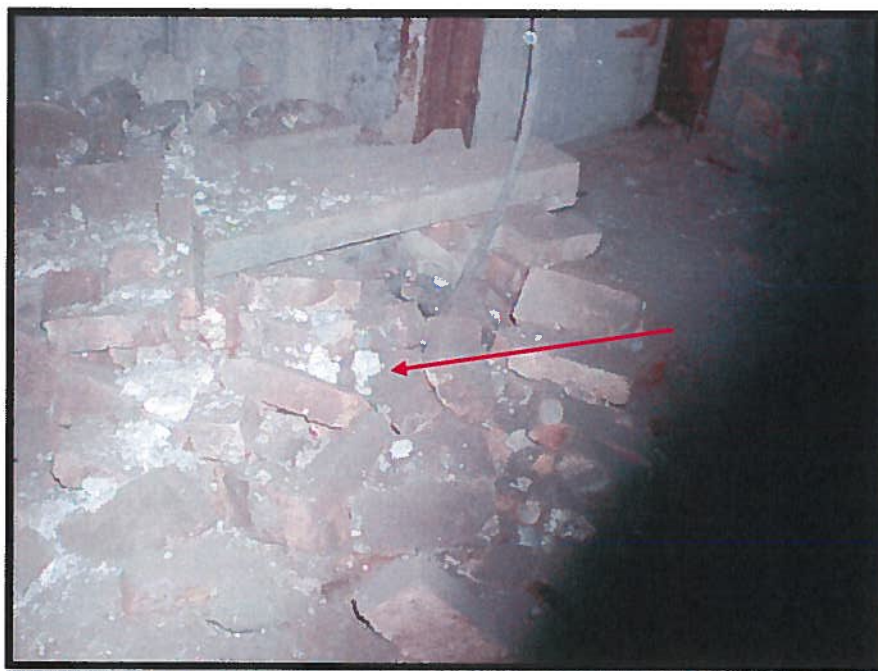
*Photograph 16: Loose Refractory Bricks, (Asbestos not Detected), Adjacent Roaster #01 (Sample 51).*

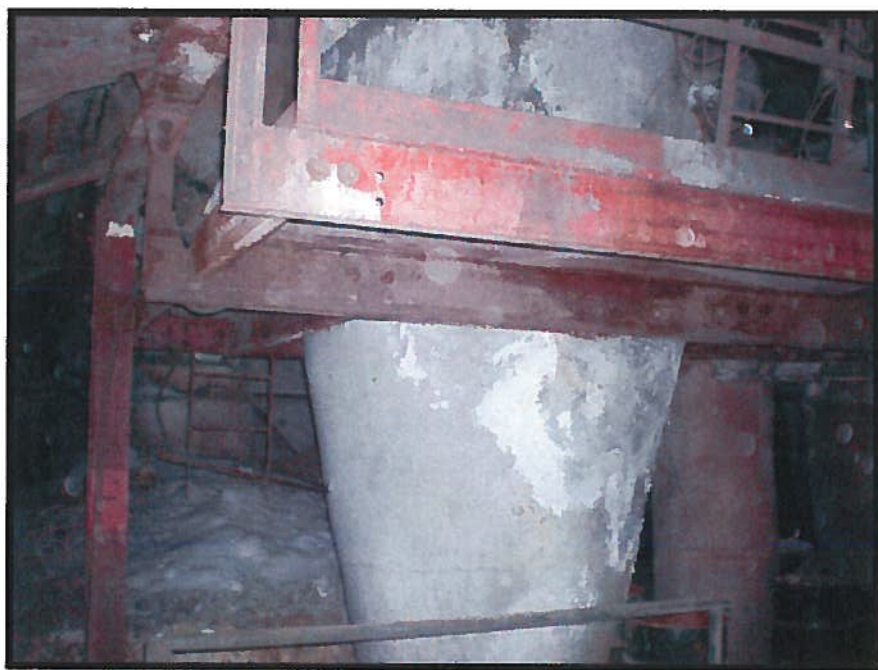
*Photograph 20: Typical Mechanical Insulation on Flue Network Cyclones (Visually Referenced, Sample 43).*

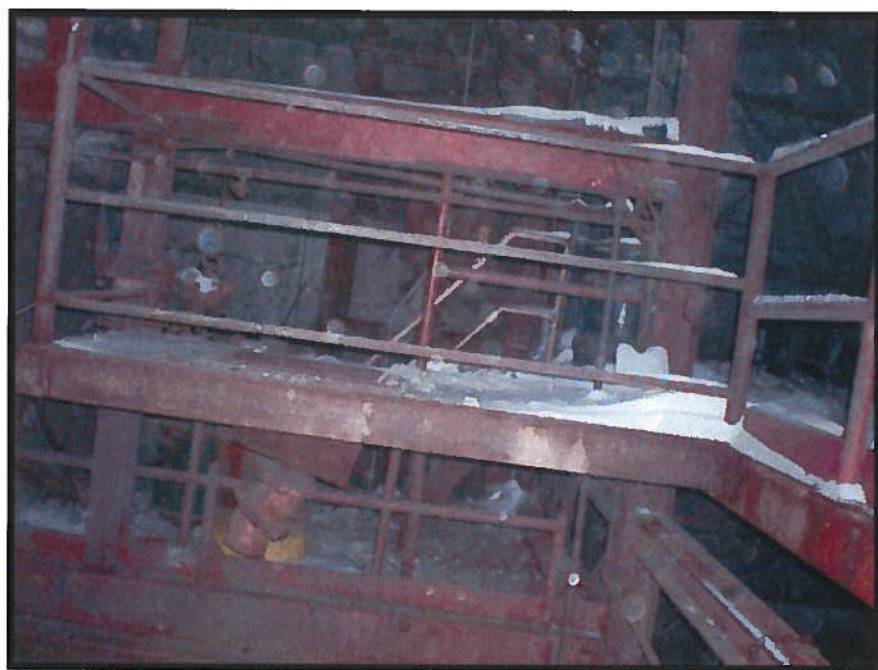
*Photograph 26: Red Paint on Structural Steel (Sample 20-Pb).*

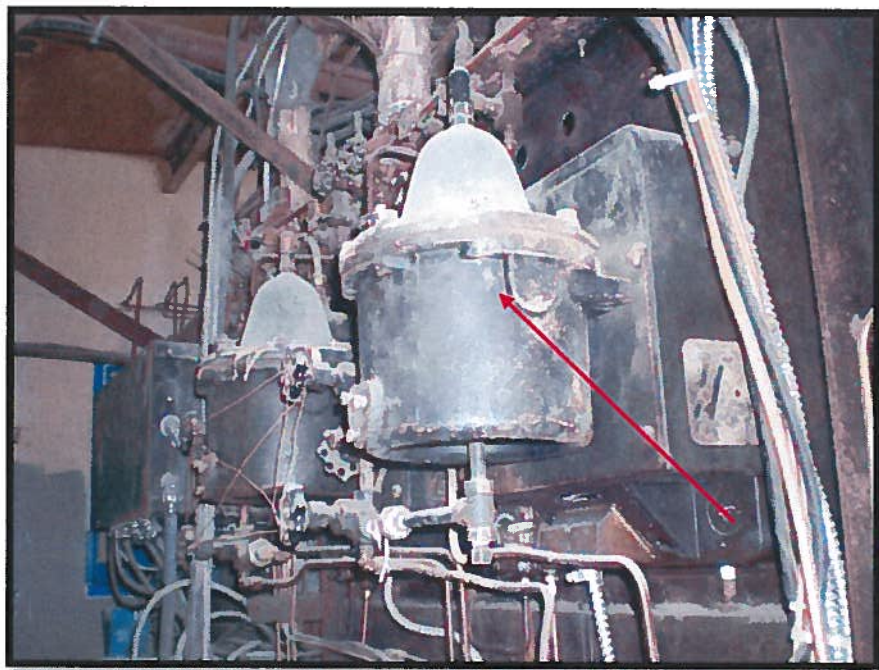
*Photograph 32: Circle Chart Recorders inside the Control Room with Mercury Reservoirs.*

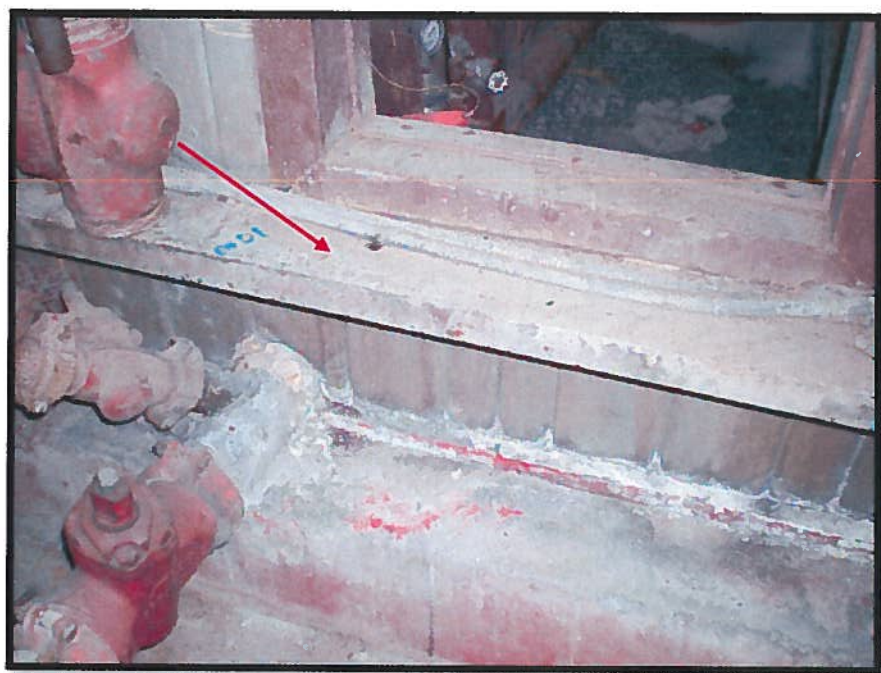
*Photograph 2: Dust Sample Location (Sample 01-D).*

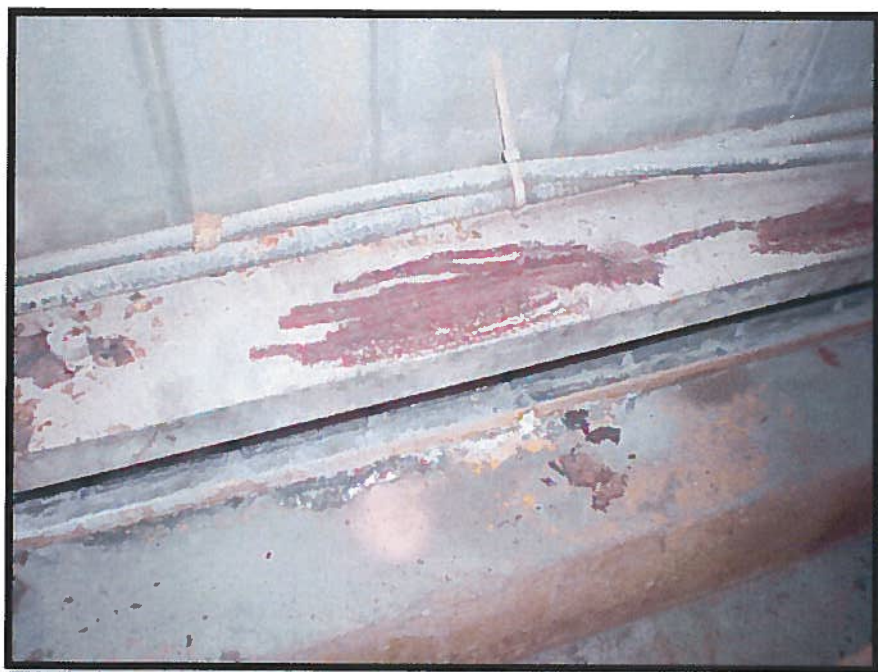
*Photograph 10: Silver over Red Paint on Structural Steel and Yellow Paint on Concrete (Samples 02-Pb and 03-Pb).*

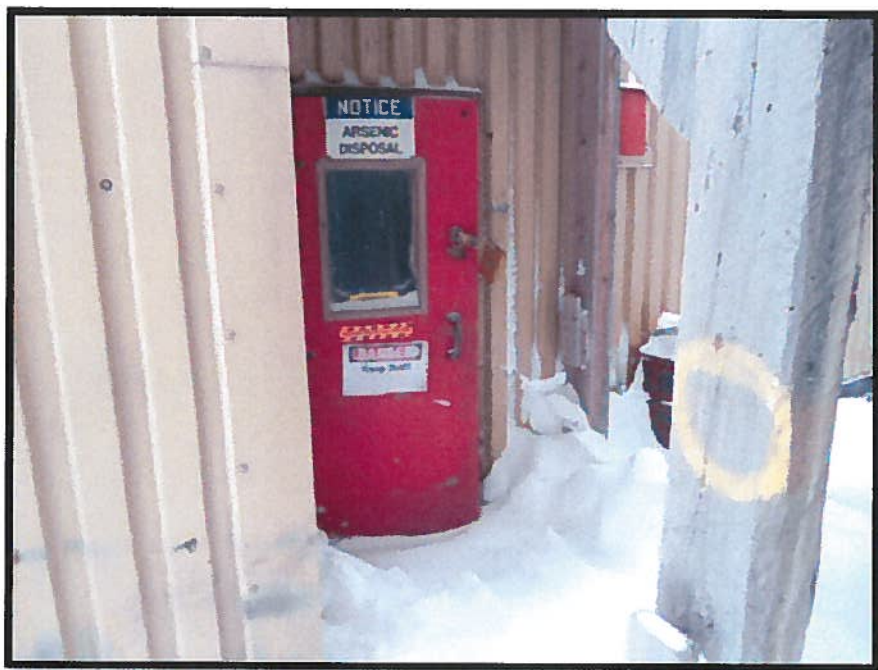
*Photograph 12: Red Paint on Wood Door (Sample 05-Pb).*

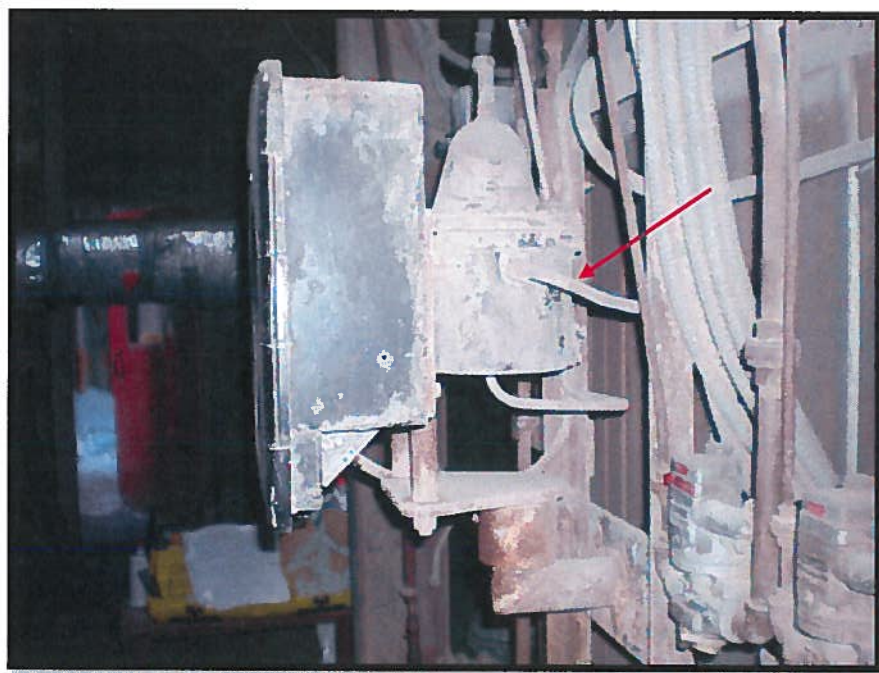
*Photograph 14: Suspect Mercury-Containing Circular Chart Recorder.*

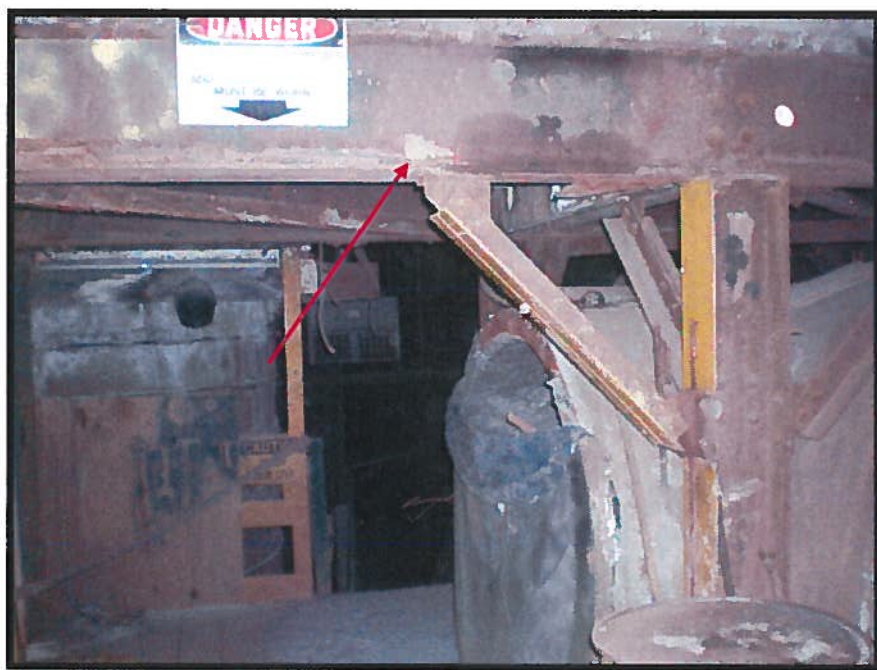
*Photograph 2: Dust on Wooden Beam Sample Location (Sample 12-D).*

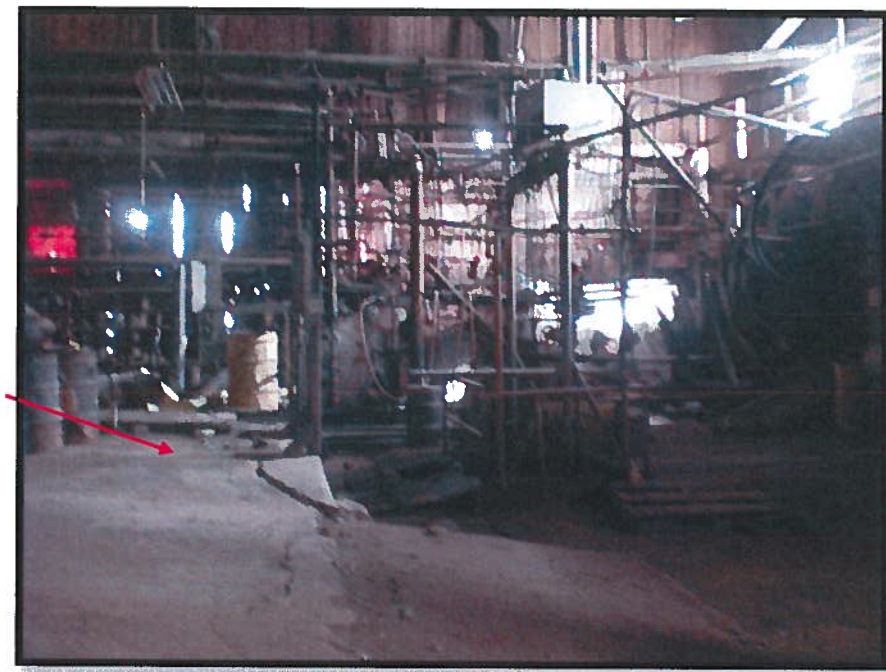
*Photograph 3: Dust on Concrete Pad/Floor South End of Building (Sample 13-D).*

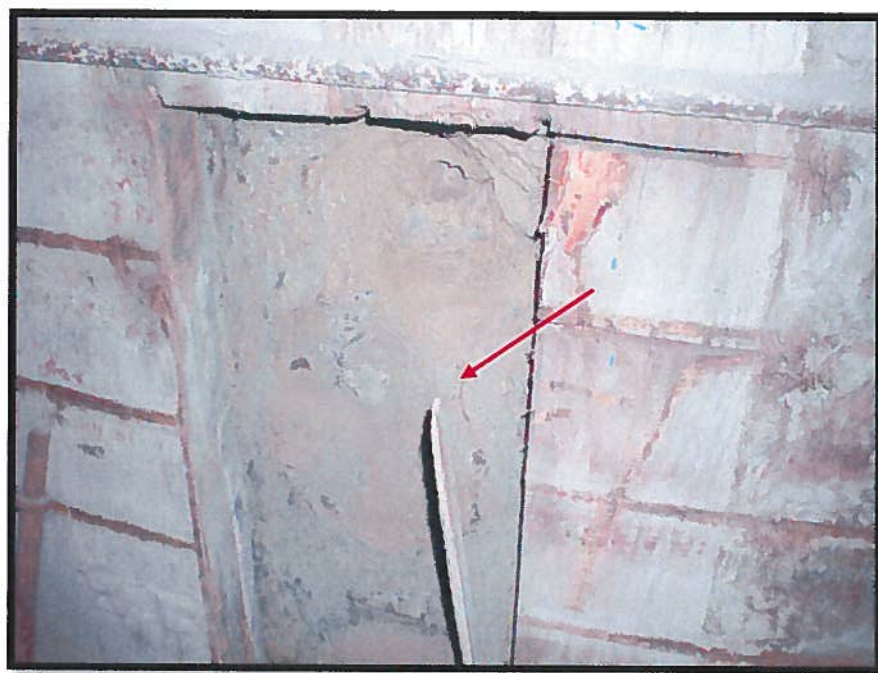
*Photograph 4: Process Dust within North Tank (Sample 14-D).*

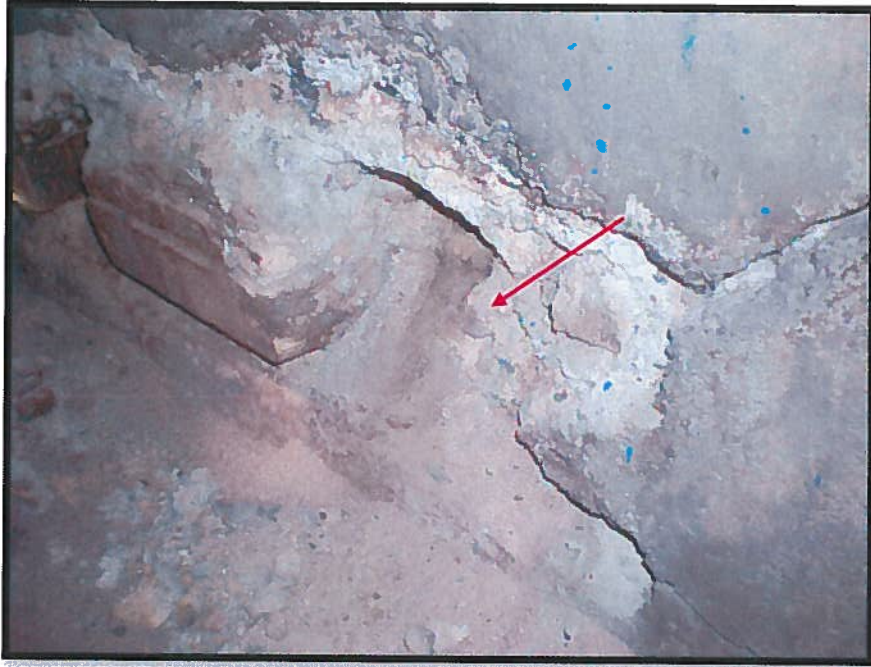
*Photograph 5: Dust beneath Concrete Foundation (Sample 15-D).*

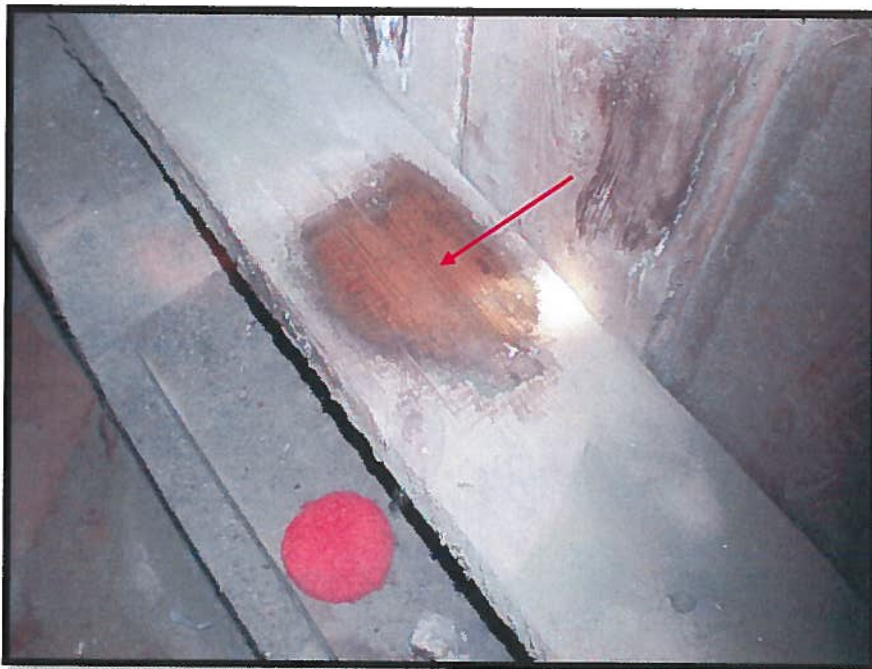
*Photograph 6: Cleaning Procedure Trial Area, Clean Wood Sample Location (Sample 16-D).*

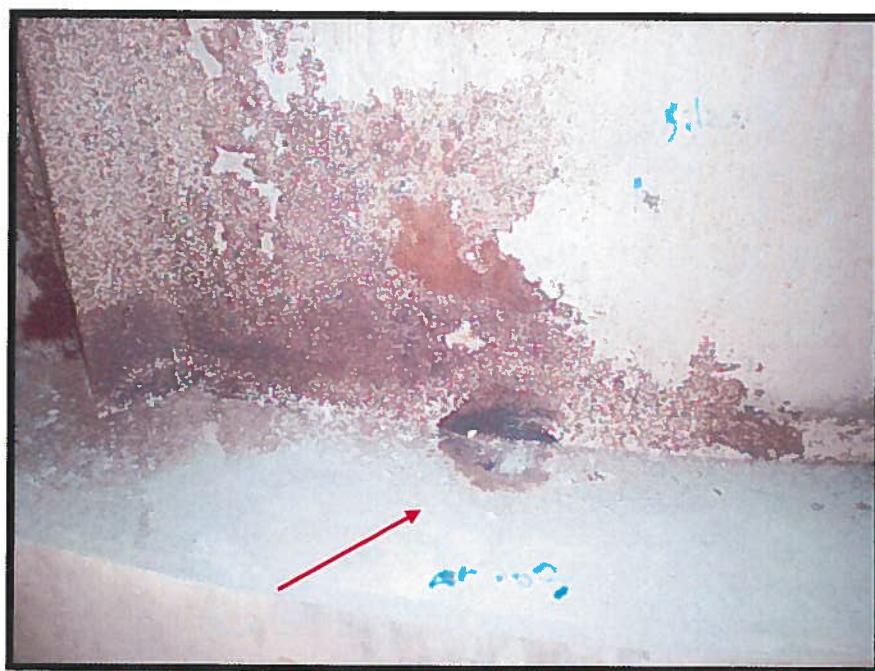
*Photograph 8: Dust on Metal Tank Base Sample Location (Sample 18-D).*

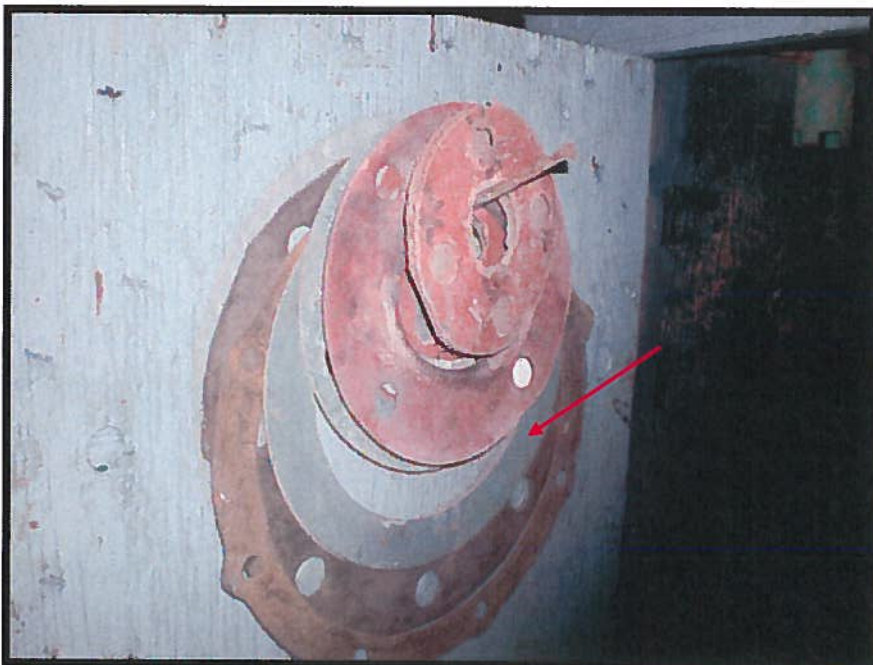
*Photograph 10: Loose Asbestos-Containing Mechanical Pipe Gaskets (Sample 32).*

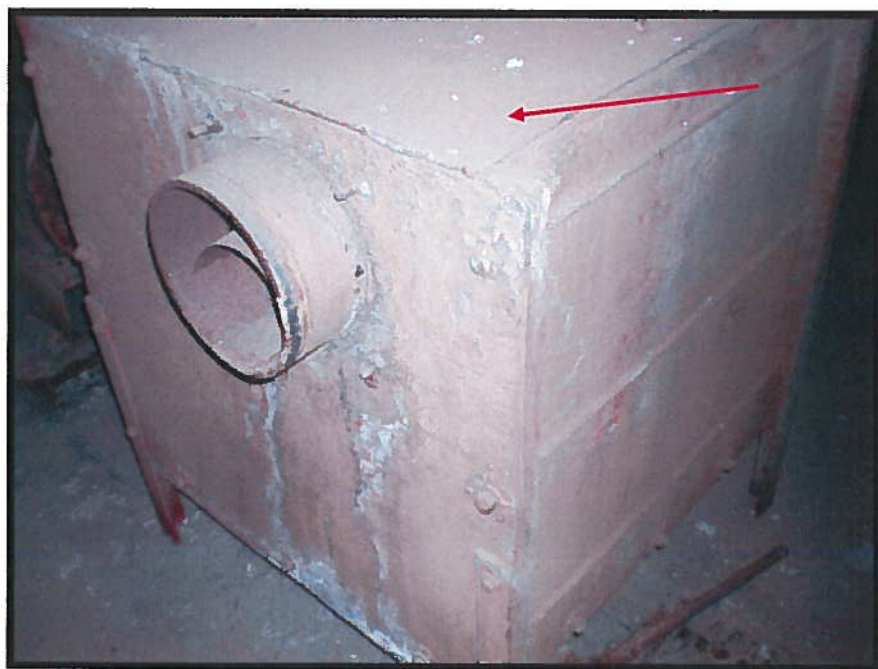
*Photograph 2: Dust Sample Location on Control Box (Sample 05-D).*

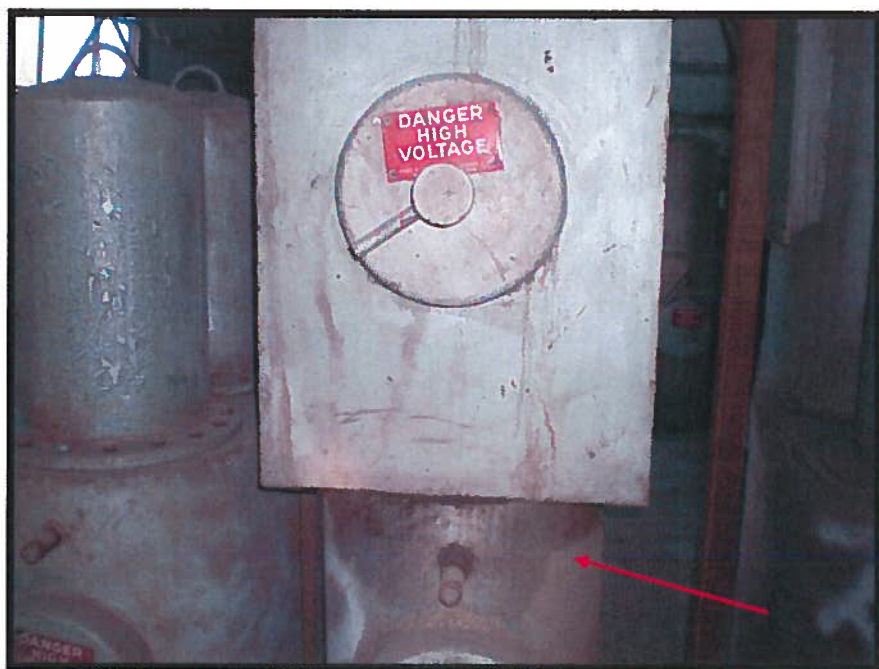
*Photograph 16: Asbestos-Containing Pipe-Insulation on South Precipitator Unit Header (Sample 19).*

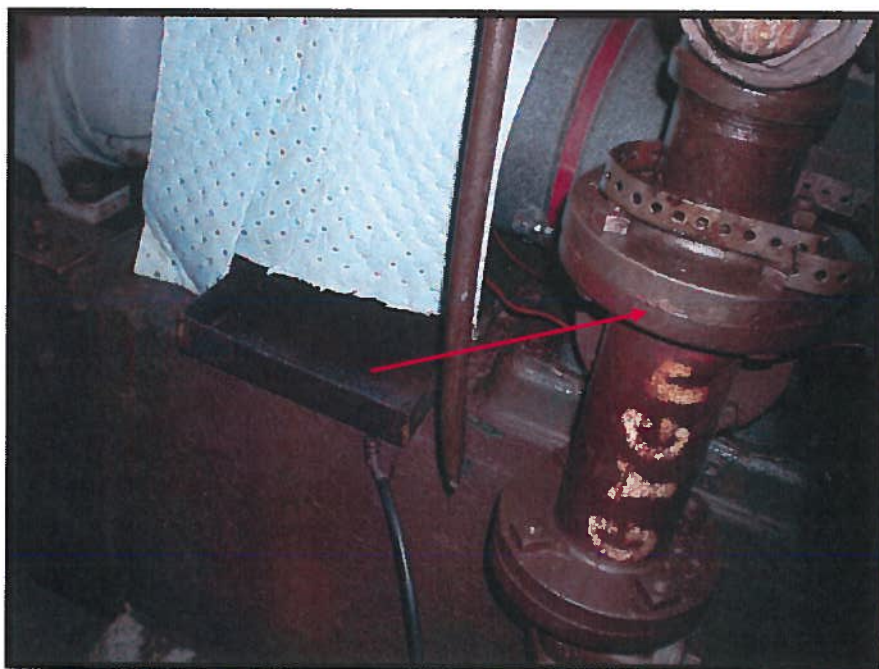
*Photograph 18: Suspect Asbestos-Containing Mechanical Gaskets (Visually Referenced).*

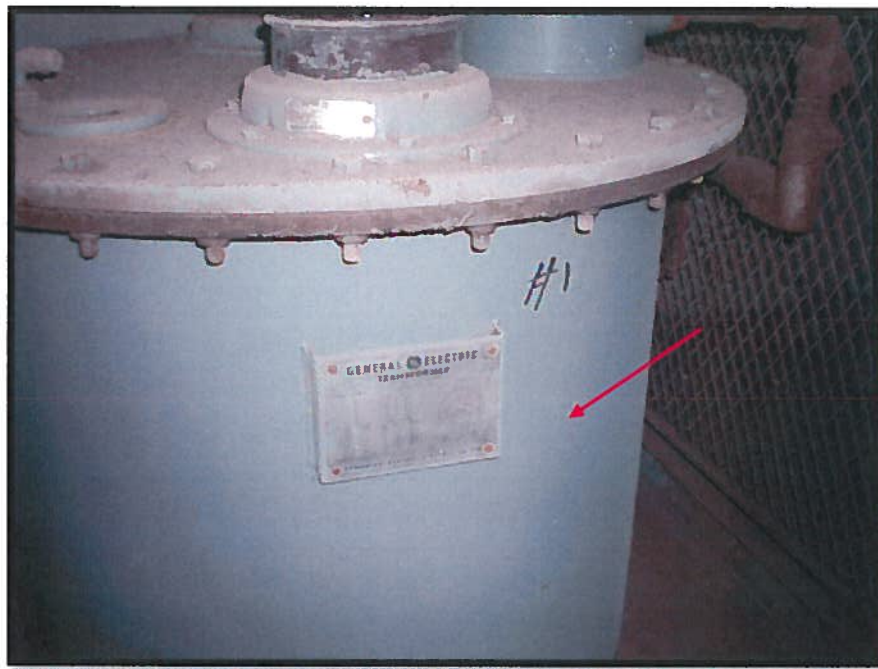
*Photograph 21: Suspect PCB-Containing Oil within Transformer Unit, Upper Mezzanine Level.*

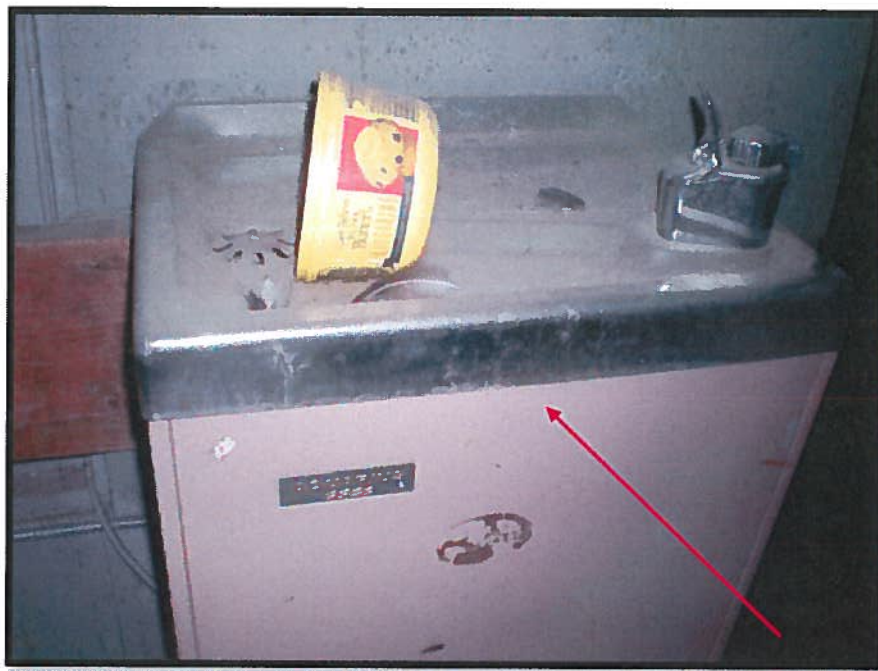
*Photograph 23: Suspected ODS within Water Cooler.*
