Public Works and Government Services Canada

# **Giant Mine Roaster Complex Deconstruction Waste Audit Report-FINAL**

003-DISO Roaster Demo-DISO-RPT-0004-Rev1\_20121128-FINAL

November 28, 2012

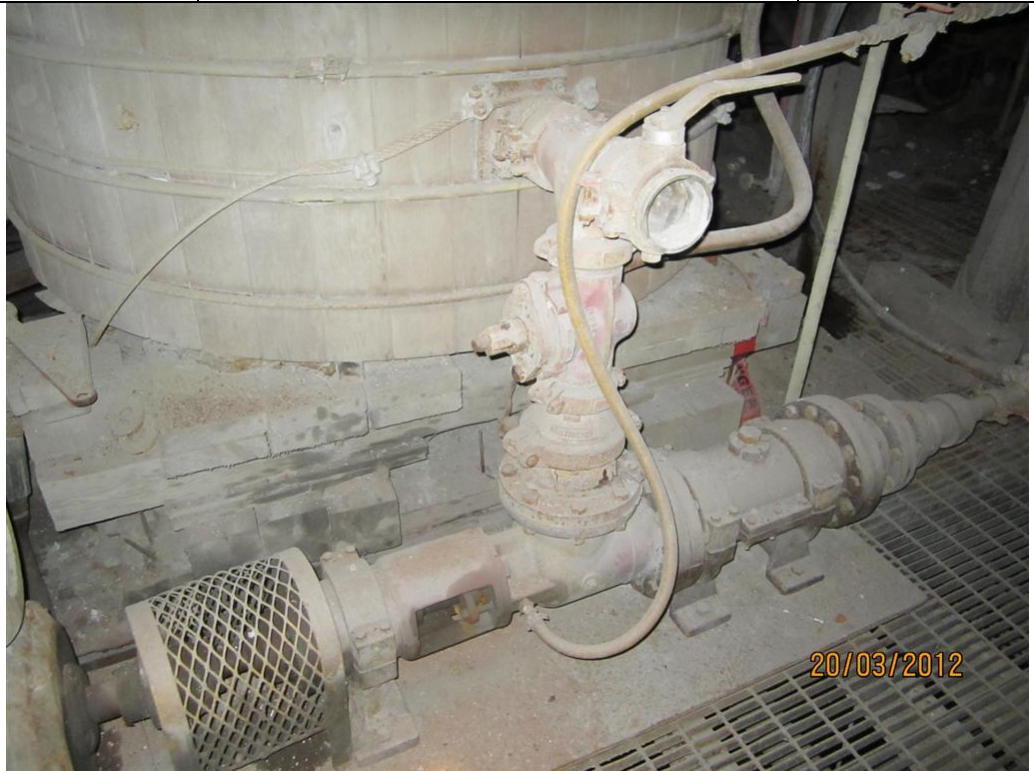
<b>Photo No.</b> 1	<b>Date:</b>
<b>Direction Photo Taken:</b>	
<b>Description:</b>	
Dorrco Roaster Building	
Tanks and process piping showing typical coating of dust in Dorrco Roaster Building

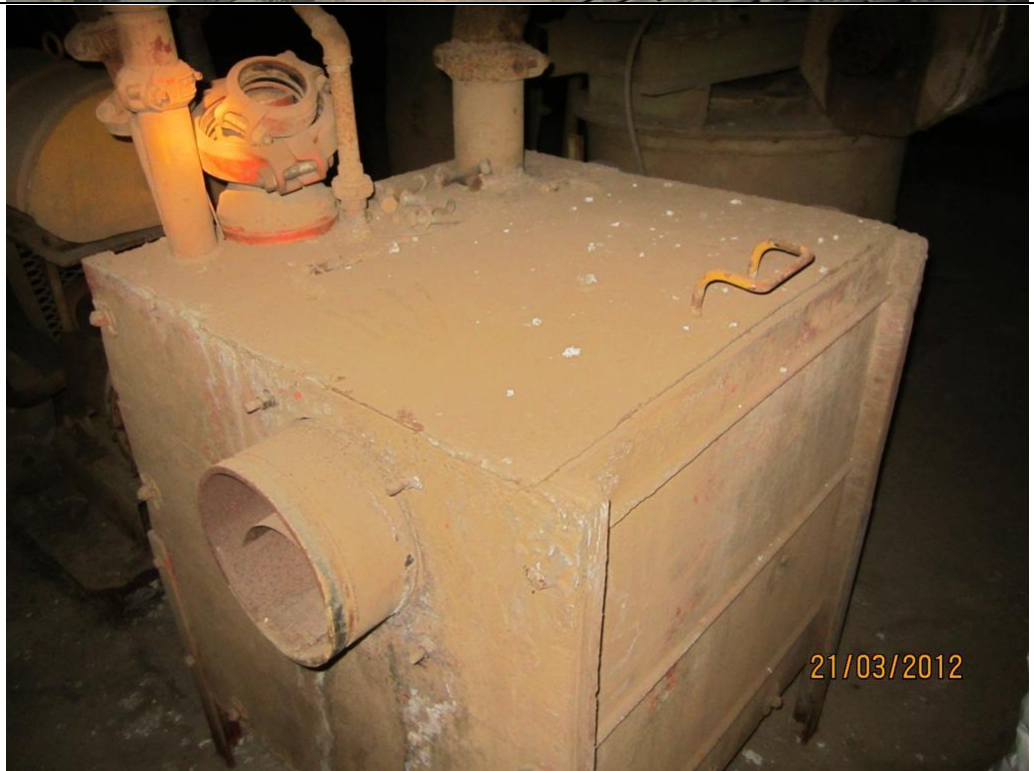
<b>Photo No.</b> 2	<b>Date:</b>
<b>Direction Photo Taken:</b>	
<b>Description:</b>	
Cottrell Precipitator Building	
Typical coating of dust in on equipment in Cottrell Precipitator Building

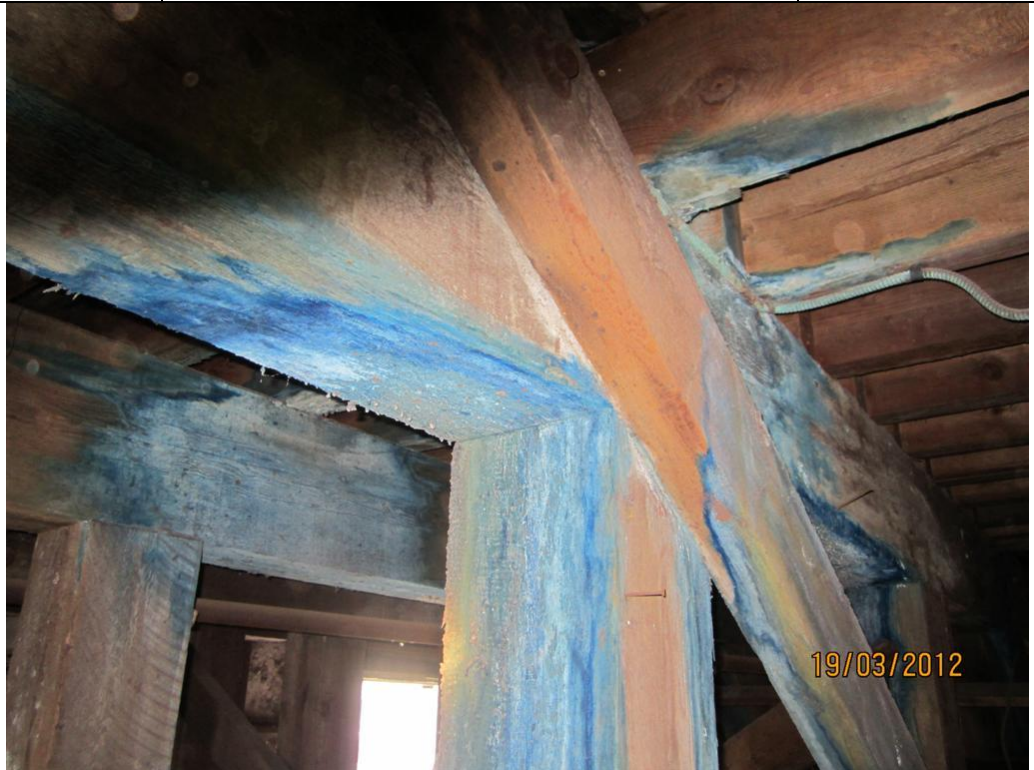
Staining in wooden timbers supporting thickener tank in Calcine Building

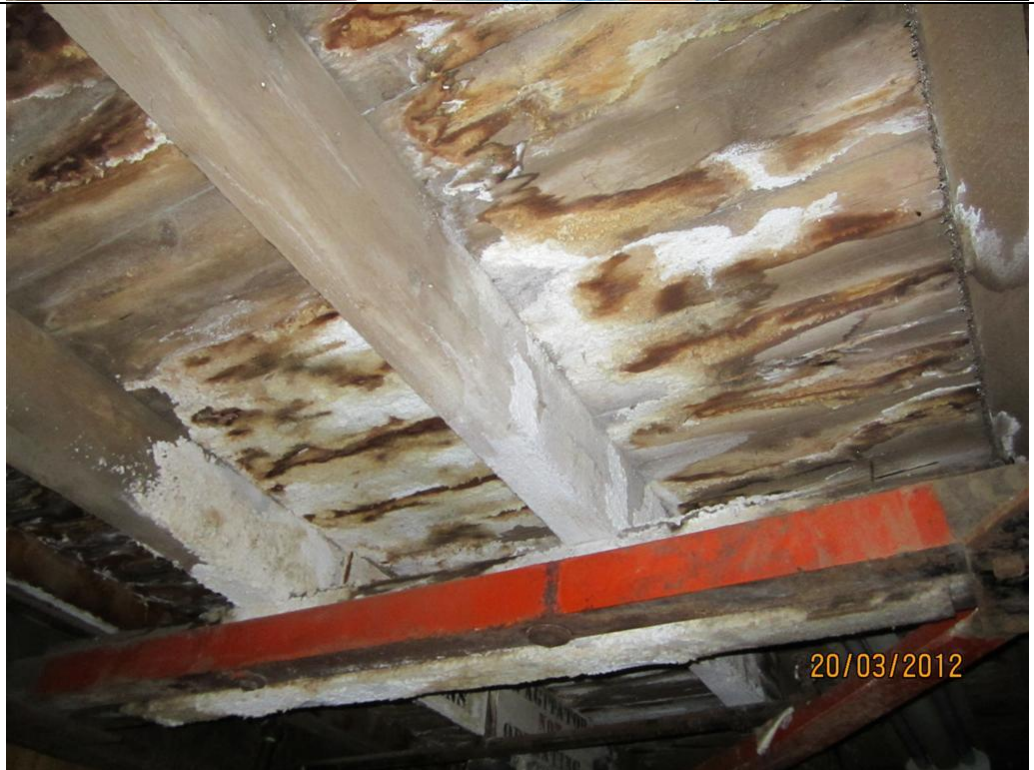
Staining of 2<sup>nd</sup> level floor boards and floor joists in AC Roaster Building

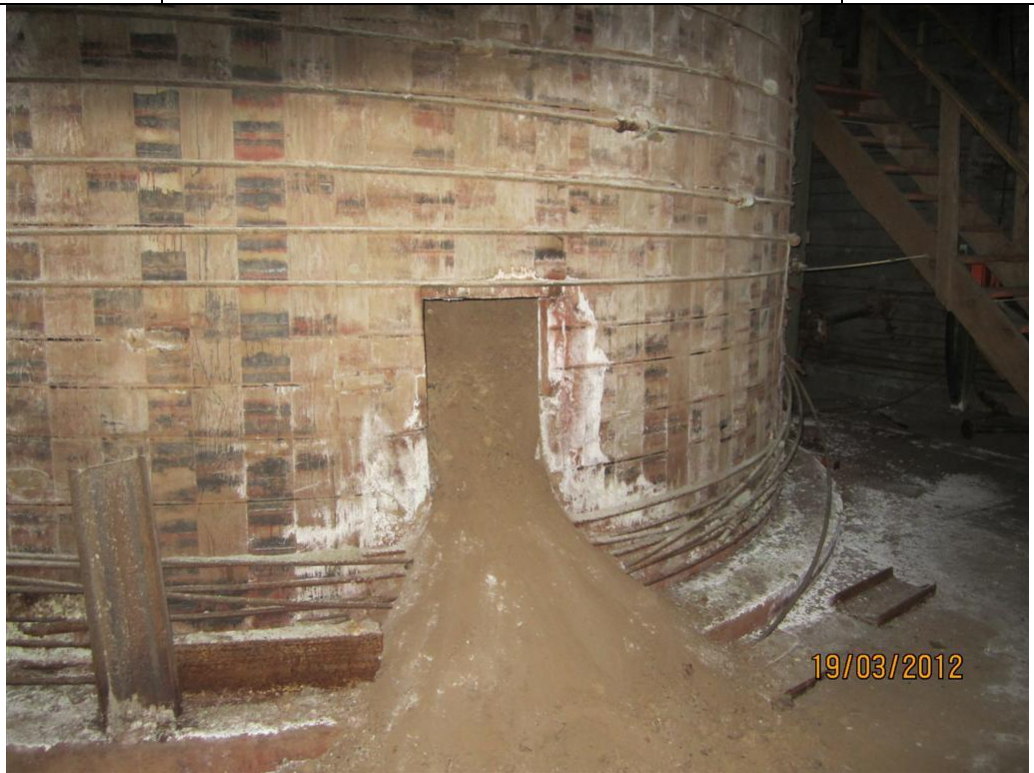
Contents of CIP tank,  
White scale on tank as  
well as on concrete  
floor

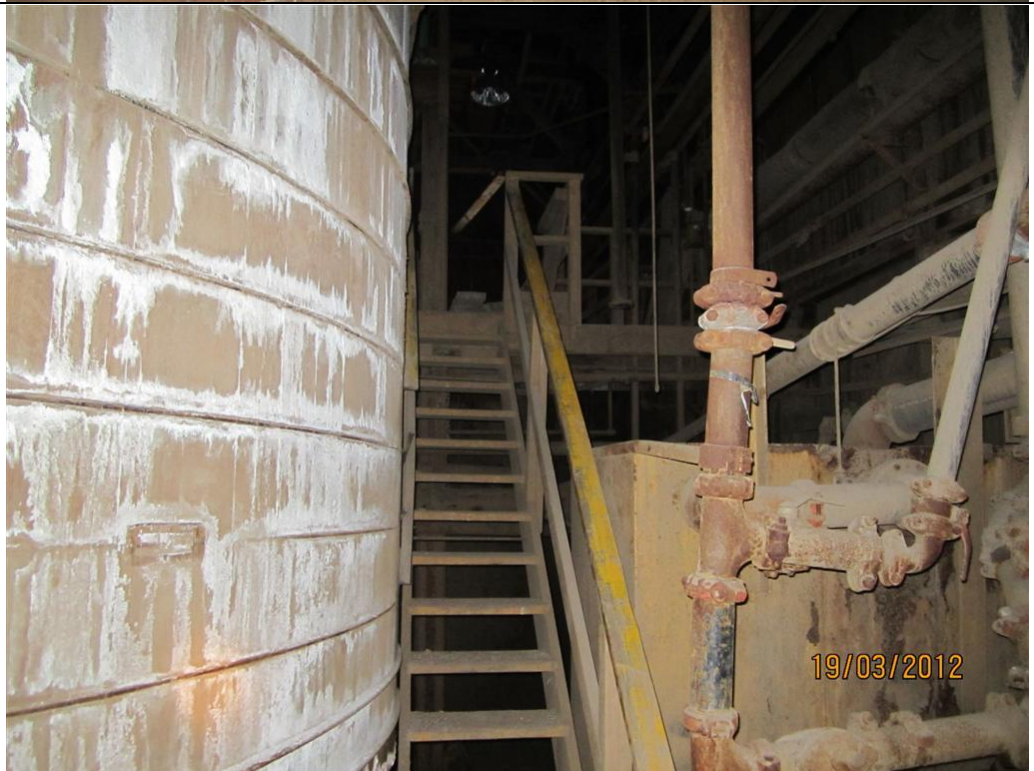
Staining on wooden  
tank, typical dust on  
process equipment in  
AC Roaster Building

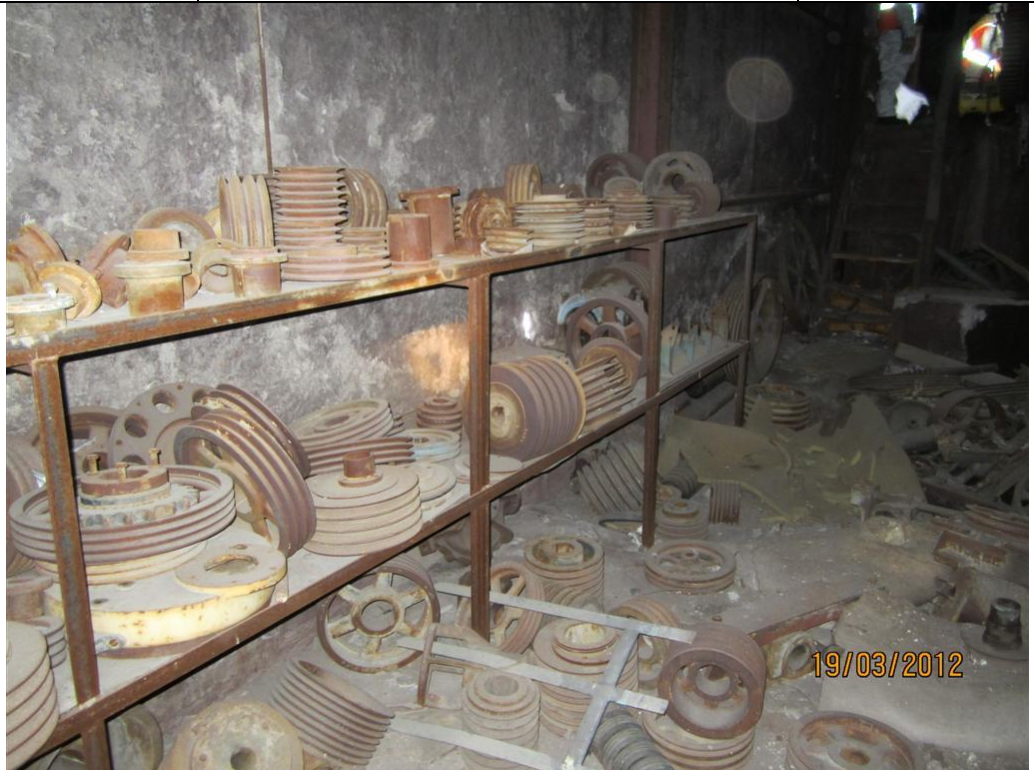
Dust covered spare parts in Calcine Building, exterior transite panels coated with spray applied asbestos insulation.

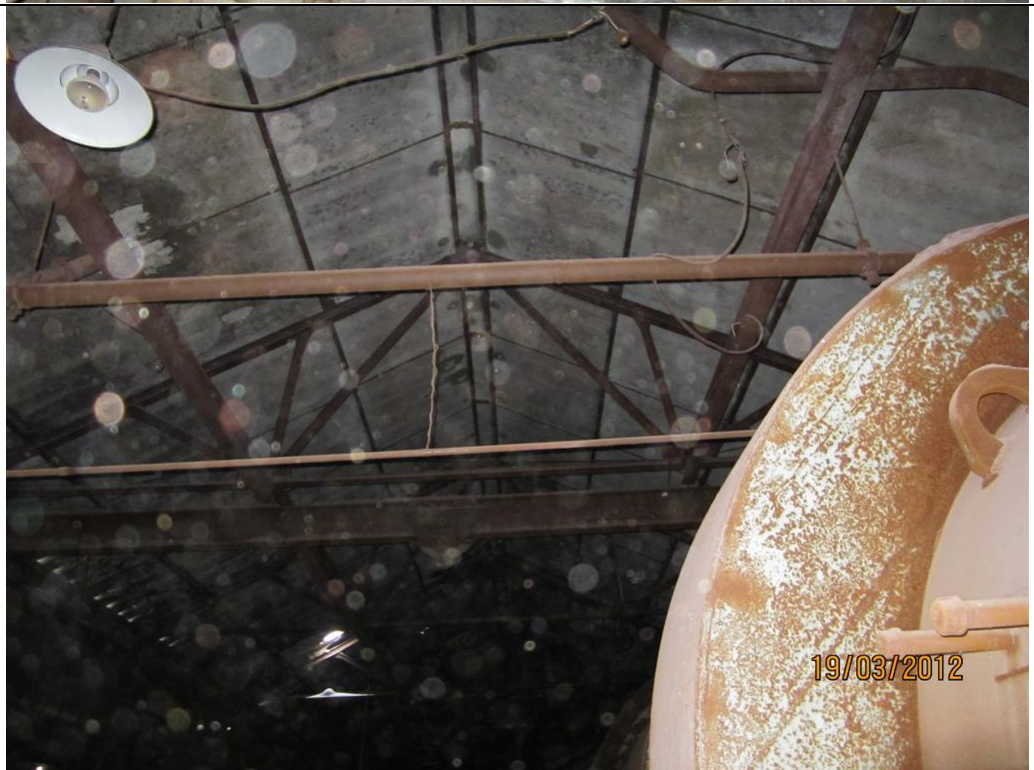
Underside of roof in Calcine Building. Delamination of sprayed on asbestos insulation is occurring, asbestos insulation debris is visible on equipment throughout building

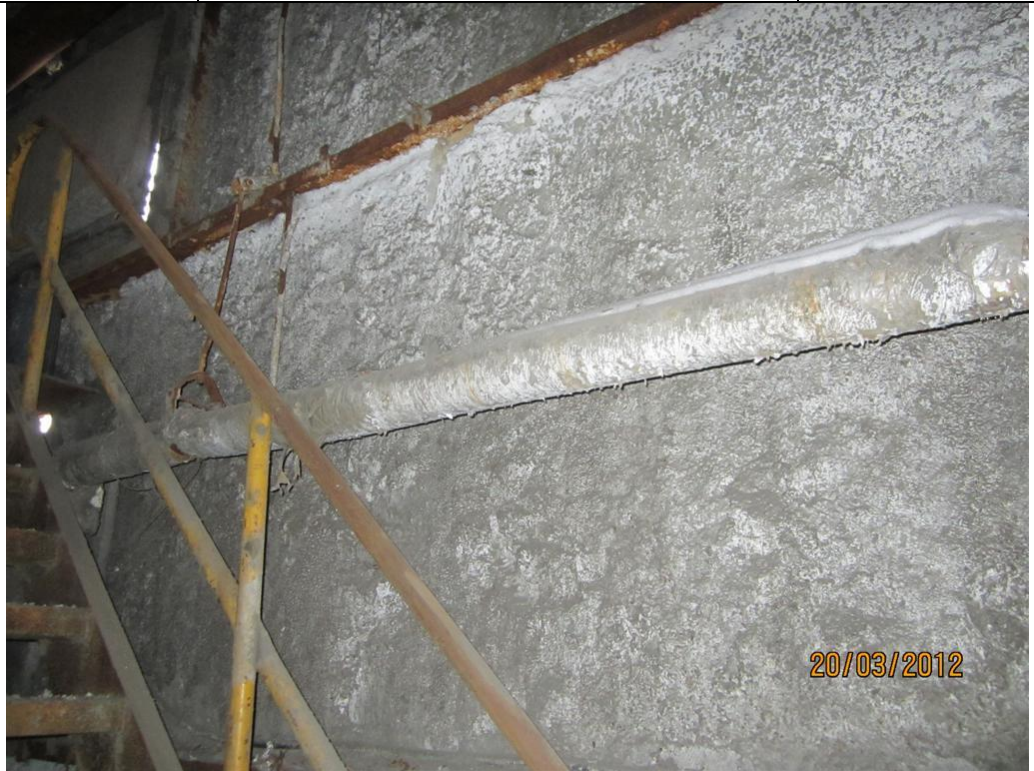
Exterior asbestos insulated wall panels coated with a spray applied asbestos insulation on the interior surfaces. Delamination of sprayed on asbestos insulation is occurring, asbestos insulation debris is visible on equipment throughout building

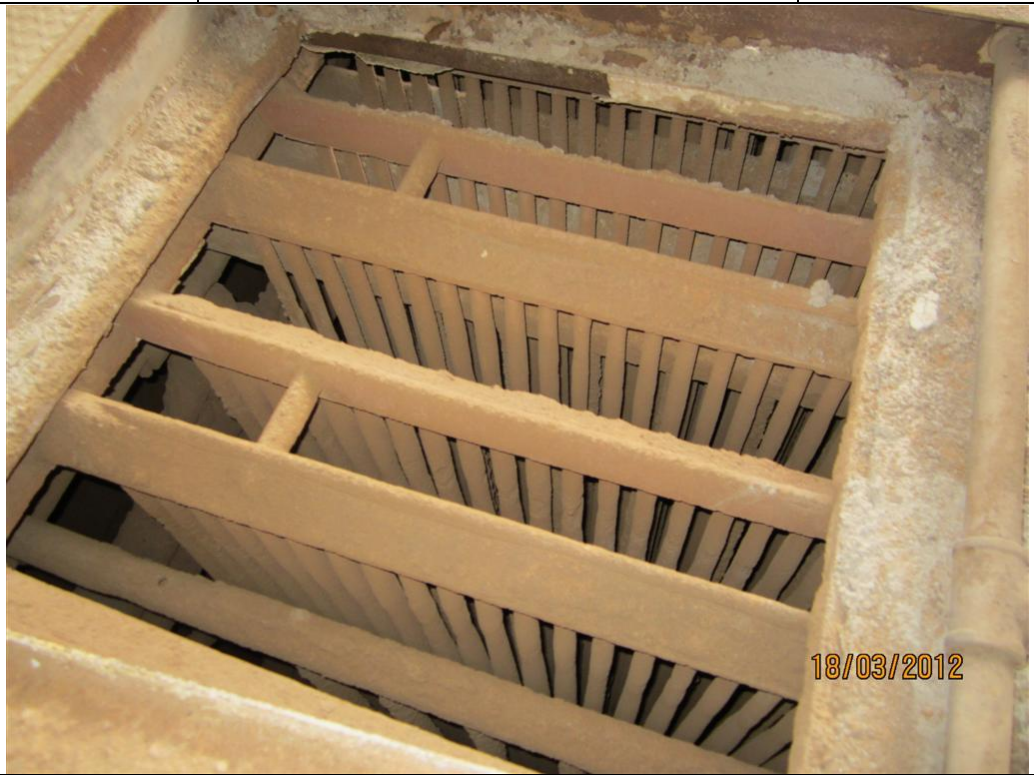
Arsenic scale on precipitator rods

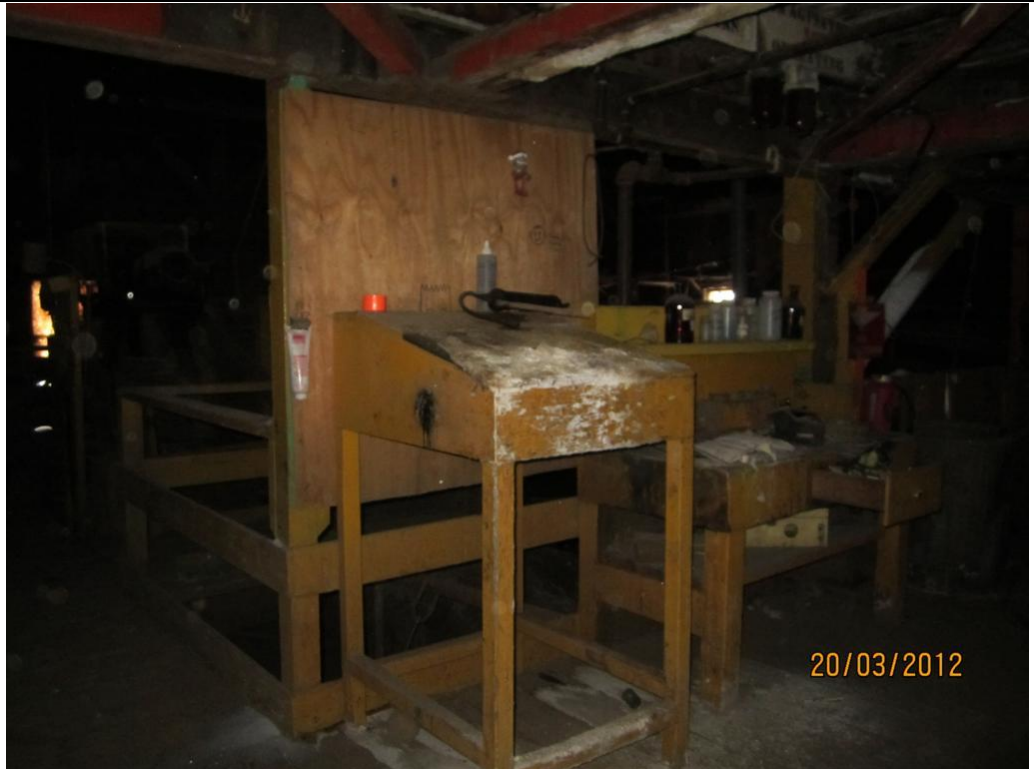
Stained wood (floor, 2<sup>nd</sup> level floor joists) in cyanide process area

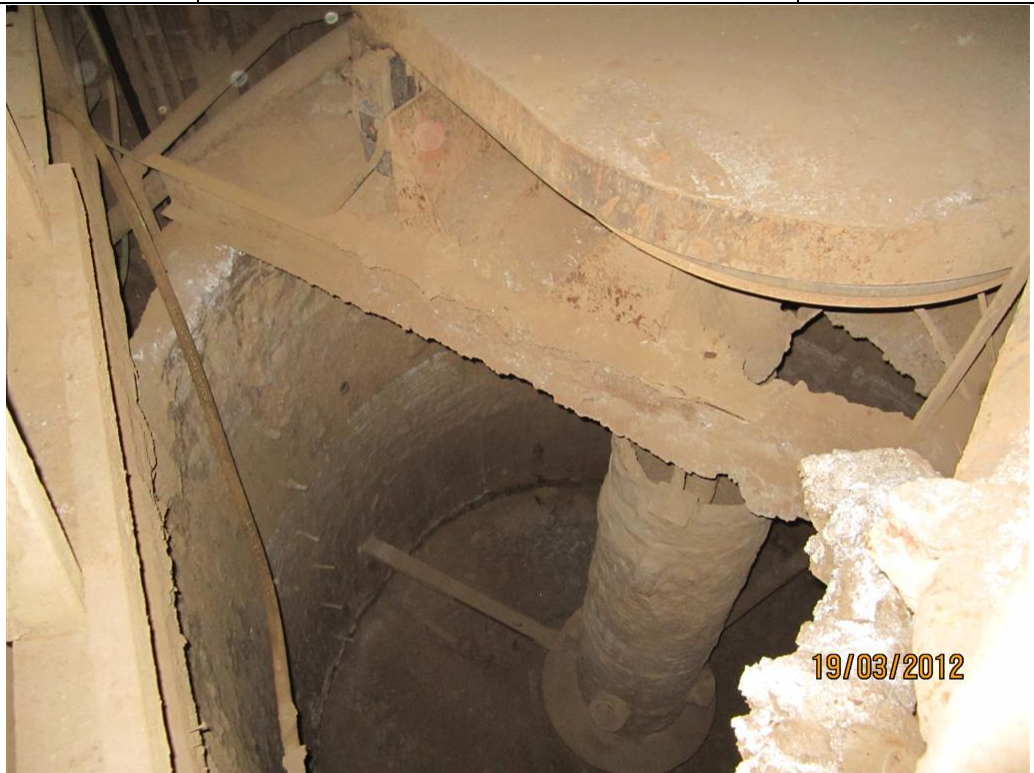
Process Residuals coating tank and equipment

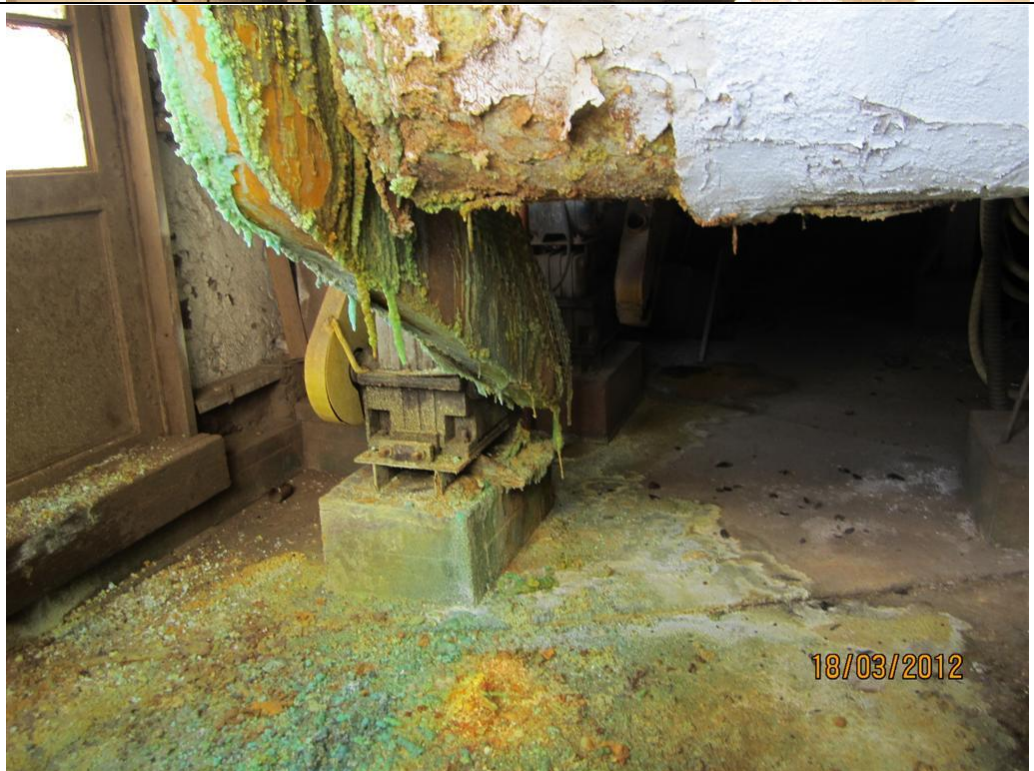
Scale on base of precipitator hopper and on concrete floor

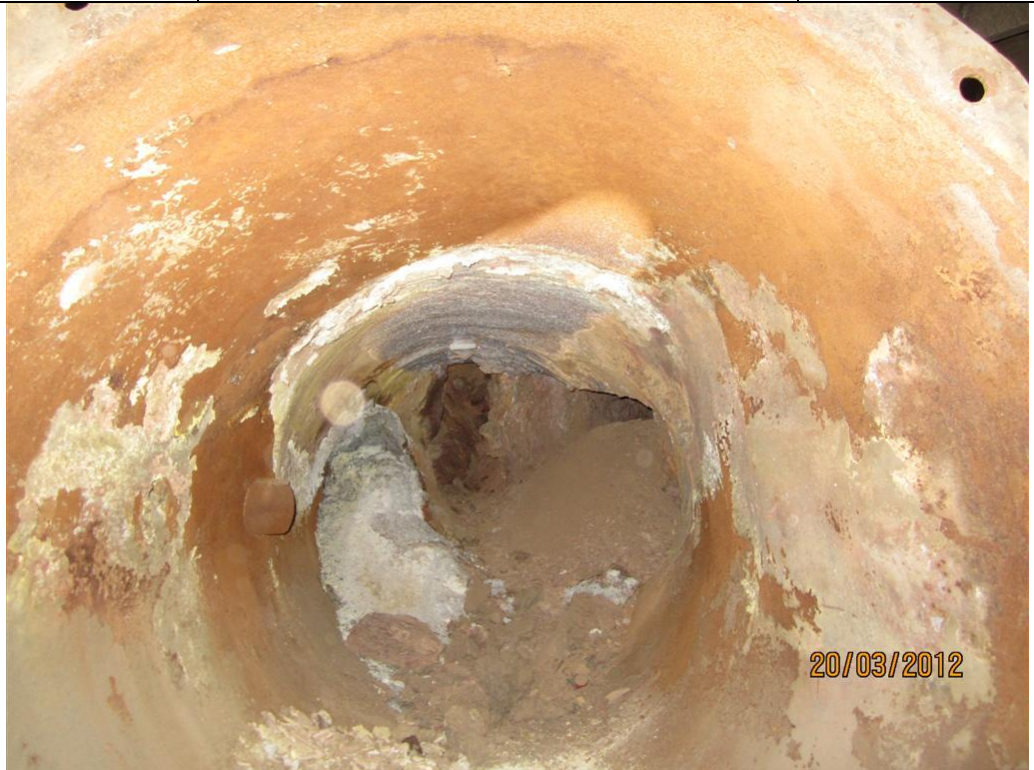
Arsenic Trioxide dust located in abandoned exhaust flue network

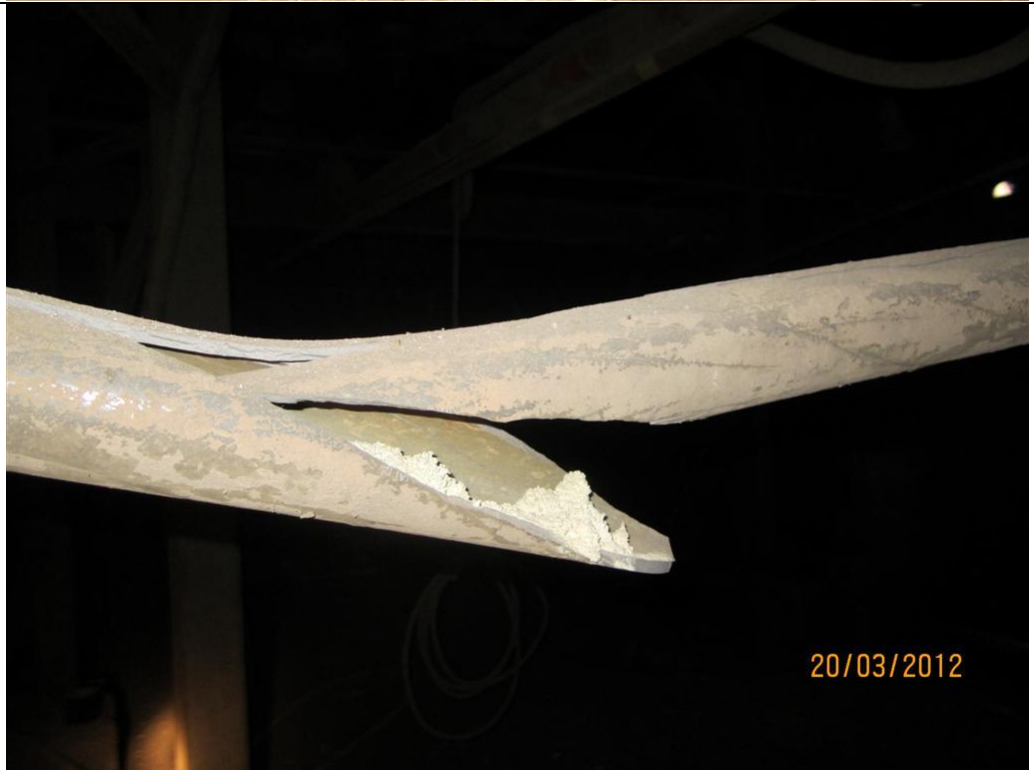
Typical scale located inside process piping

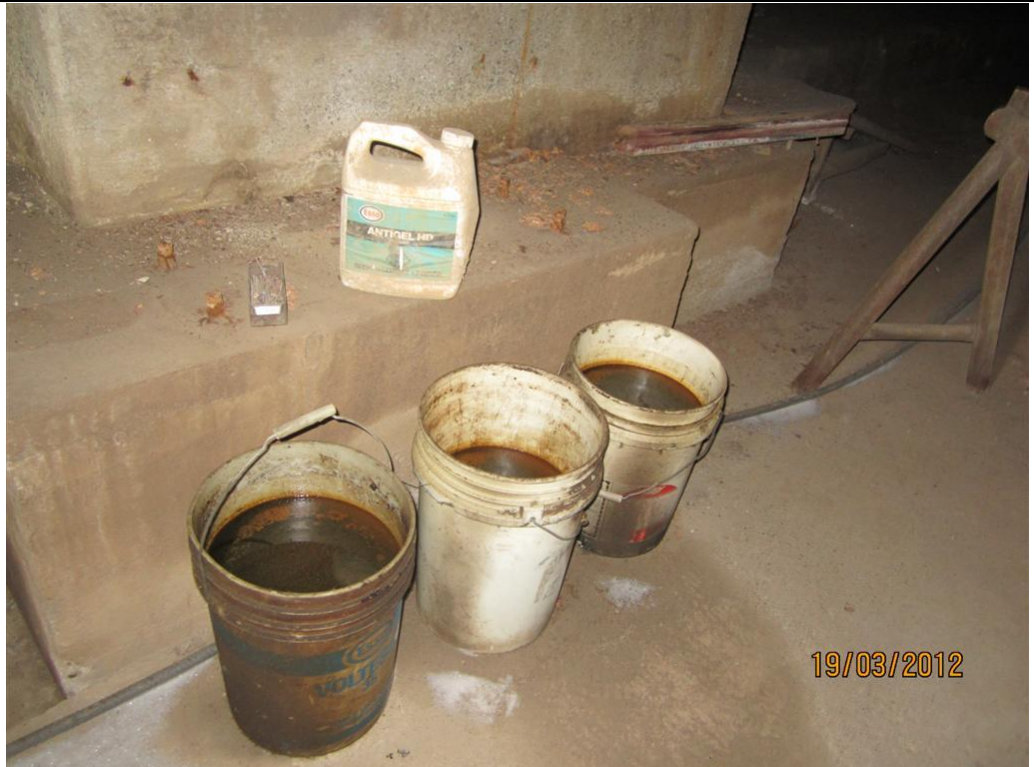
Open pails of unidentified oils

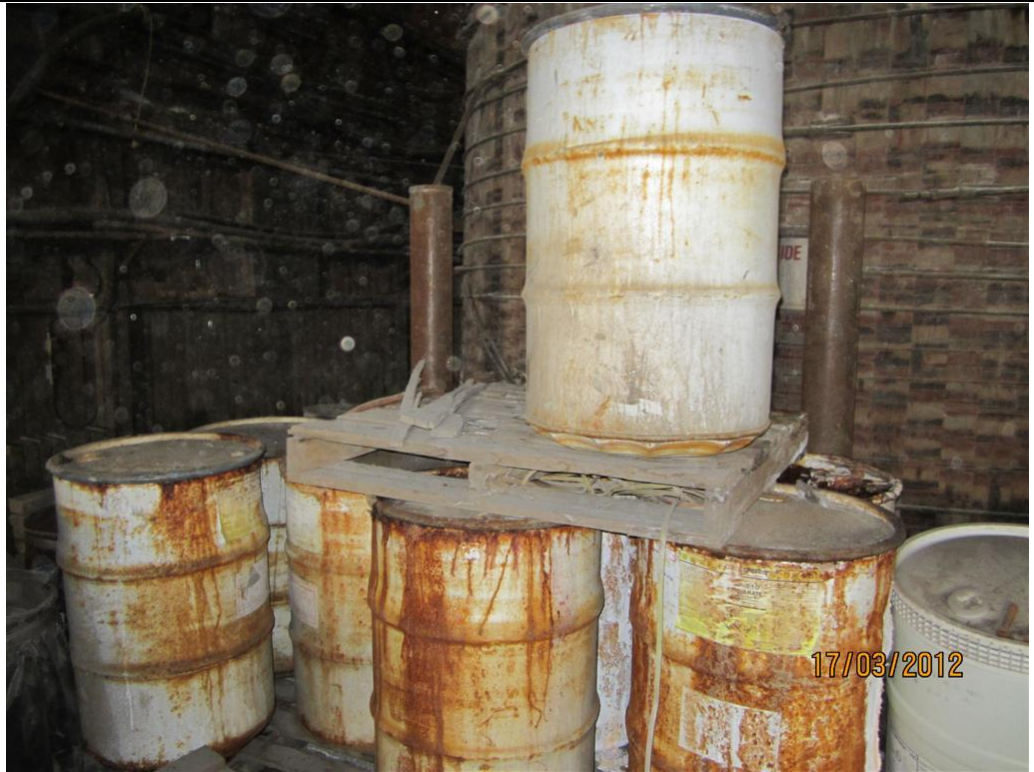
Barrels of asbestos encapsulant

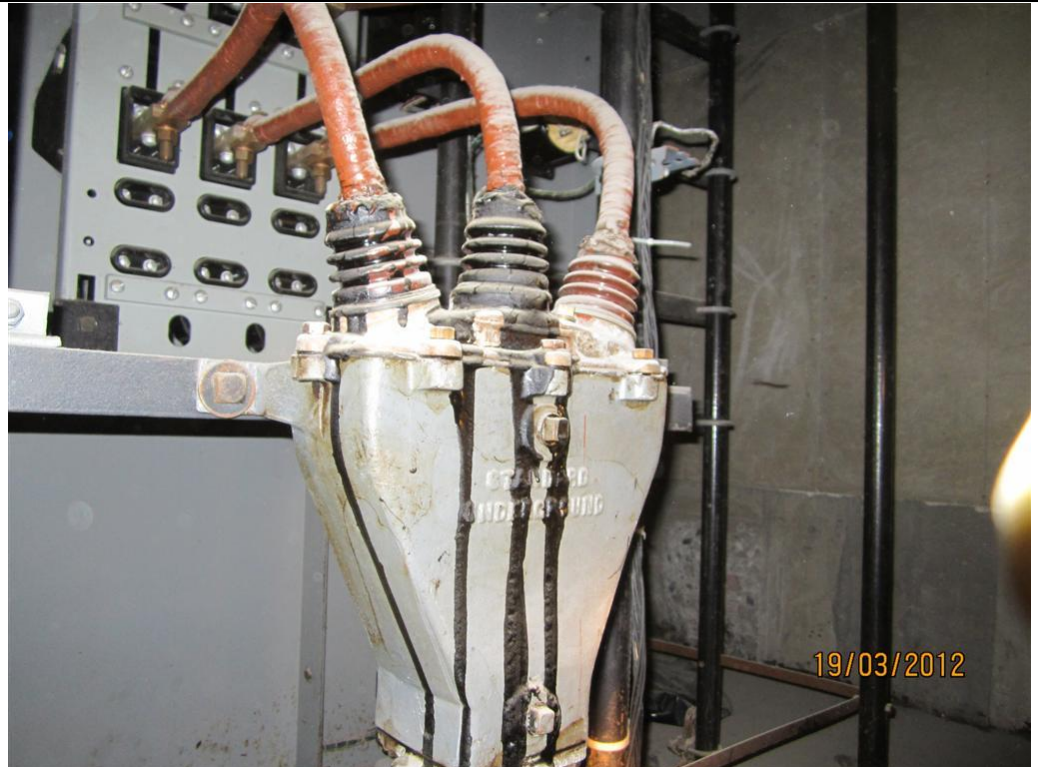
Suspect PCB  
containing electrical  
equipment

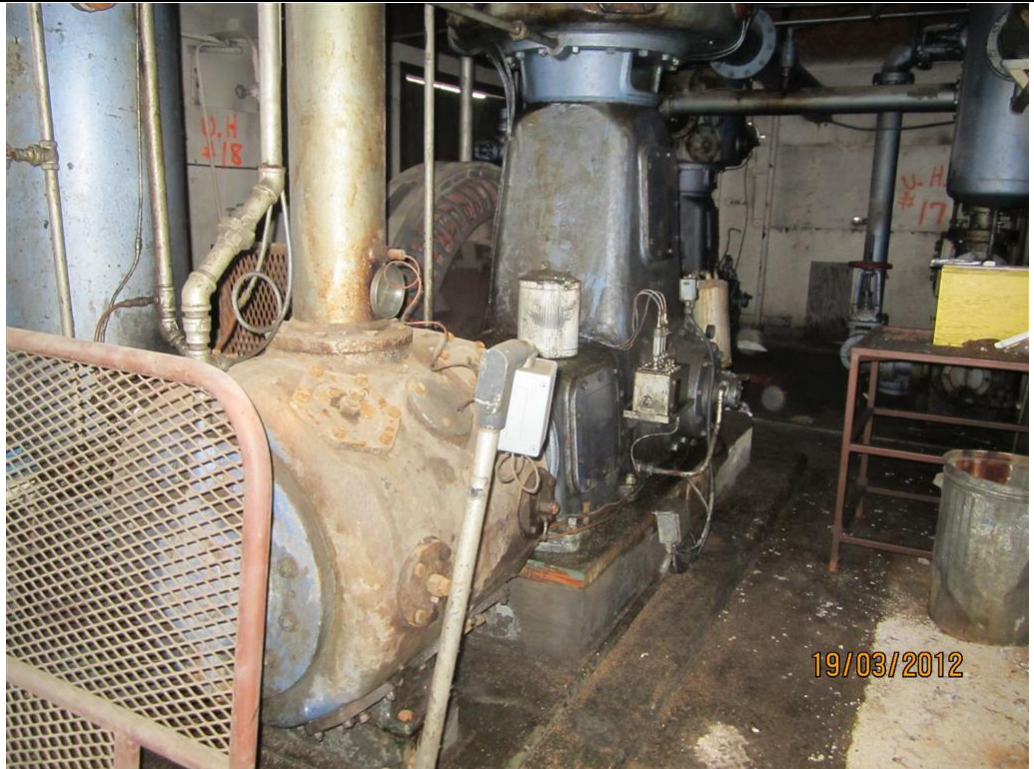
Compressor equipment, potentially containing oils and lubricants

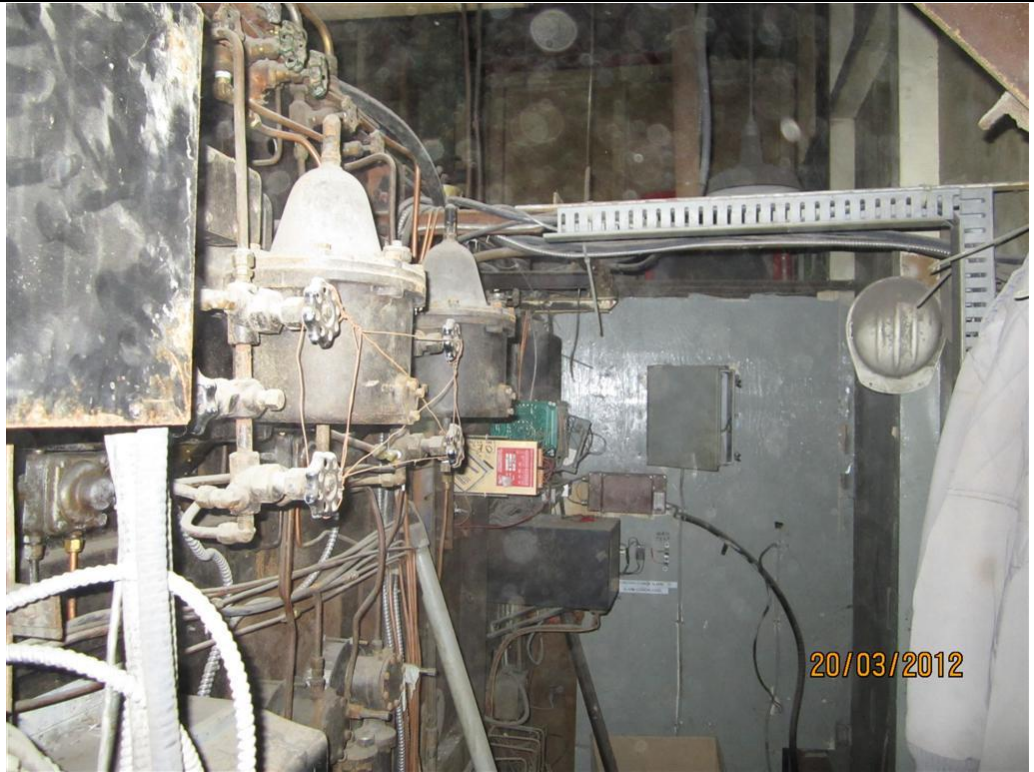
Mercury containing equipment in control room

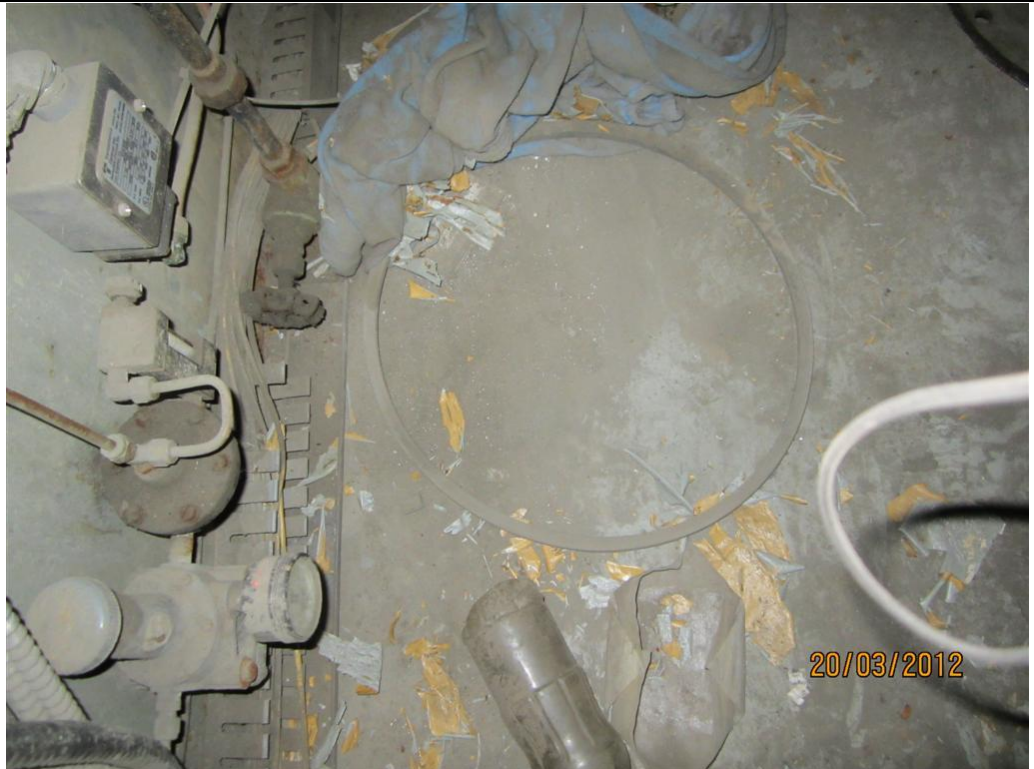
Spilled mercury and dust/debris located on control room floor

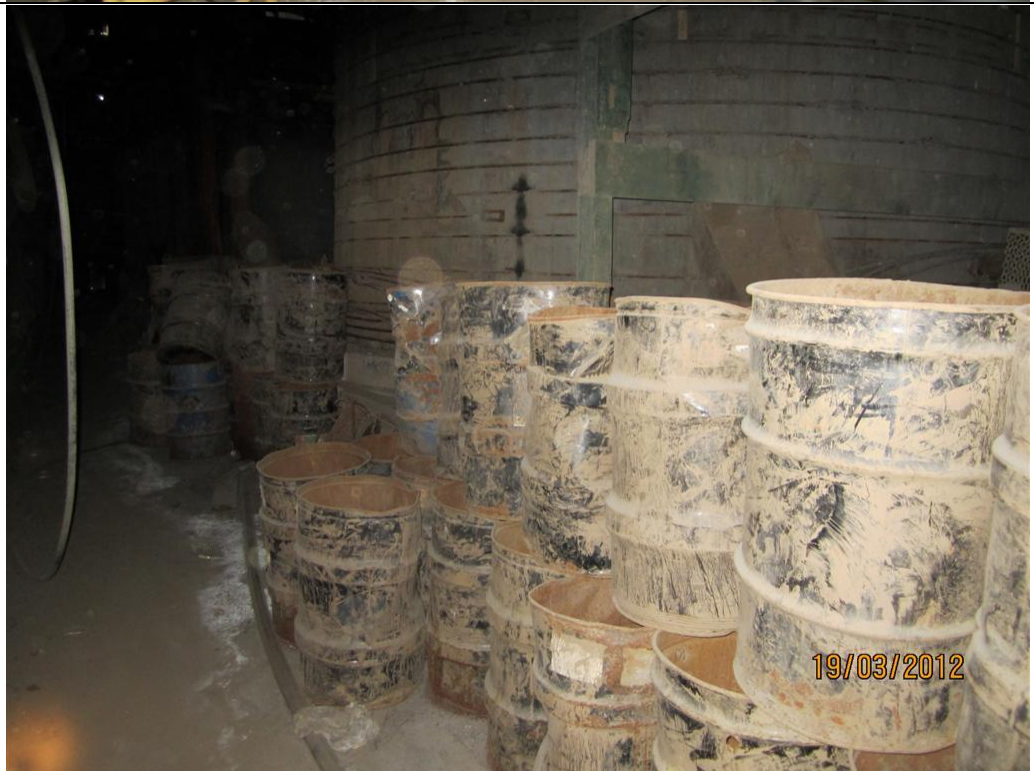
Suspect empty sodium cyanide barrels, potentially containing residual amounts of product
