G I A N T
YELLOWKNIFE MINES LIMITED

SUBJECT: TRP - PLANT MONTH END REPORT - JULY 1988

TRP SUMMARY OF OPERATIONS

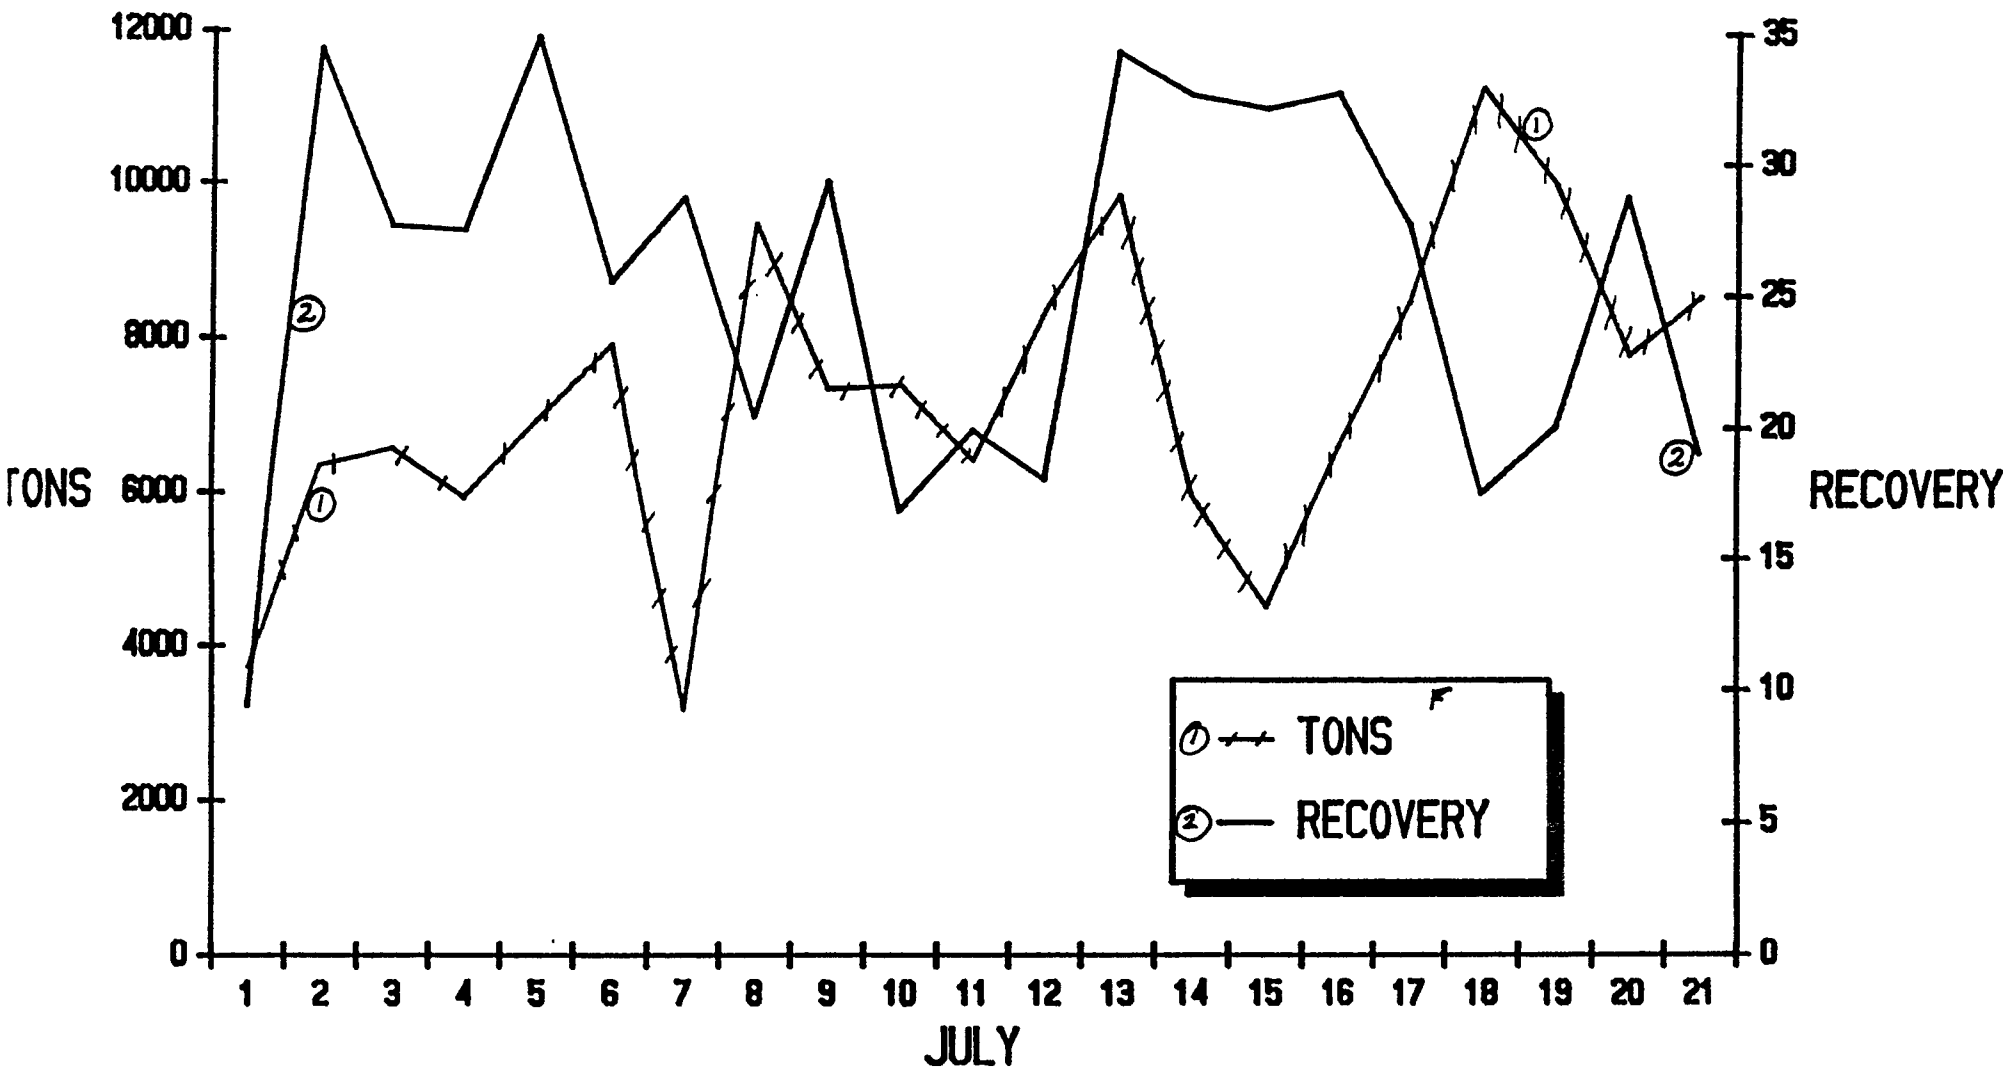
FIG. 1 TONS/RECOVERY RELATIONSHIP
TRP 1988

FIG. 1 shows the relationship between tons of ore fed to the CIL area and the CIL recovery. No specific conclusions can be drawn from this. The recovery problem does not appear to be related to feed rate. FIG. 2 shows plant head grade compared to recovery, and again there does not appear to be any specific trend.

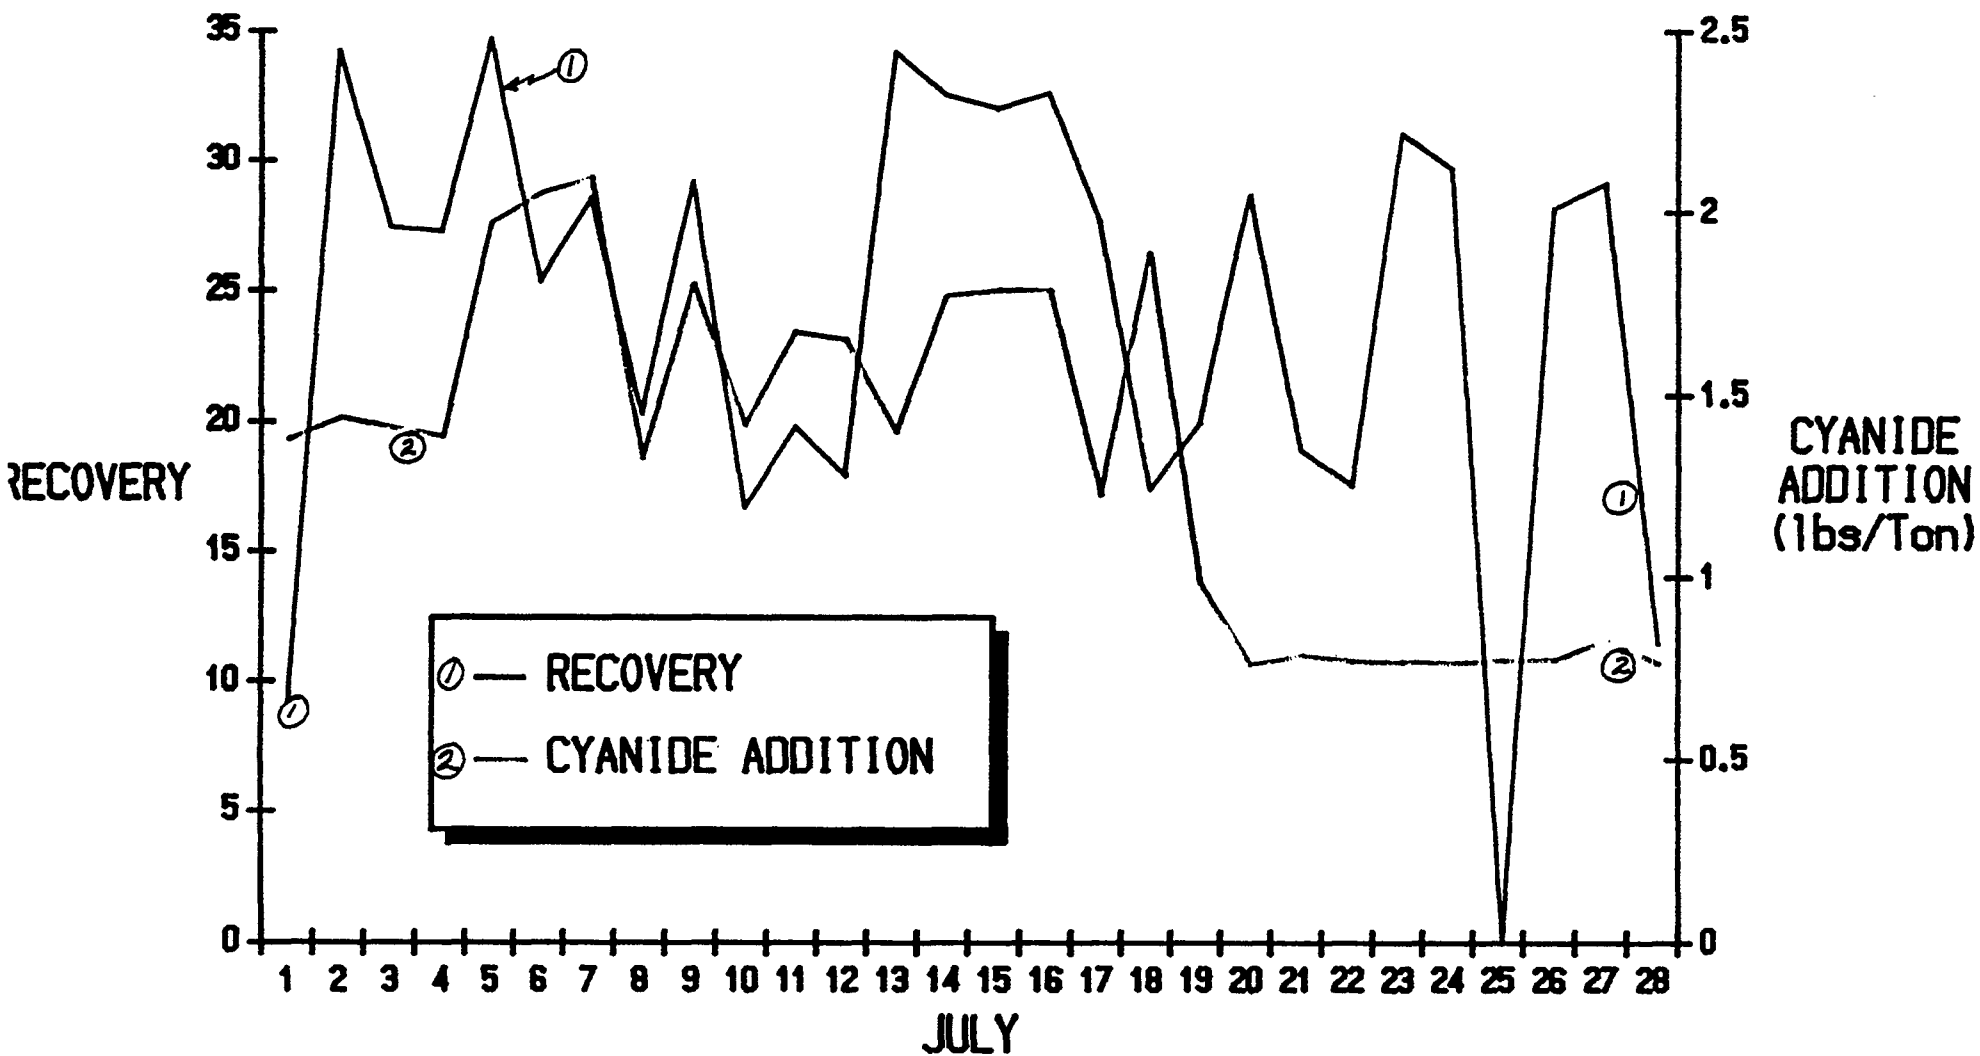
FIG 3 CYANIDE ADDITION/RECOVERY RELATIONSHIP
TRP 1988

FIG. 3 compares cyanide addition and recovery. Some short term trends appeared but when the addition rate was cut these trends were not maintained.
