Final Abandonment and Restoration Plan Miramar Giant Mine Ltd.

VOLUME III OF III

APPENDIX A-9
ANNUAL DAM INSPECTION 2001

**2001 GEOTECHNICAL INSPECTION OF
GIANT MINE TAILINGS DAMS
YELLOWKNIFE, NT**

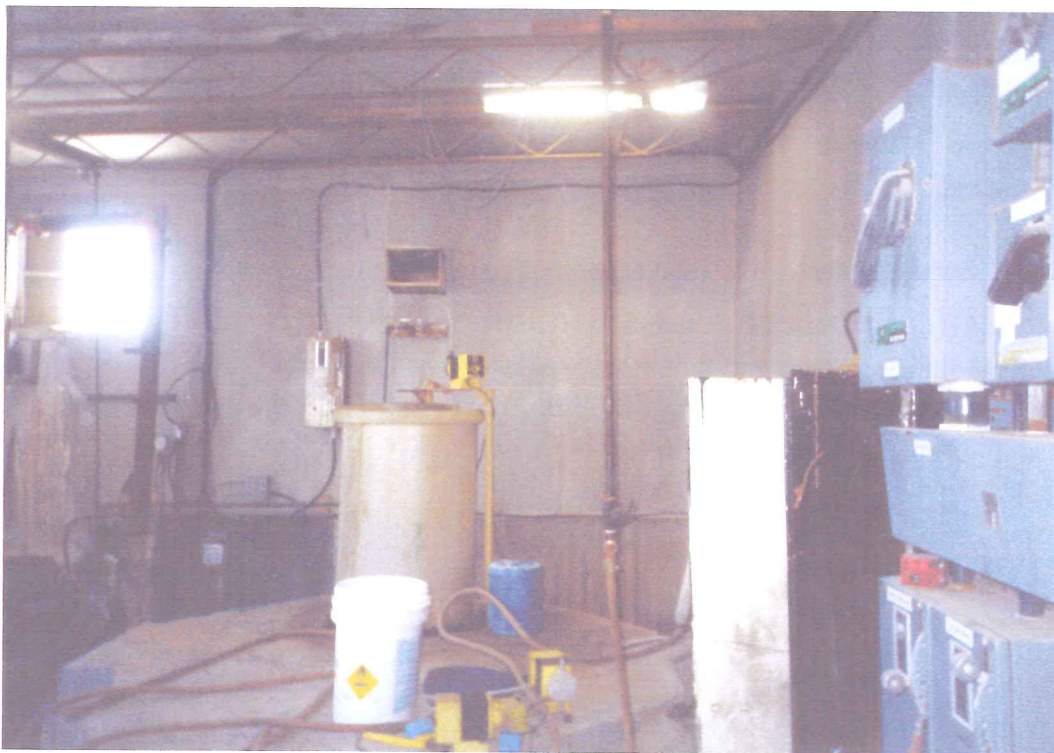
**"A" SHAFT
BUILDING #076
#2 MAIN PUMP HOUSE**

Interior Showing Steel Roof Supports
Asbestos Type 1 on Walls & Ceiling and Concrete Pedestal

- all workers to wear Class "C" complete with dust particle respirators as minimum protection;
- proper handling of Asbestos material;
- proper handling of PCBs; and
- proper handling of lead painted items.

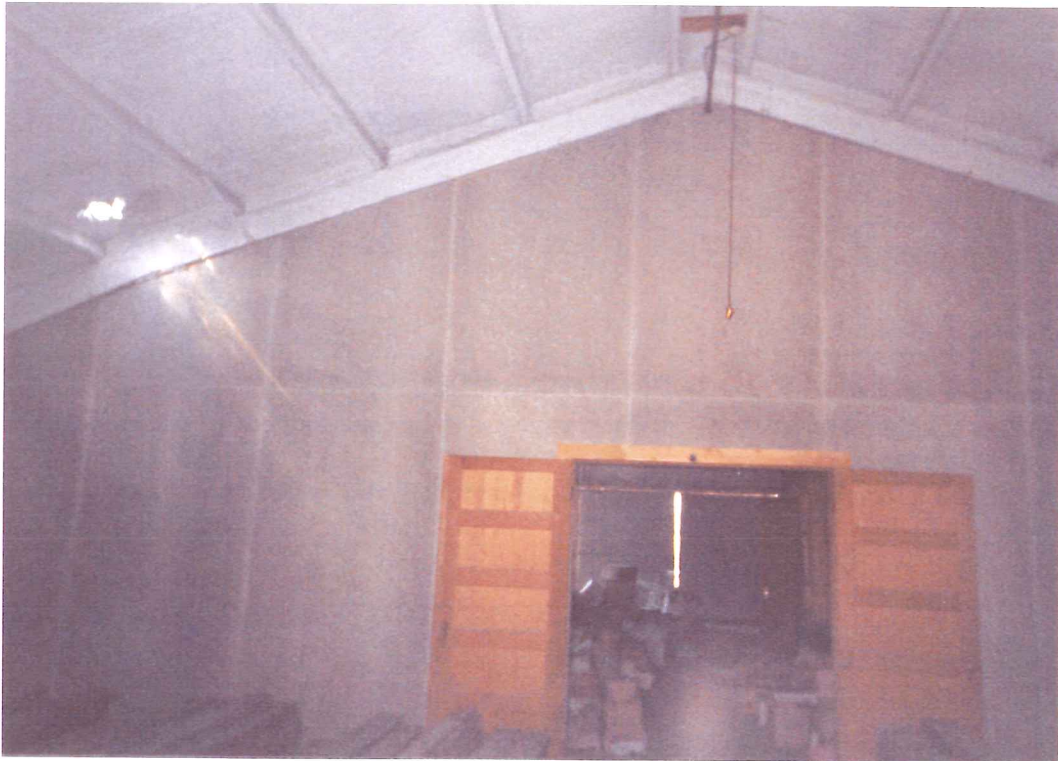
**AKAITCHO MINE SITE
EXPLORATION BUILDING**

Interior 2nd Floor - Asbestos Type 1 and Type 2

- all workers to wear Class "C" complete with dust particle respirators as minimum protection;
- measures must be taken to ensure that Asbestos Type 2 insulation attached to siding, roofing and steel is not allowed to escape into the environment during the demolition and transportation of same; and
- enforce safe working habits for demolition type projects.

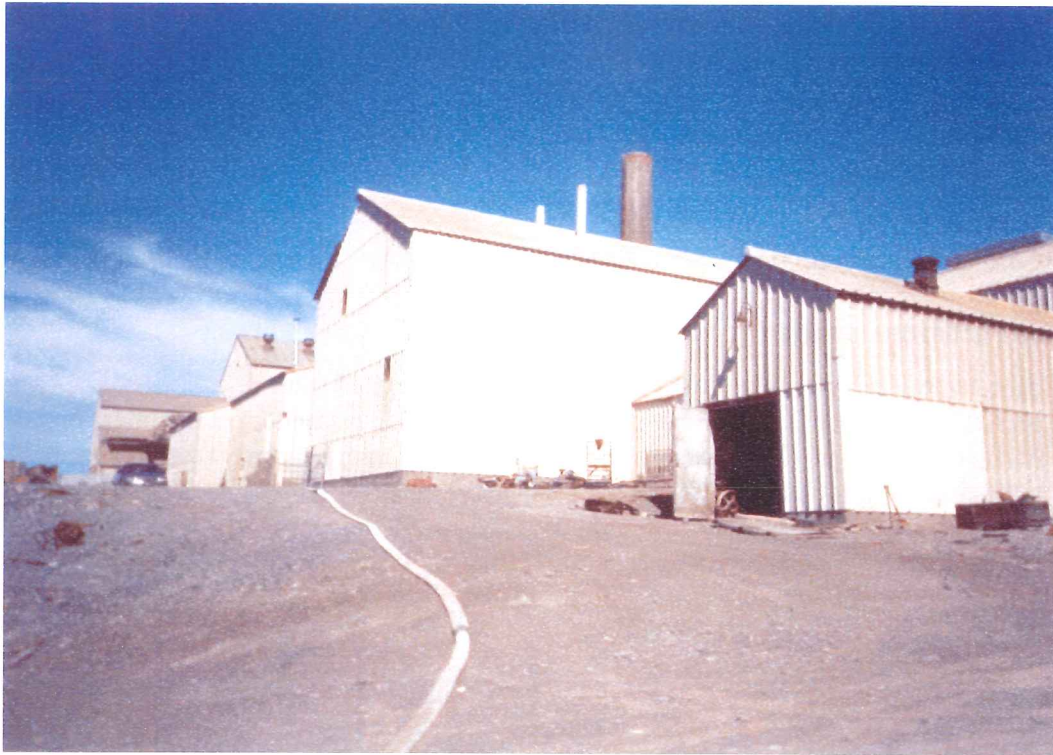
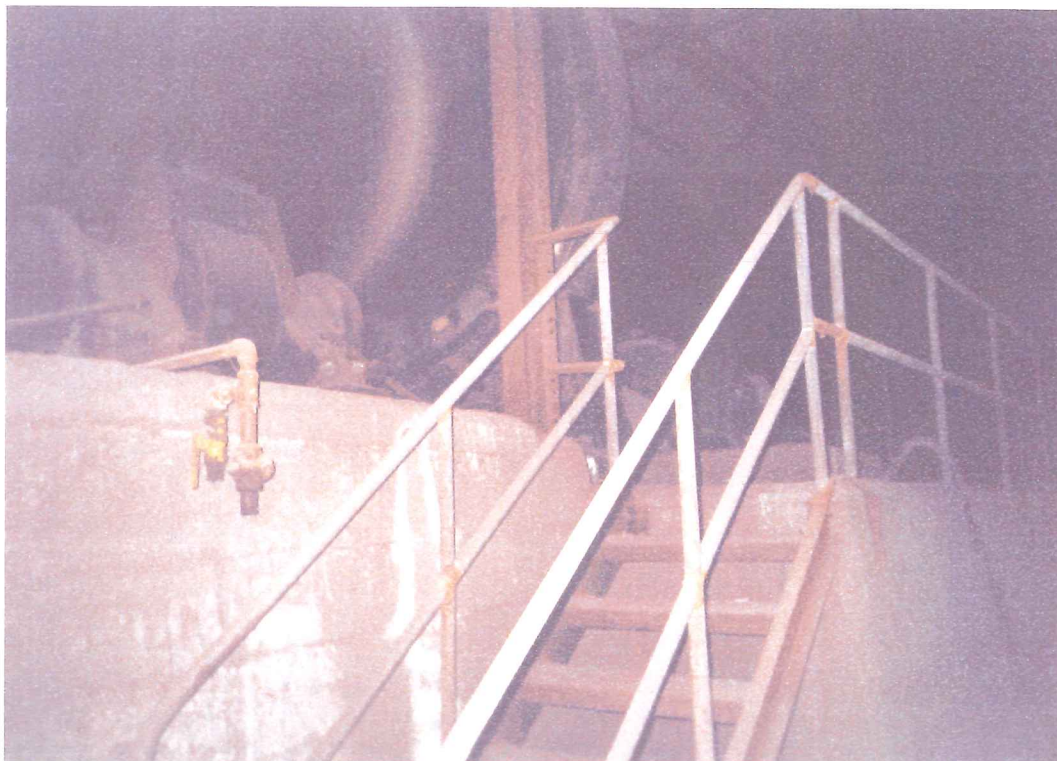
**"C" SHAFT
BUILDING #162
CALCINING PLANT**

Interior – Concrete Pedestals Kiln
