Baker Creek 2011 Fish & Water Monitoring

Presented by Hilary Machtans,
Golder Associates, Yellowknife Office

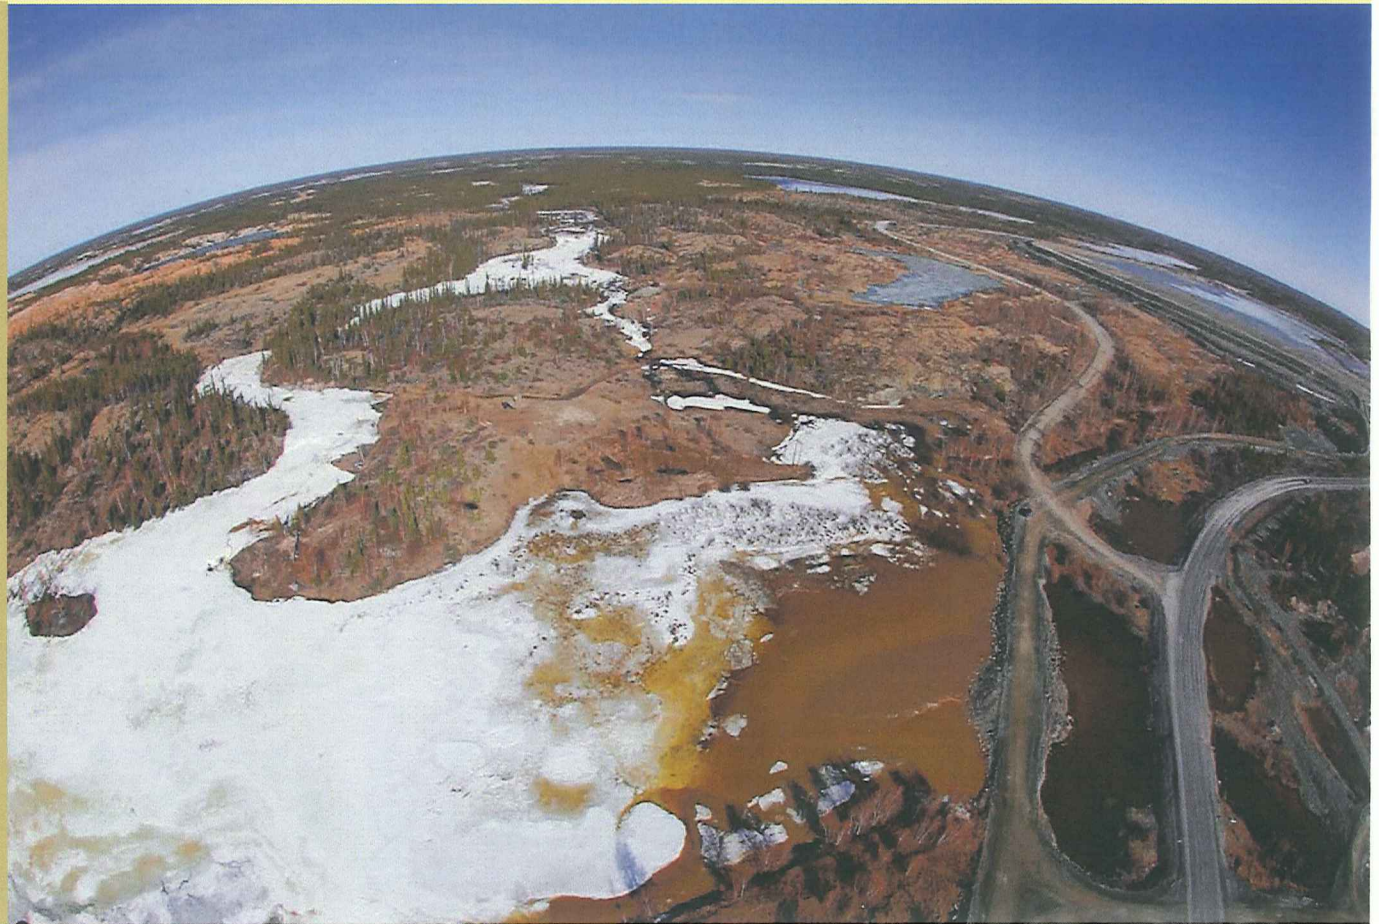
- During 2011 spring freshet, an ice-dam created throughout the winter, caused the creek to leave its channel and flow over some new areas

The tailings submerged by overflow, viewed from the air

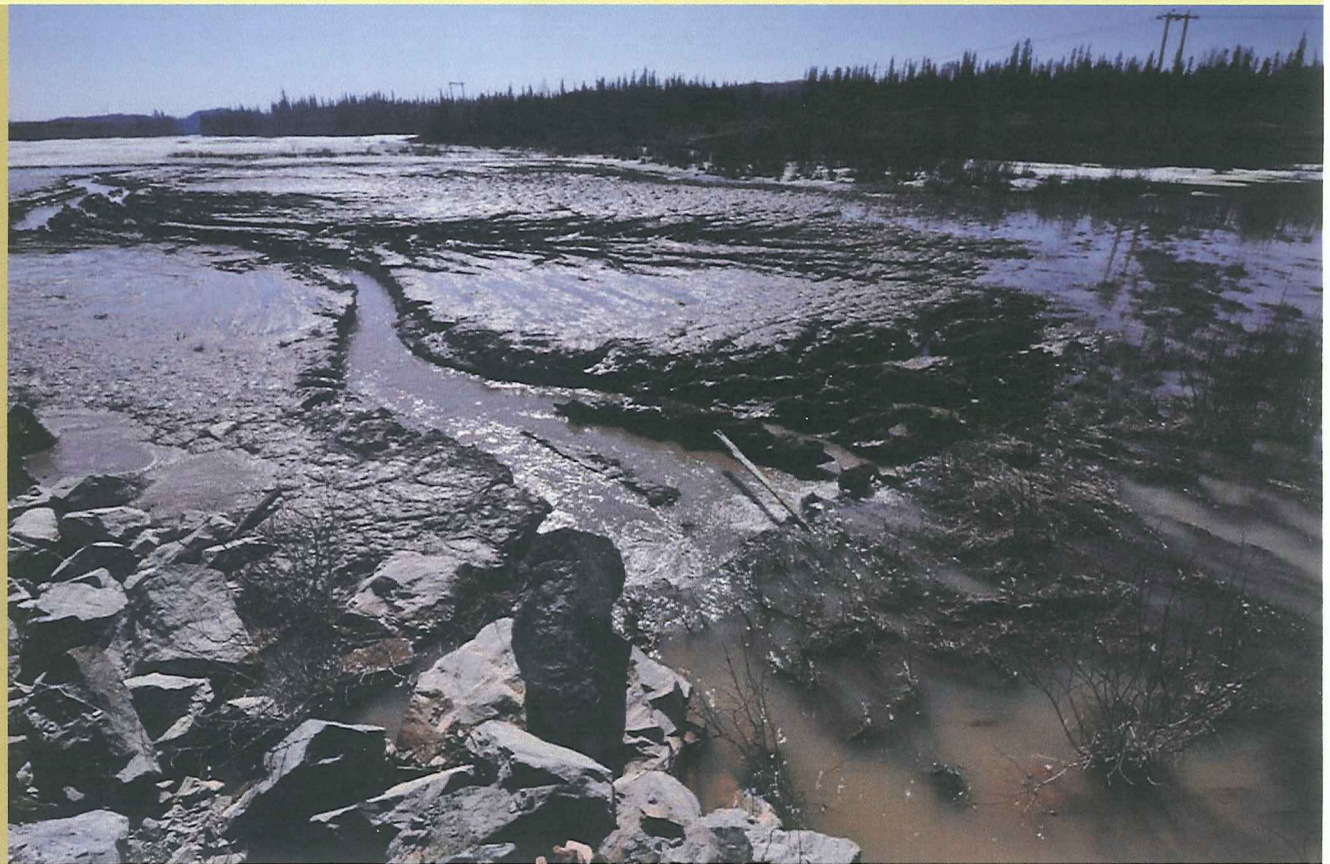
- Large amounts of contaminated tailings were seen to flush into Baker Pond

The tailings viewed from
Vee Lake road, looking towards
Baker Pond

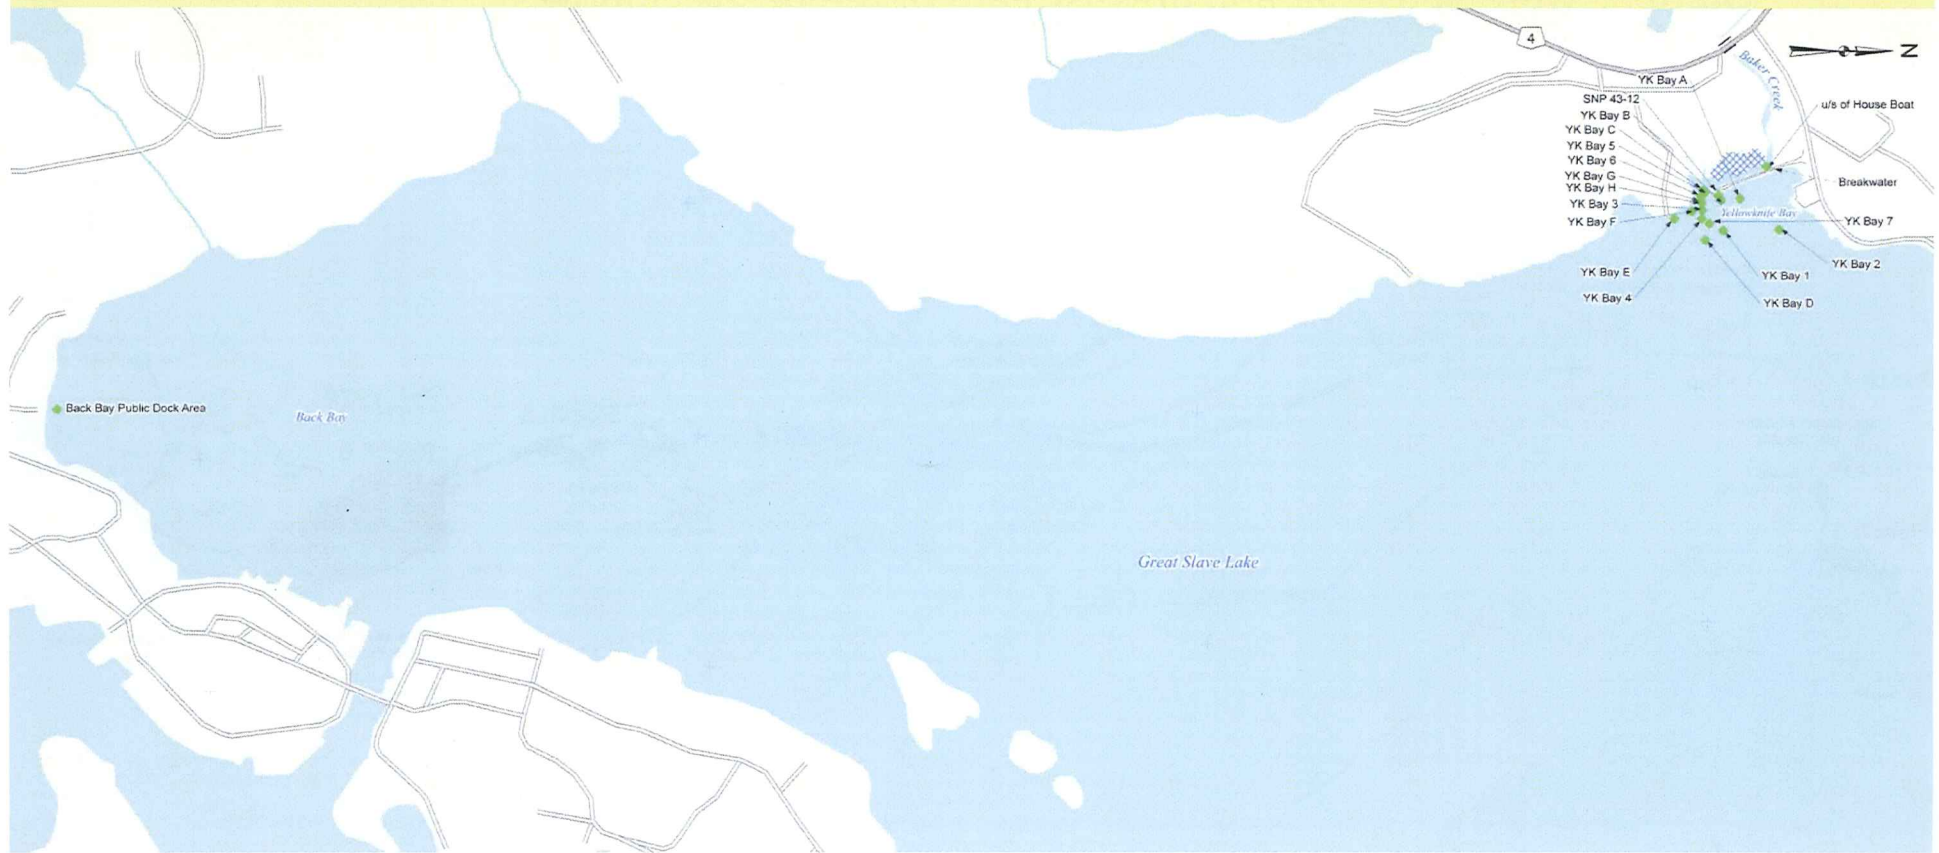
- We also established sampling stations throughout the possibly affected areas in Yellowknife Bay

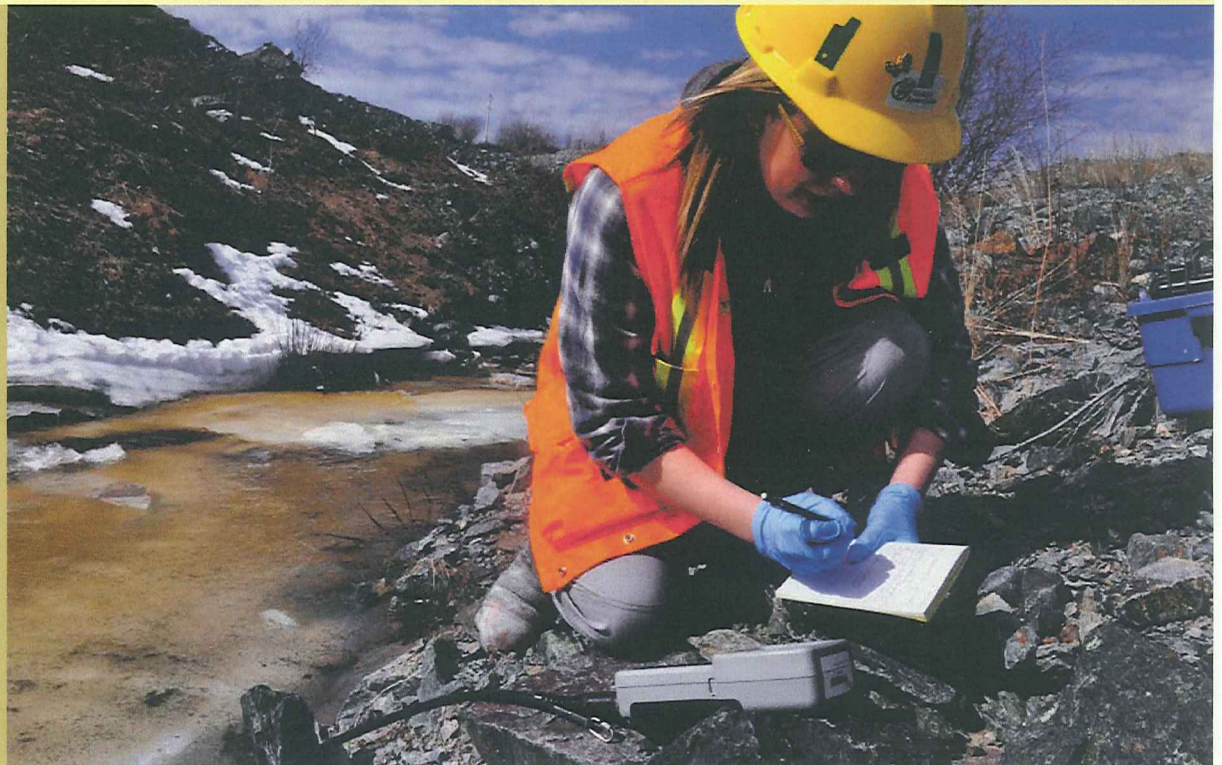
Immediately on May 16, field crew collected water for acute toxicity

- Water samples were sent to laboratory in Calgary

Daily field work for taking water samples and on-site readings

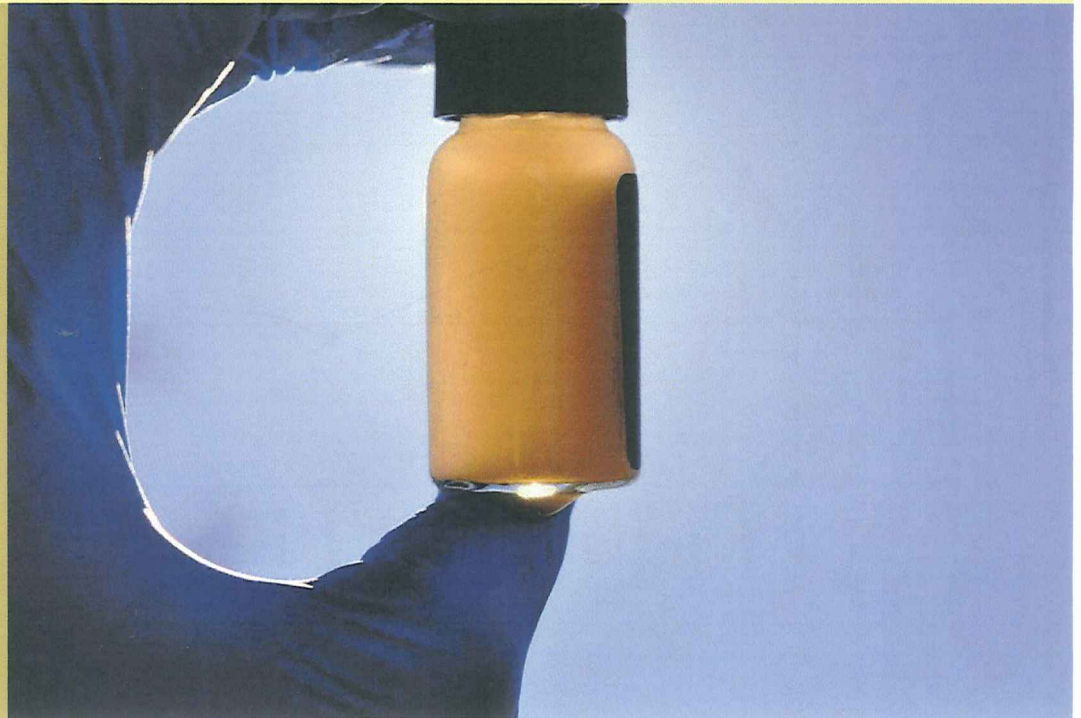
- Early water samples should high levels of turbidity
- This was due to the high amount of silt (fine particles) washed into Baker Creek
- High turbidity levels lasted approximately two weeks

A water sample from Baker Pond shows high turbidity levels in mid May
