Final Abandonment and Restoration Plan Miramar Giant Mine Ltd.

**FINAL ABANDONMENT AND
RESTORATION PLAN
PREPARED FOR
INDIAN & NORTHERN AFFAIRS CANADA
BY
MIRAMAR GIANT MINE LTD.
YELLOWKNIFE, NT**

VOLUME II OF III

September 26, 2001
002-2418/9000

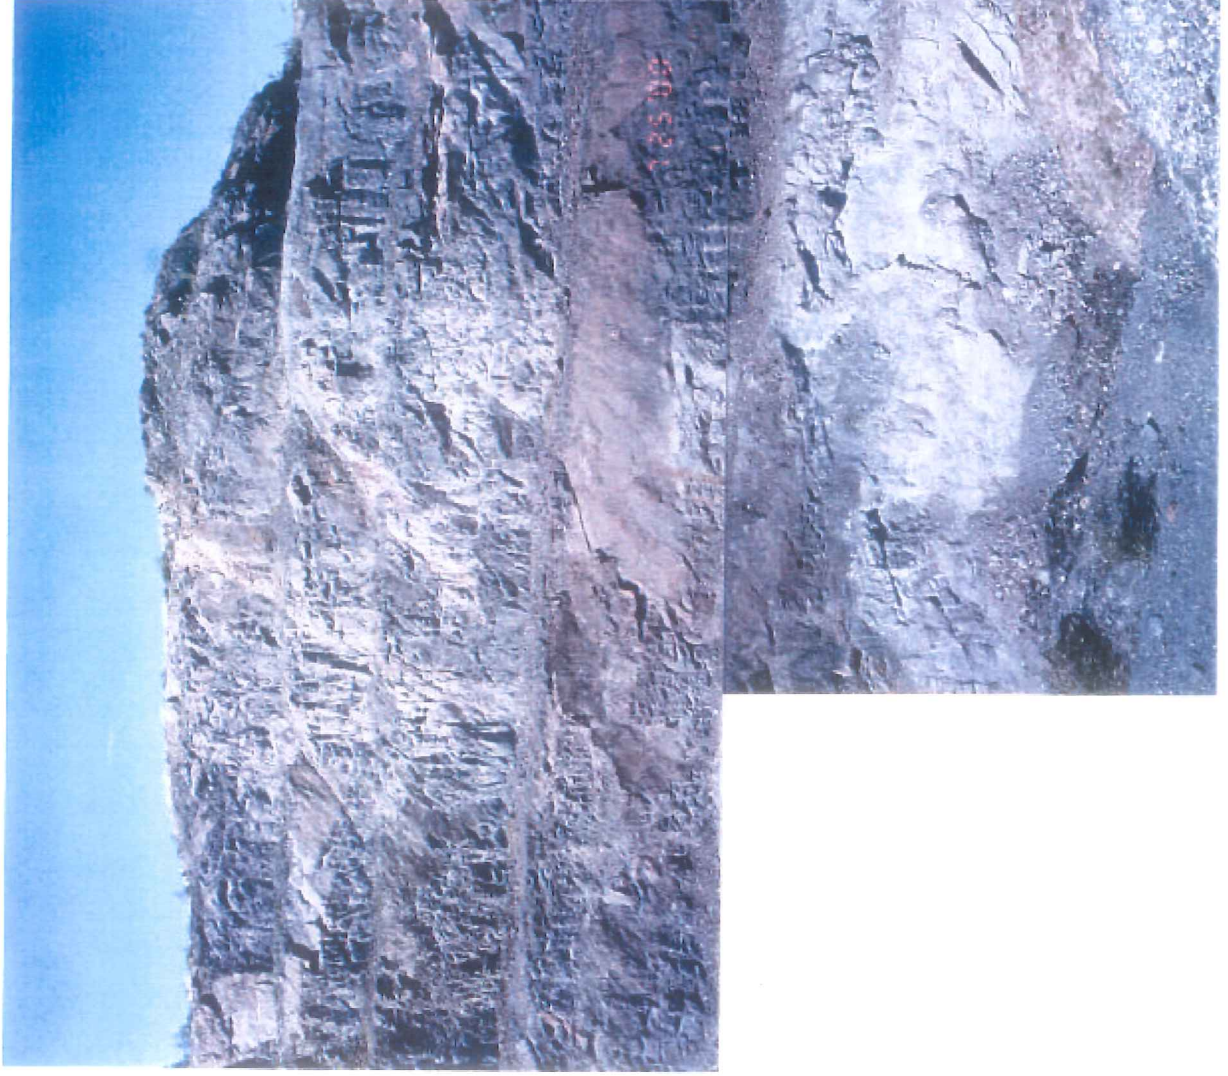
The overall pit and the pit slopes are generally in good condition and appear stable. The rock on the west pit slope has raveled and is collecting on the slope benches. This is as anticipated. The slope in the northeast corner of pit appears to be creeping towards the pit. The movement appears to be minor.

The west and south pit slopes appear to be in good condition and there is no concern with these pit walls. The benches on the west slope are partly covered with rock that has raveled from the slopes above each bench.

Photo 1: West Slope with rock on benches.
Golder Associates

The west and southwest pit slopes may be left as they are at present, with a low earth berm around the outside edge. The northeast slope should be re-graded at final closure.

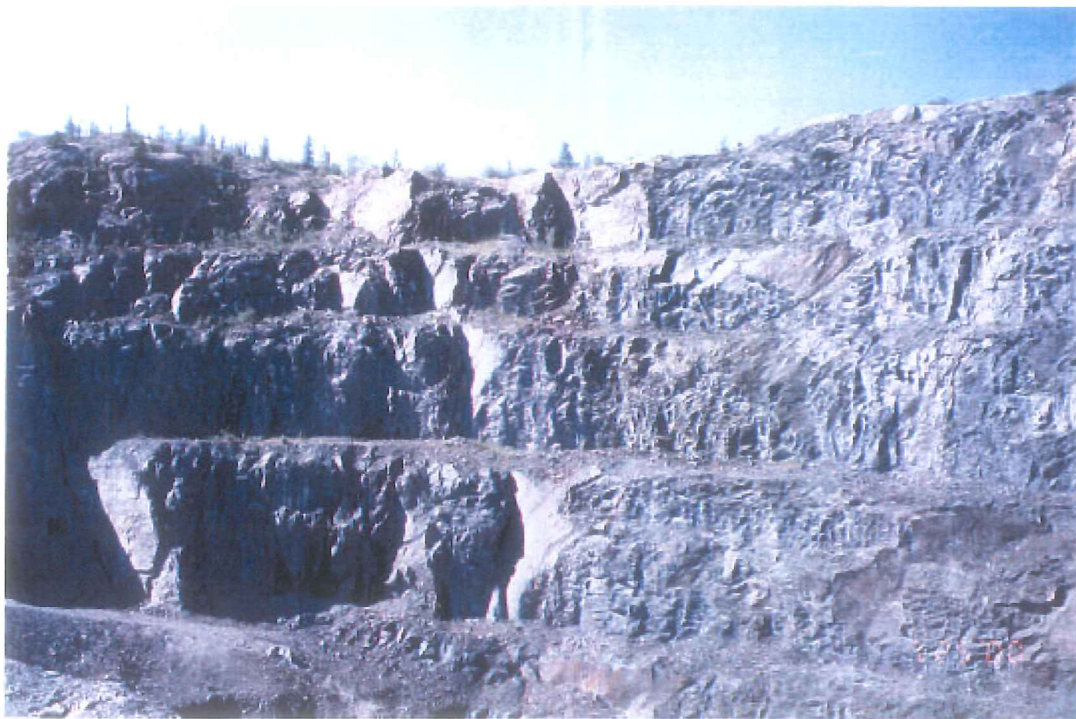
Photo 2: Southeast corner of pit. Slope in good condition.

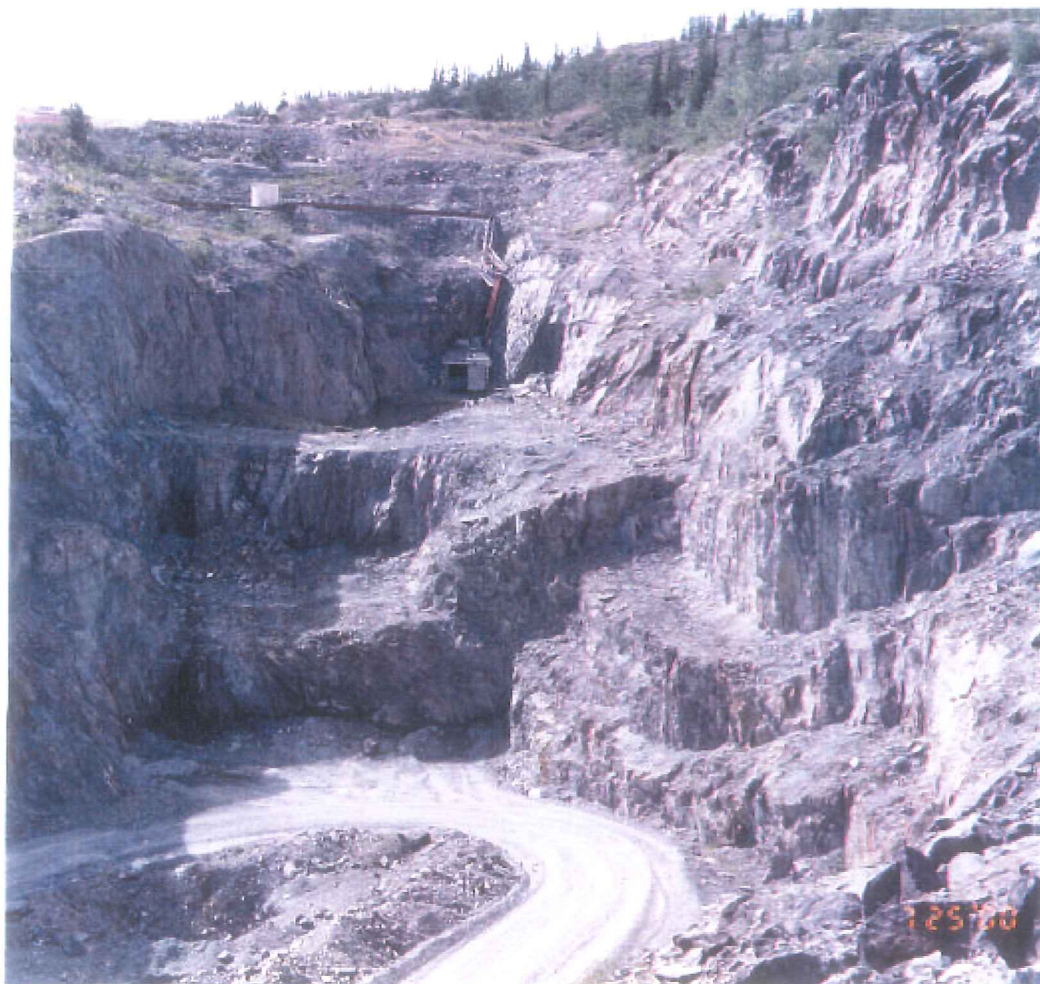
The overall pit slopes are in good condition and appear stable. The rock on the west pit slope has raveled and is collecting on the slope benches.

Photo 3: South slope with rock on benches.

In general, the pit slopes may be left as they are at present, with a low earth berm around the outside edge. This is most critical along the west and southwest slope.

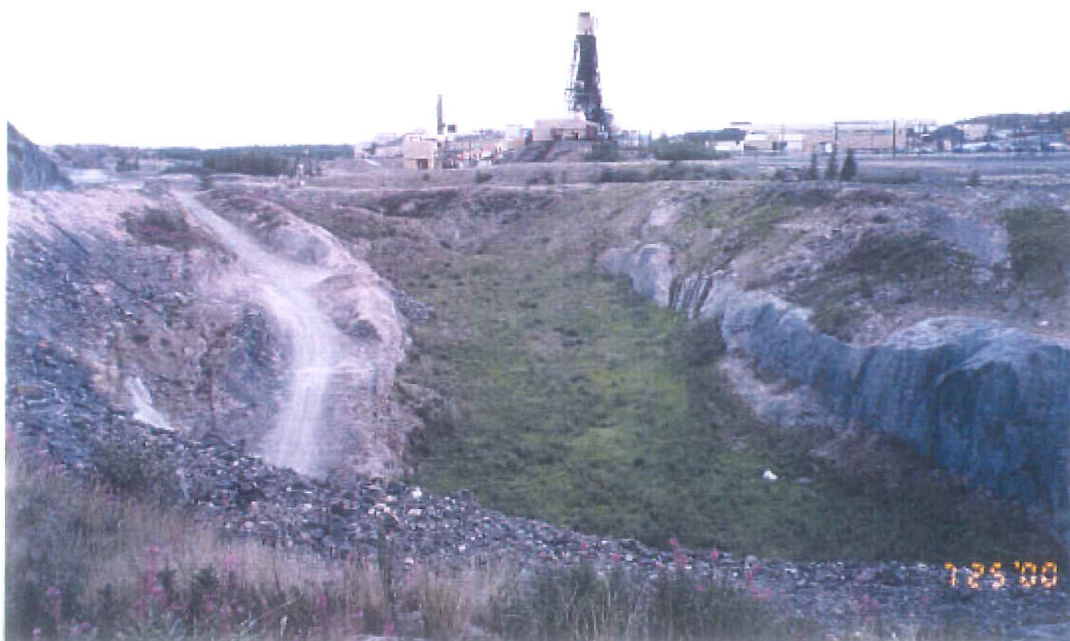
Photo 5: North Slope of C-1 Pit.

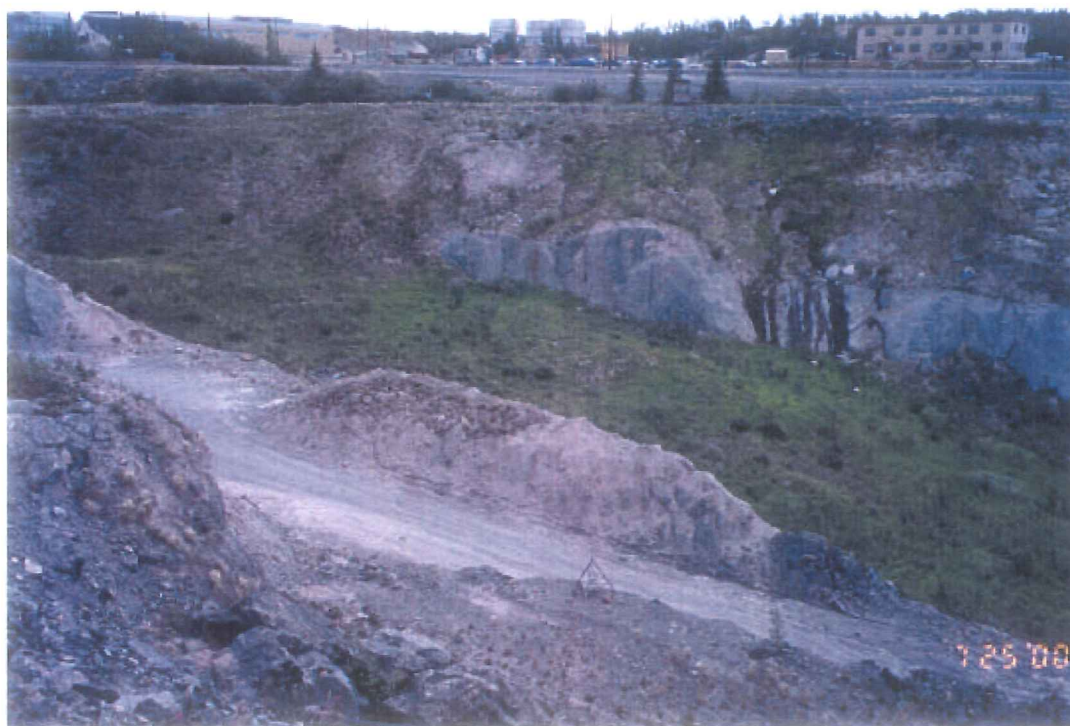
Photo 6: Northeast Slope of C-1 Pit with mill in background.

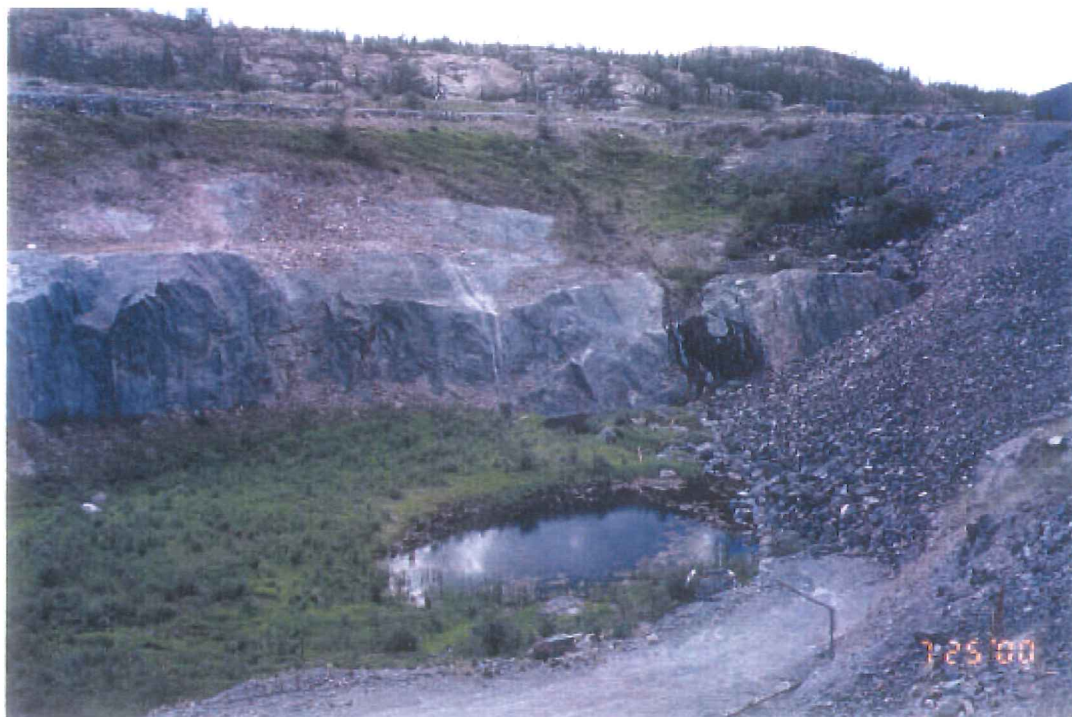
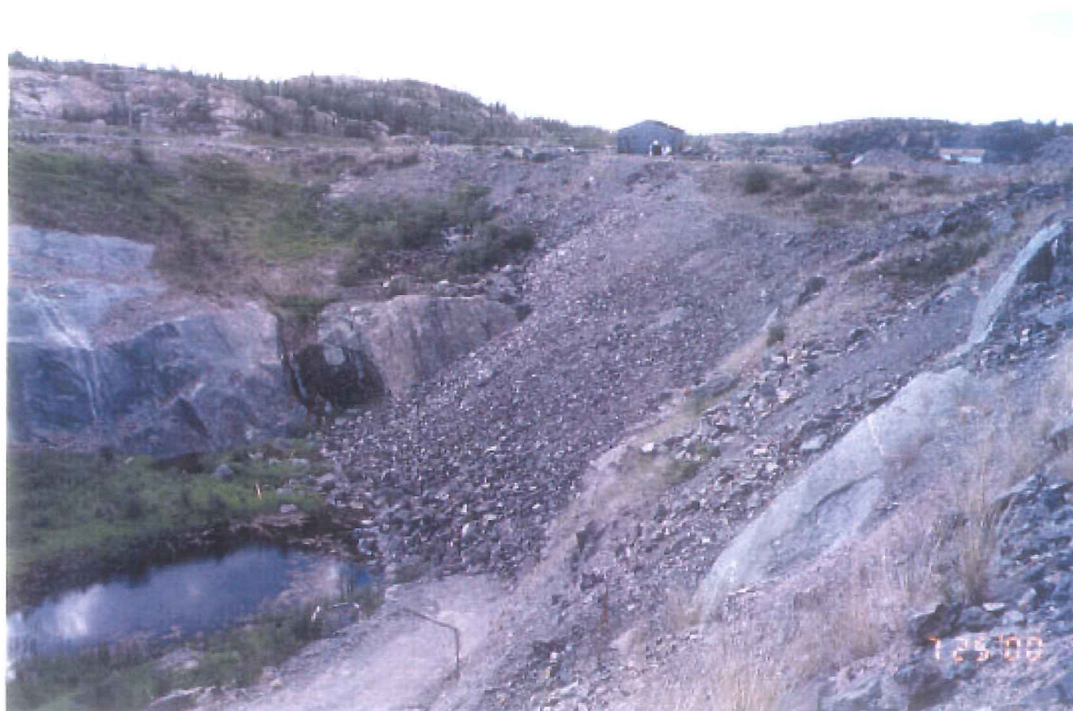
The overall pit slopes are in good condition and appear stable. The rock on the south pit slope has raveled and the rock is collecting at the toe of the pit slope. This is as anticipated.

Photo 7 and 8: South and southeast C-1 Pit slope.

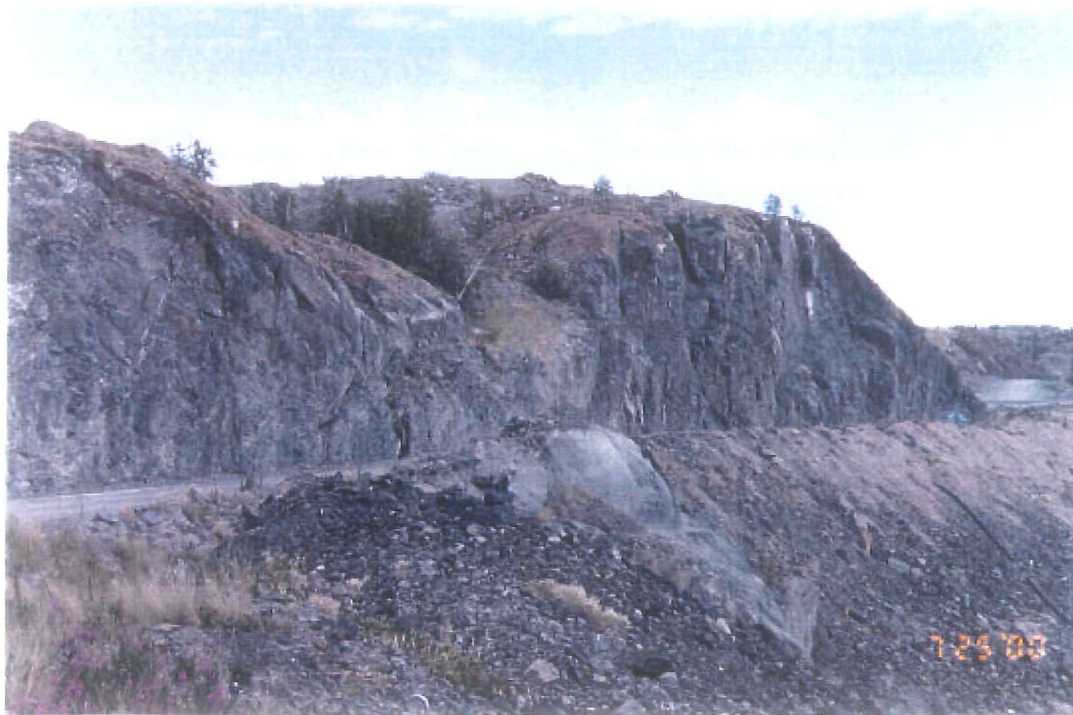
The rock slope west of the Baker Creek diversion is in good condition.

Photo 9: Rock slope on west side of Baker Creek diversion. Slope is in good condition.

The slope on the west side of the Baker Creek diversion will require a further evaluation once the closure plan for the underground arsenic storage chambers is finalized and the long term plan for Baker Creek is finalized.

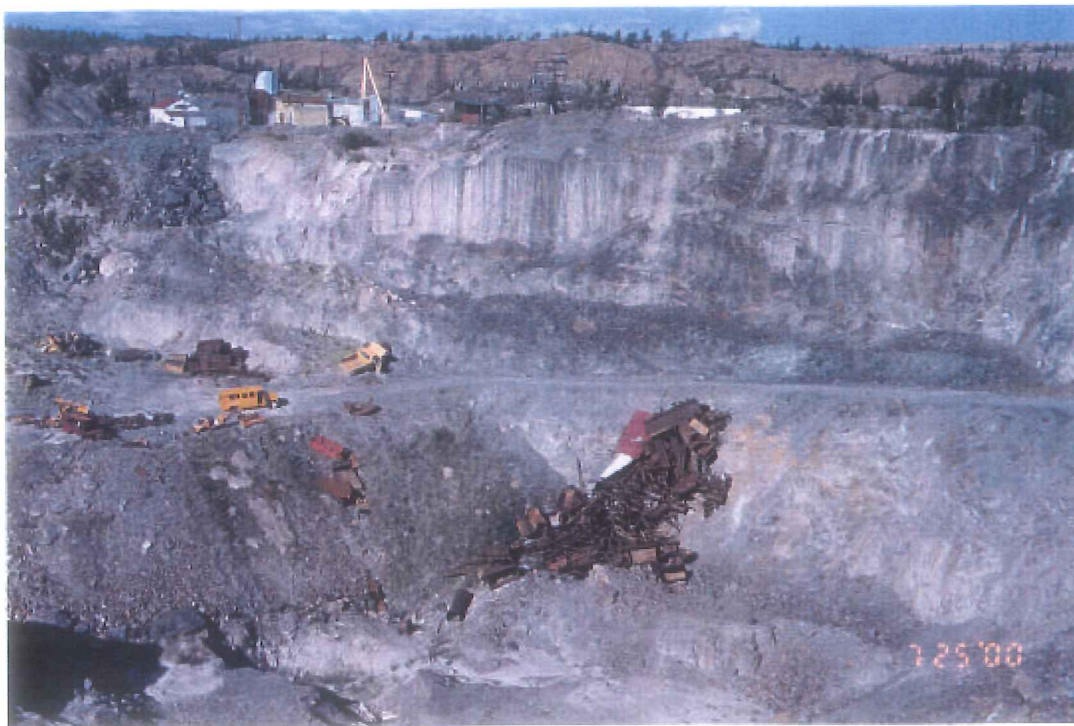
Waste steel from the Giant operation has been placed in the pit. The steel was cleaned before it was placed in the pit. This is not causing any concerns at present with access or pit slope conditions.

Photo 11: West Slope of B-1 Pit. Note scrap steel in pit.

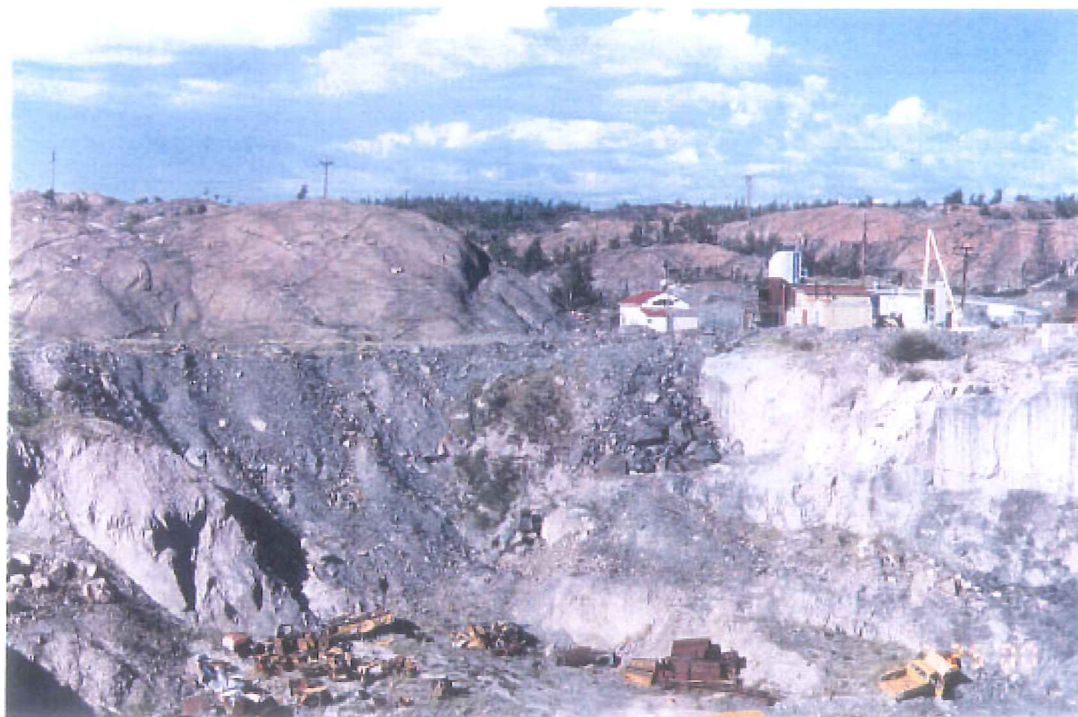
Photo12: South slope of B-1 Pit. Baker Creek is just beyond crest of pit.

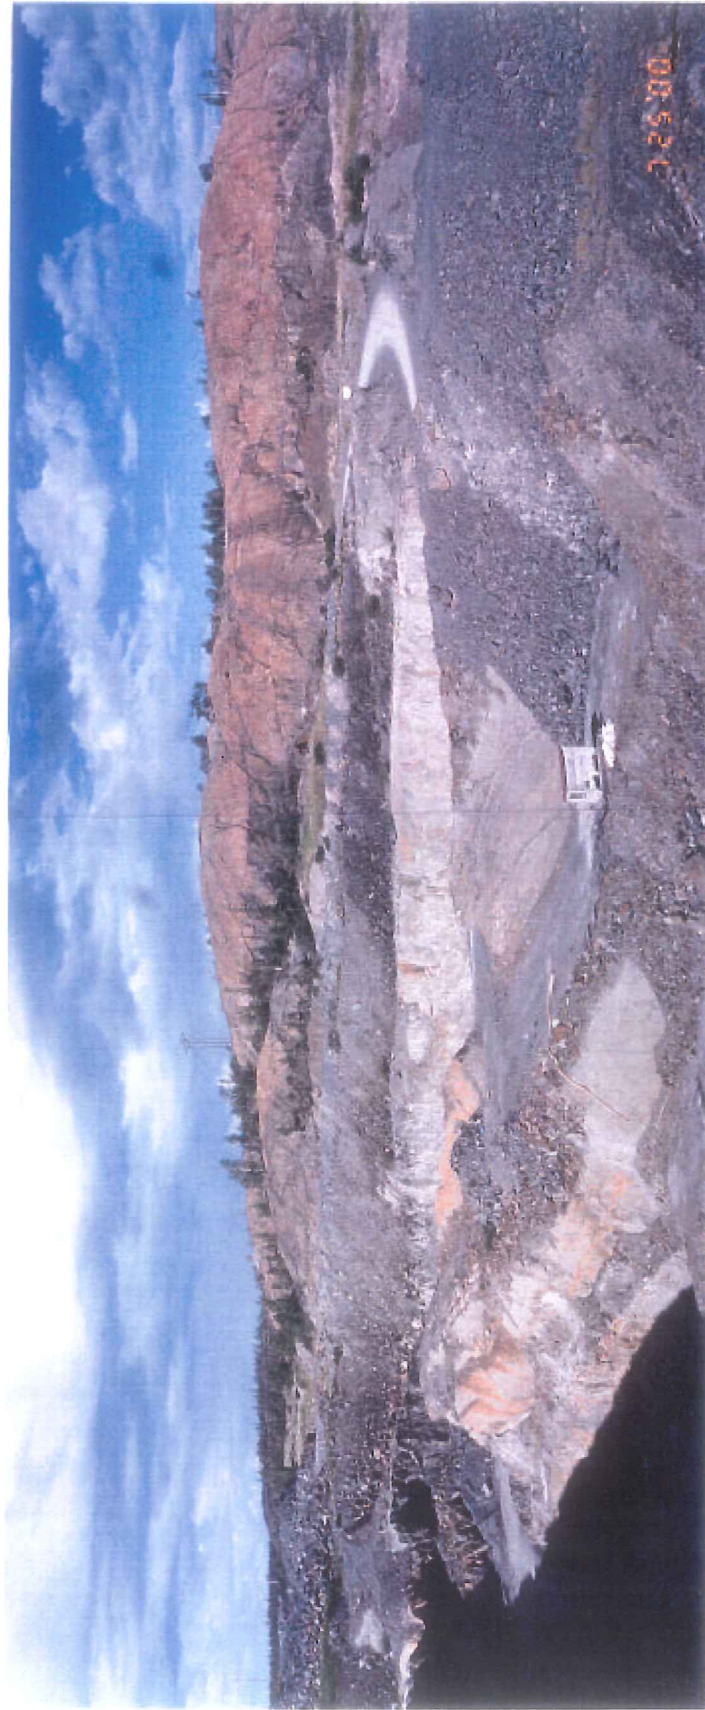
Photo 14: West side of B-2 Pit.

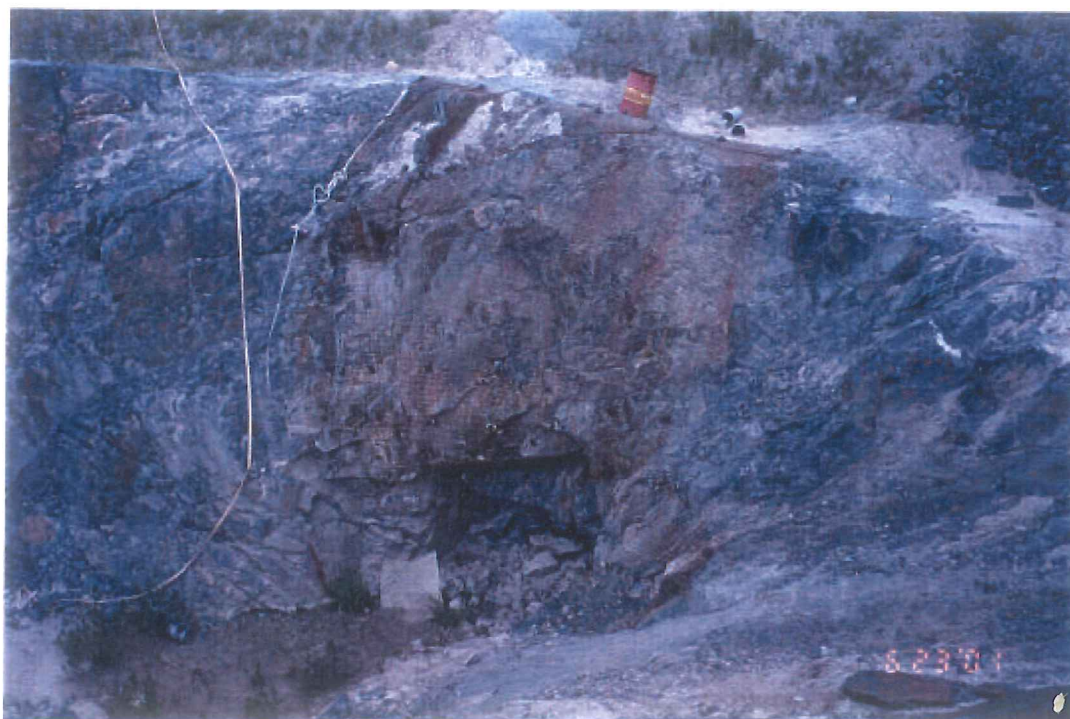
Photo 17: West side of Brock Pit.

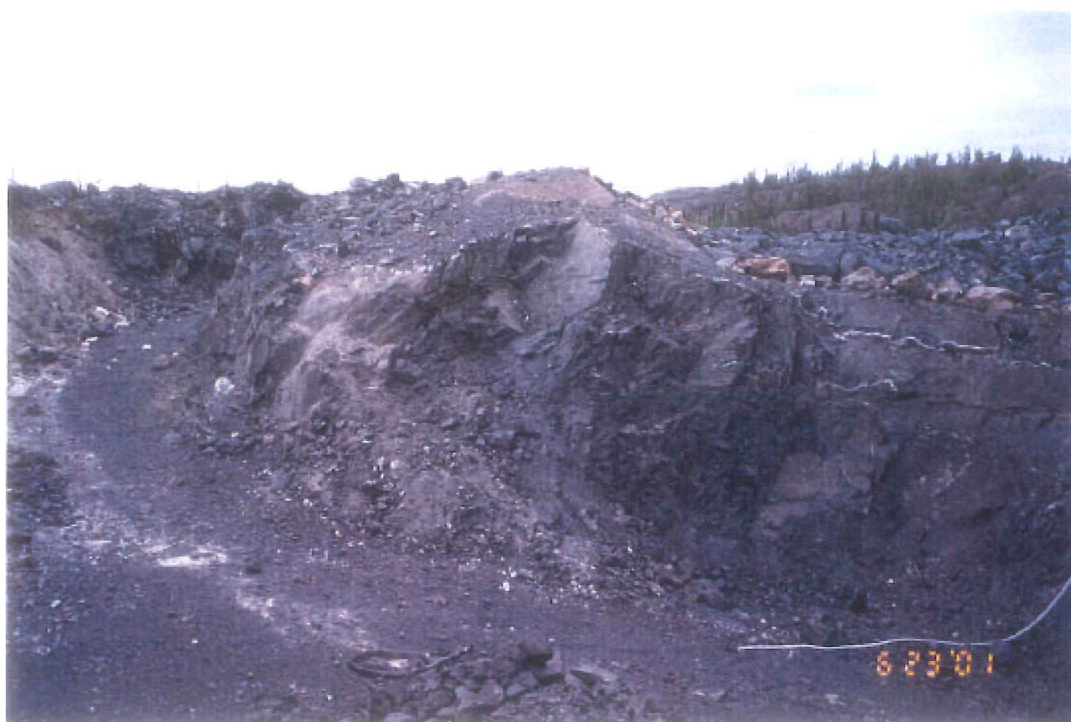
Photo 18: South side of Brock Pit.

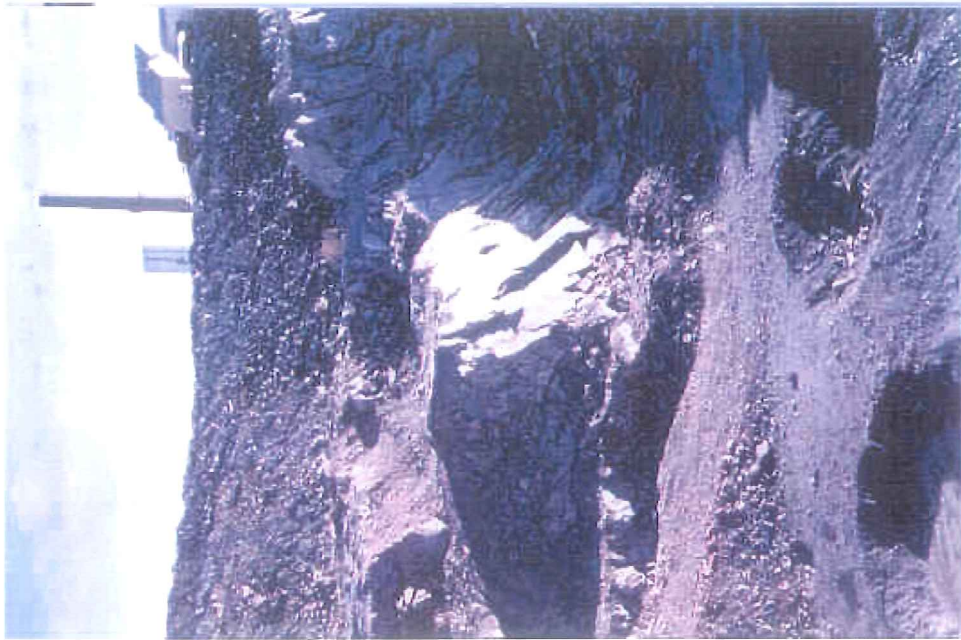
Photo A2-9. B1 Pit, looking south-east.
Showing broken timber from the fill raise in the
floor of the pit

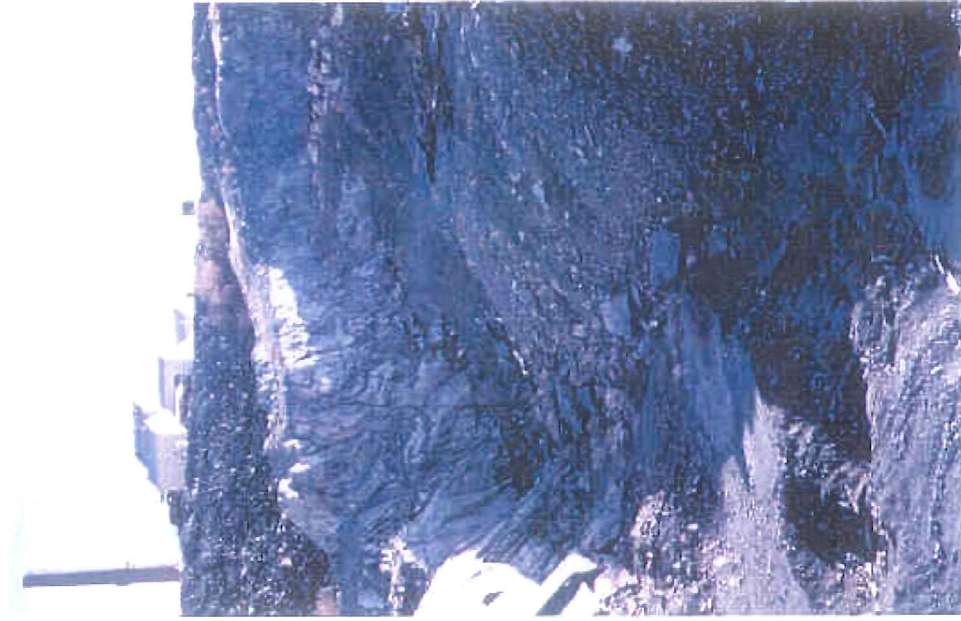
Photo A2-10. B1 Pit, looking south south-east.
Showing eastern side of the fill plateau, bedrock
and overburden, with the mill in the background.

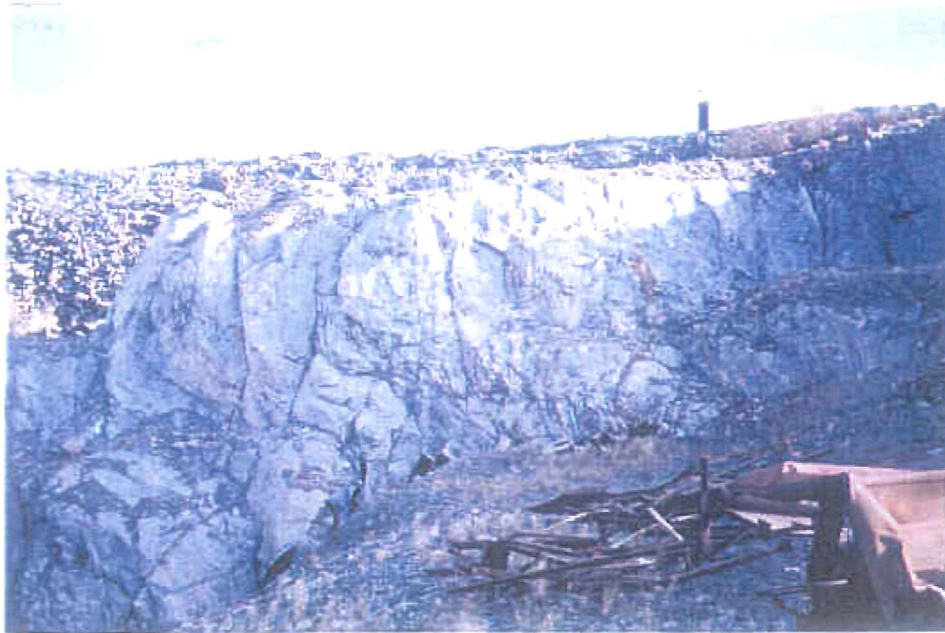
Photo A2-11. B1 Pit, looking east. Showing bedrock conditions.

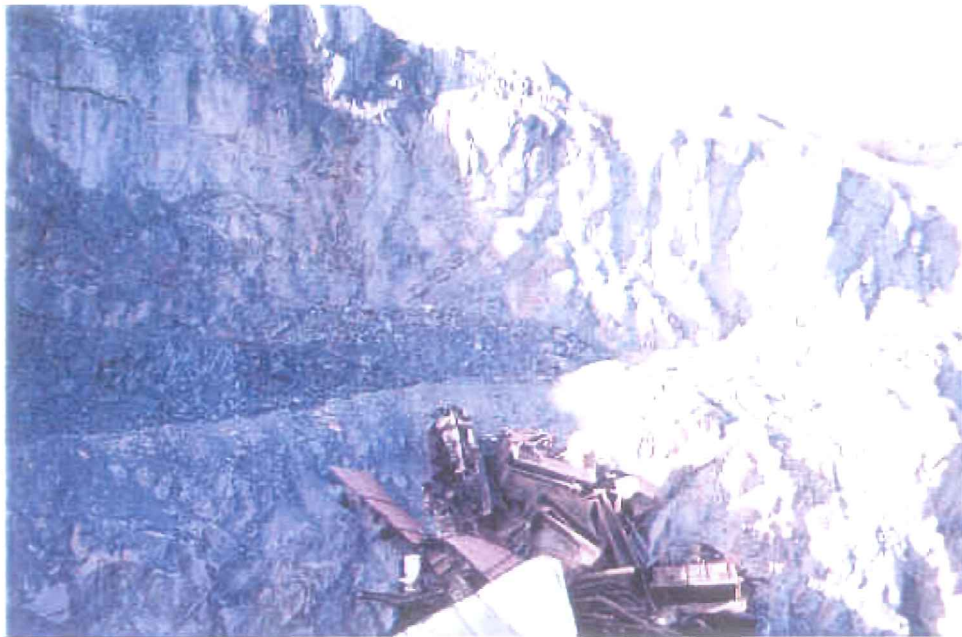
Photo A2-12. B1 Pit, looking north north-west, towards the access ramp, showing bedrock conditions.

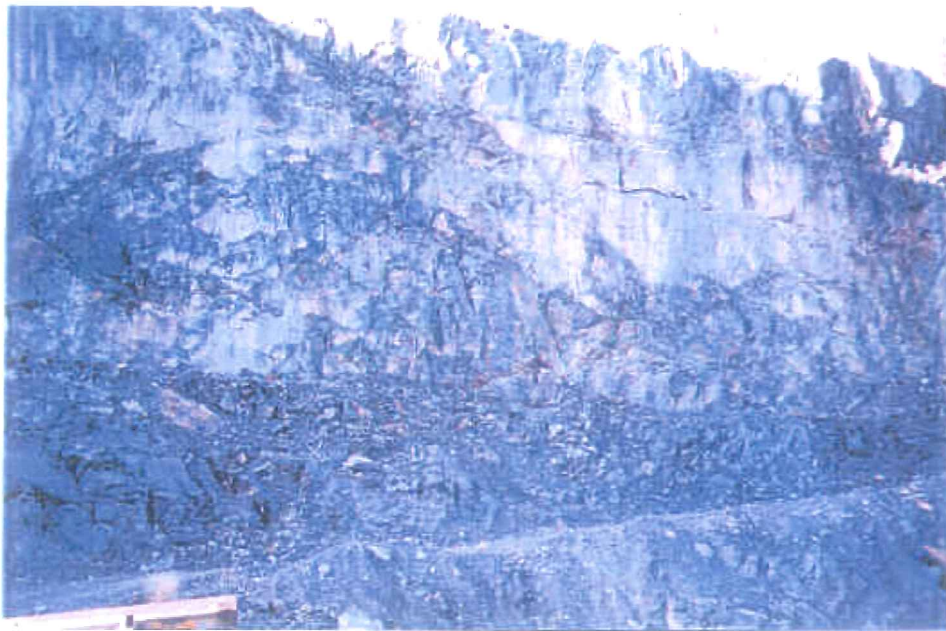
Photo A2-13. B1 Pit, looking north-west towards access ramp and showing bedrock conditions.

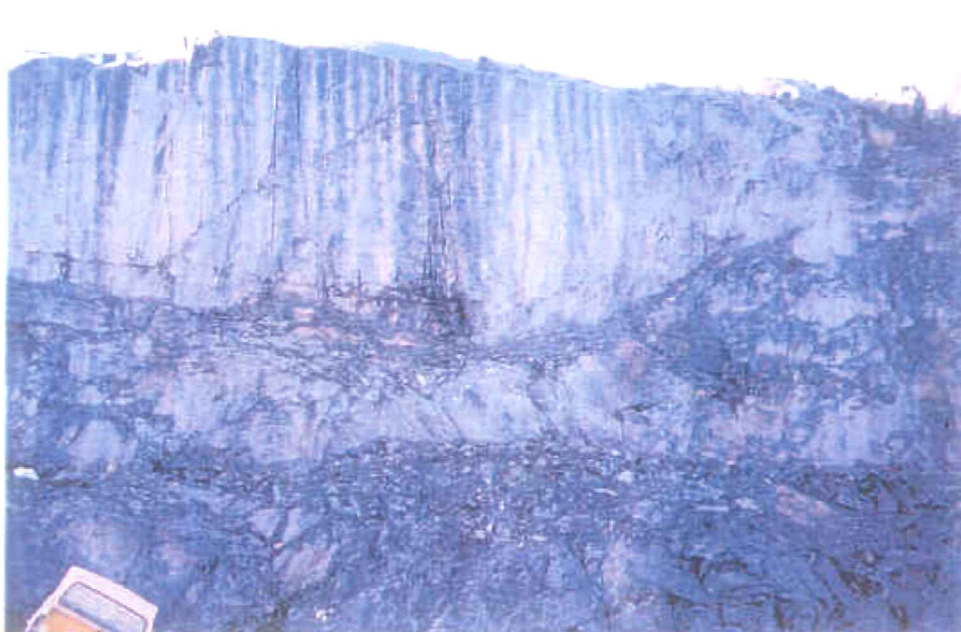
Photo A2 -14. B1 Pit, looking west north-west, showing bedrock conditions.

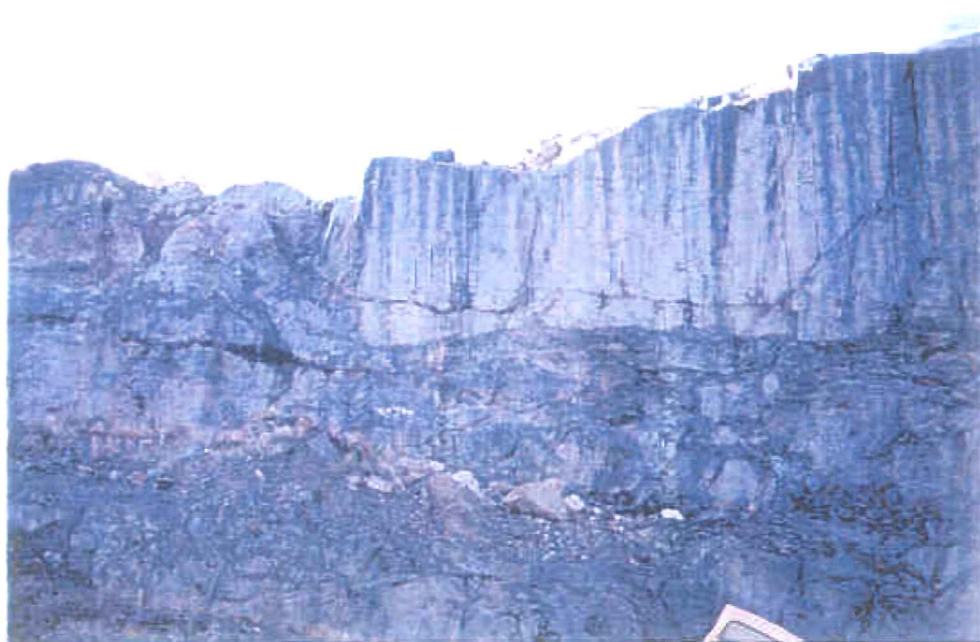
Photo A2-15 B1 Pit, looking west, showing bedrock conditions.

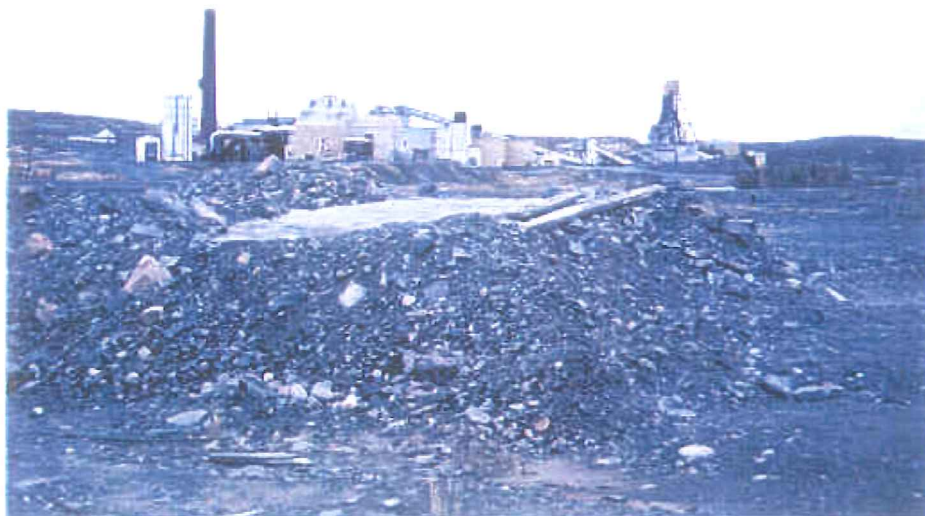
Photo A2-16. General view, looking south, of the mill and C Shaft. The capped raise in the foreground is located north of the B1 Pit, to the east of the mine road.

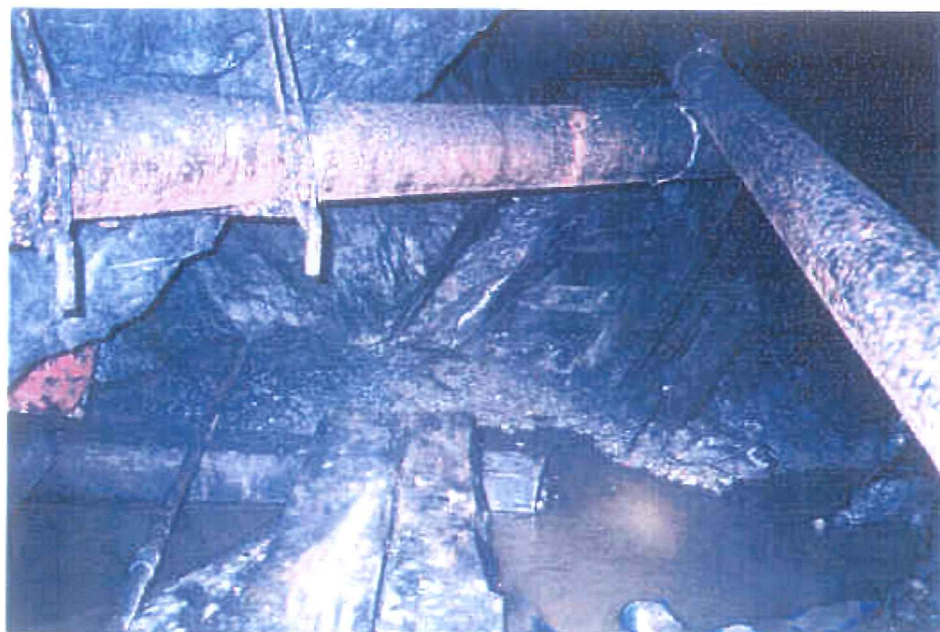
Photo A5-9. The floor of the ADD on the south-east of the main access drift. In this area above caverns B230/33/34/35/36 the conditions are not frozen.

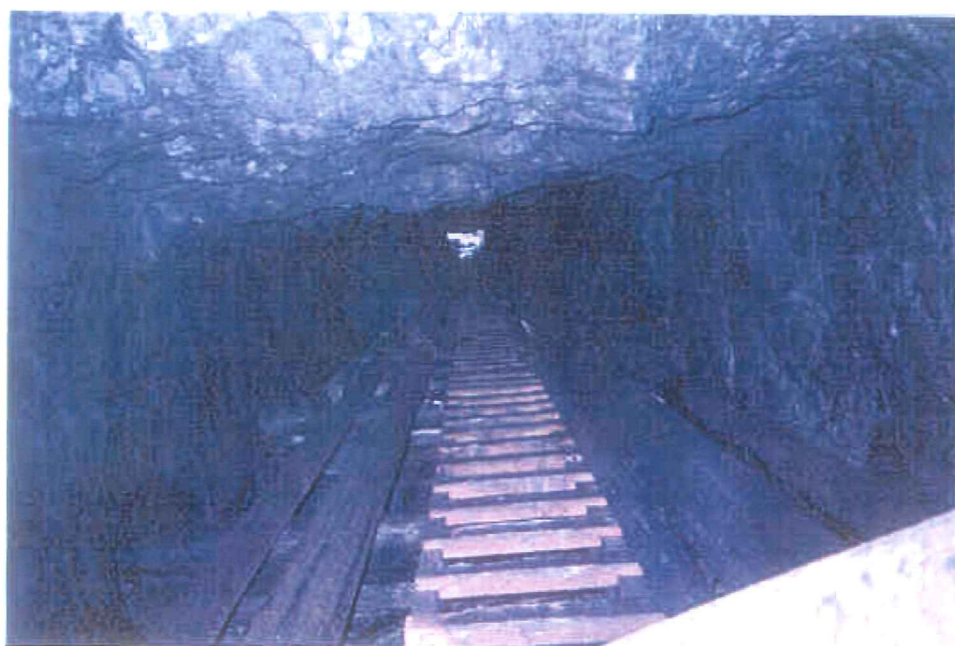
Photo A5-10. Raise and ladder-way to surface at the south end of the ADD.

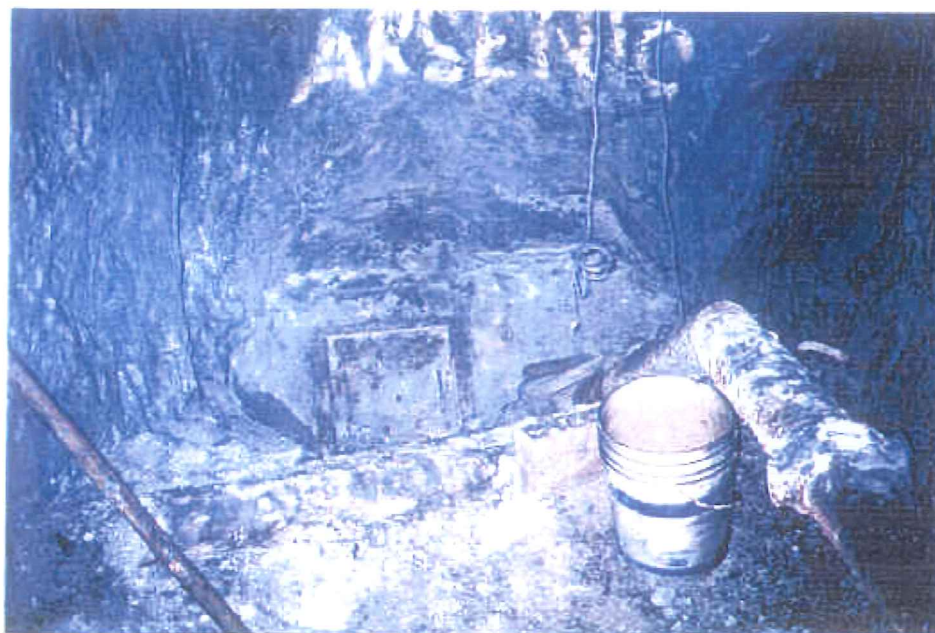
Photo A5-11. The inspection hatch into the storage cavern B208 in the floor of the northern end of the ADD. The floor is covered with frost.

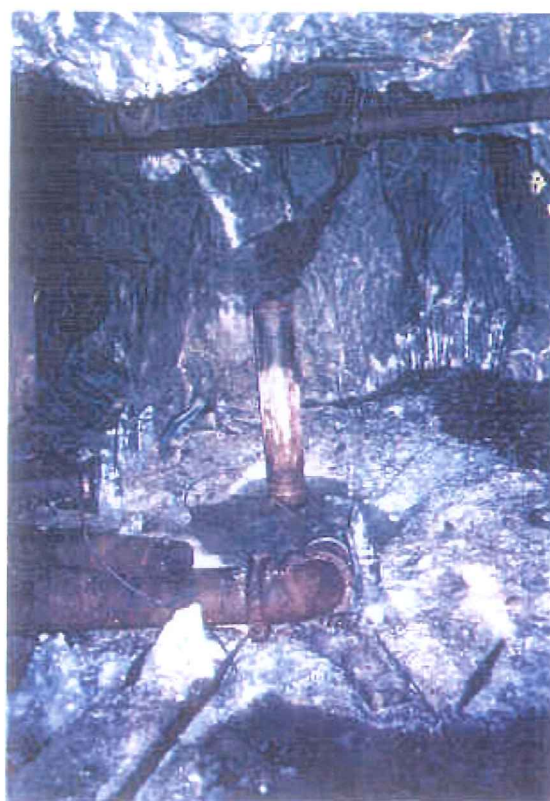
Photo A5-12. The pipelines in the floor of the ADD supplying the B208 cavern with arsenic dust. ice stalagmites and frost on the floor (late September).

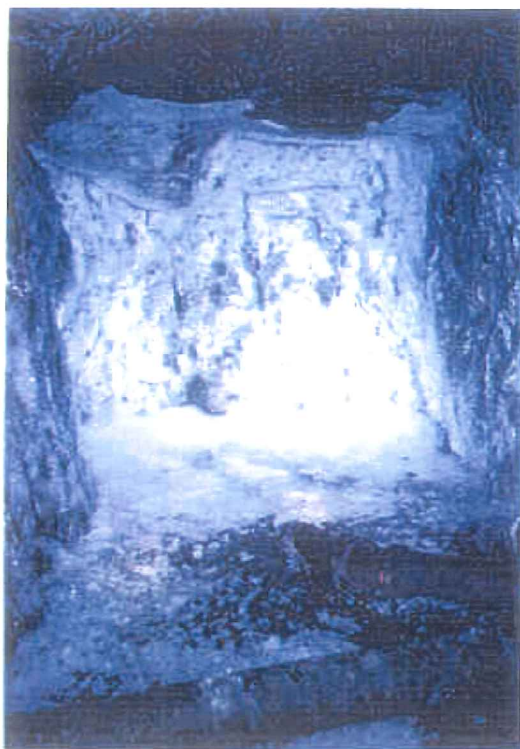
Photo A5-13. The frost in the stub drift on the north-west side of the ADD immediately above the B208. The wall is covered in frost and ice (late September).

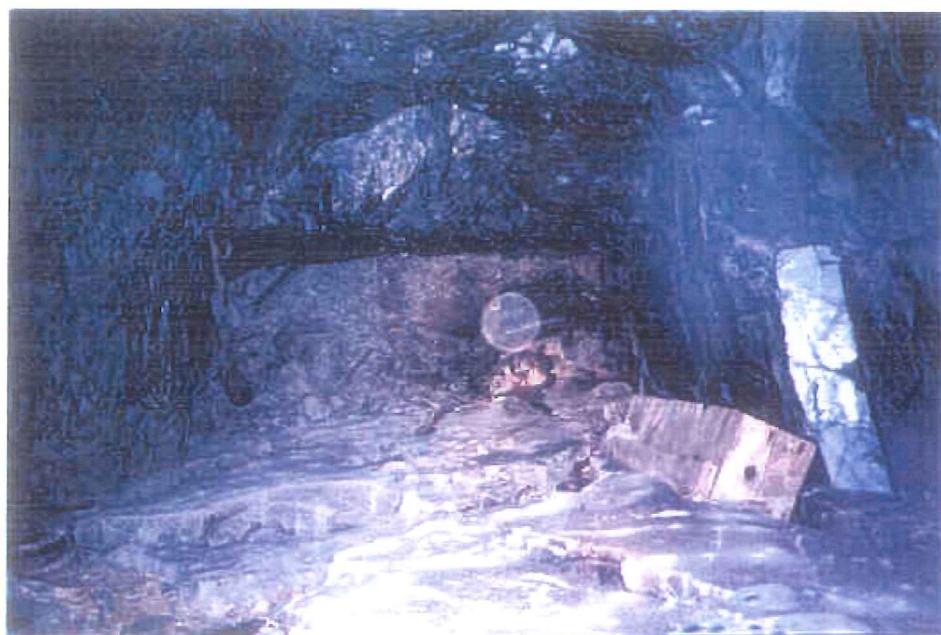
Photo A5-14. The north-west bulkhead at the end of the ADD, leading to the B208 storage cavern. The floor is covered in 4-6 inches of ice.

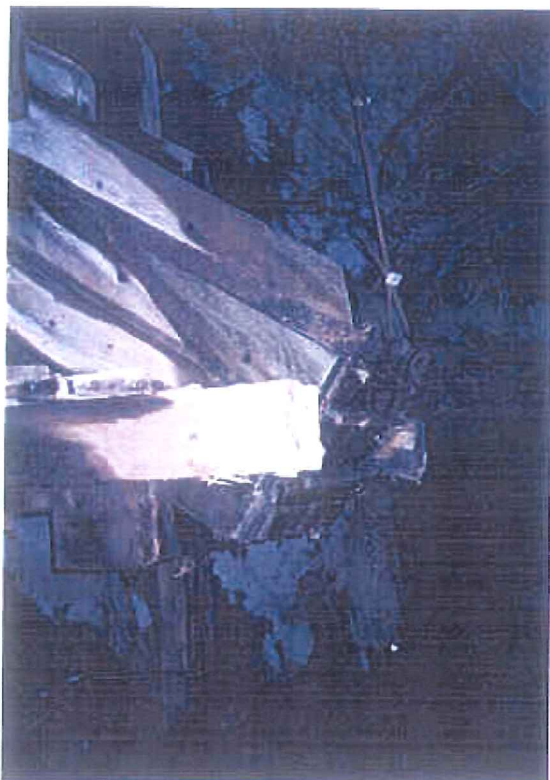
Photo A5-15. The waste chute leaking water and fines. This fill raise is connected directly to surface, opening in the floor of the B1 Pit.
