Section 10

High Cyanide Addition Test

Giant
YELLOWKNIFE MINES LIMITED

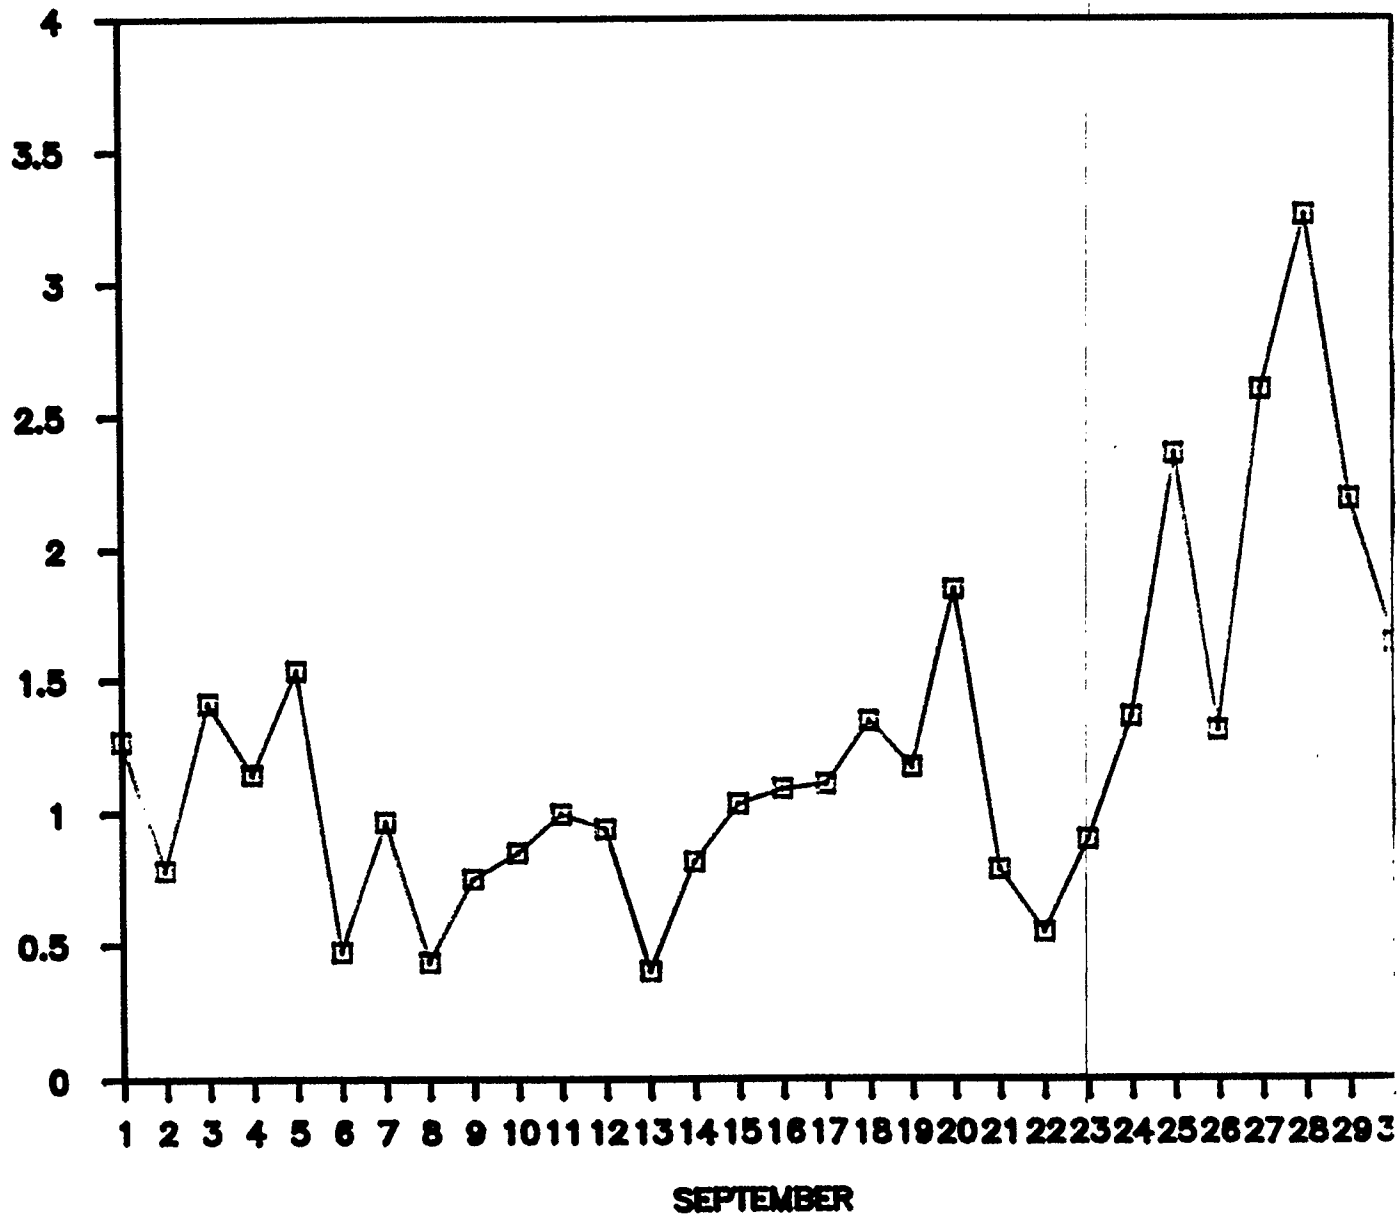
SEPTEMBER CIL CYANIDE CONSUMED lb/ton

The enclosed graphs show that relative to the background trending of % gold extraction, this variable did not respond sharply to the increased cyanide. Tailings residual cyanide measurements were not accurate during the test due to an error (new Staff Member) in titrant solution preparation. Cumulative data indicates that there was at least 0.6 lb NaCN/ton solution (300 ppm) present in tailings compared to the norm for 1988 of 0.3 lb/ton.

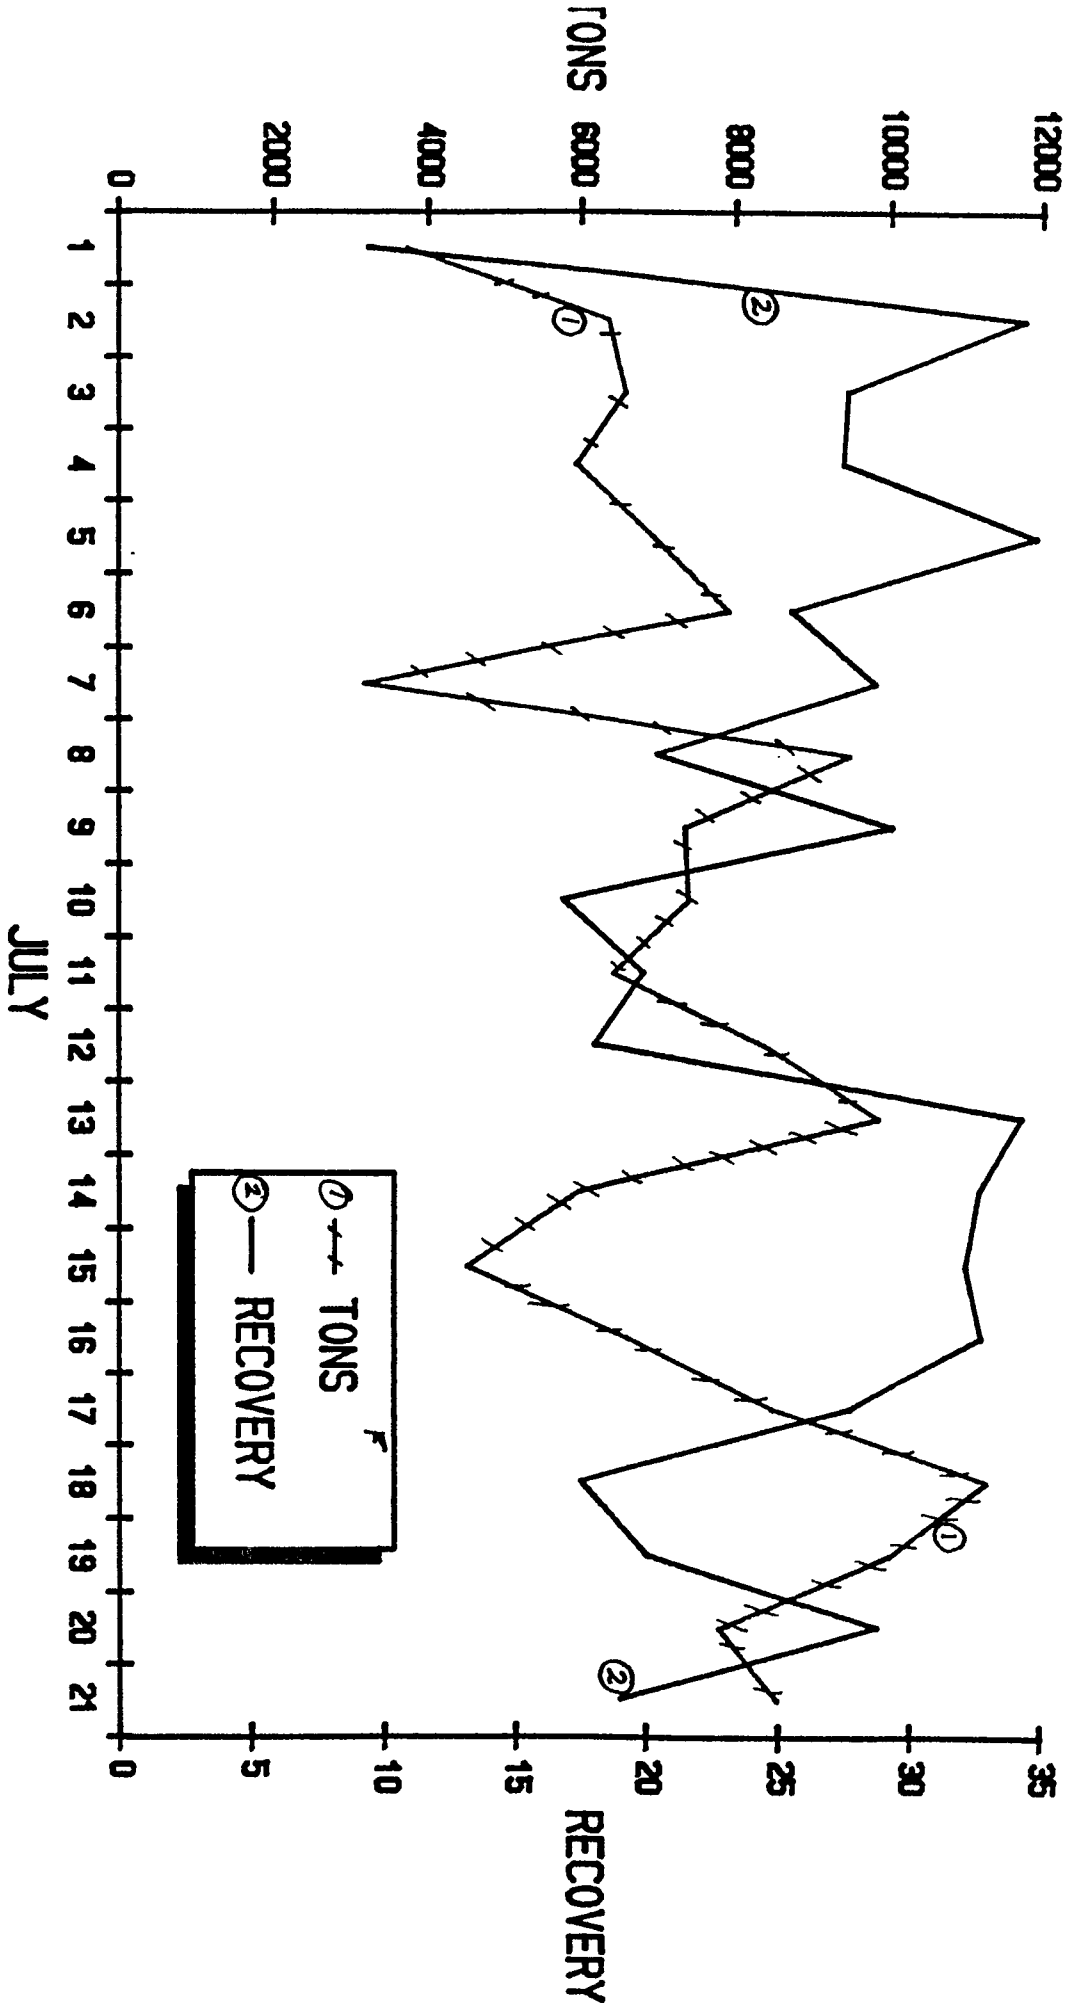
FIG. 1 TONS/RECOVERY RELATIONSHIP
TRP 1988

FIG. 1 shows the relationship between tons of ore fed to the CIL area and the CIL recovery. No specific conclusions can be drawn from this. The recovery problem does not appear to be related to feed rate. FIG. 2 shows plant head grade compared to recovery, and again there does not appear to be any specific trend.

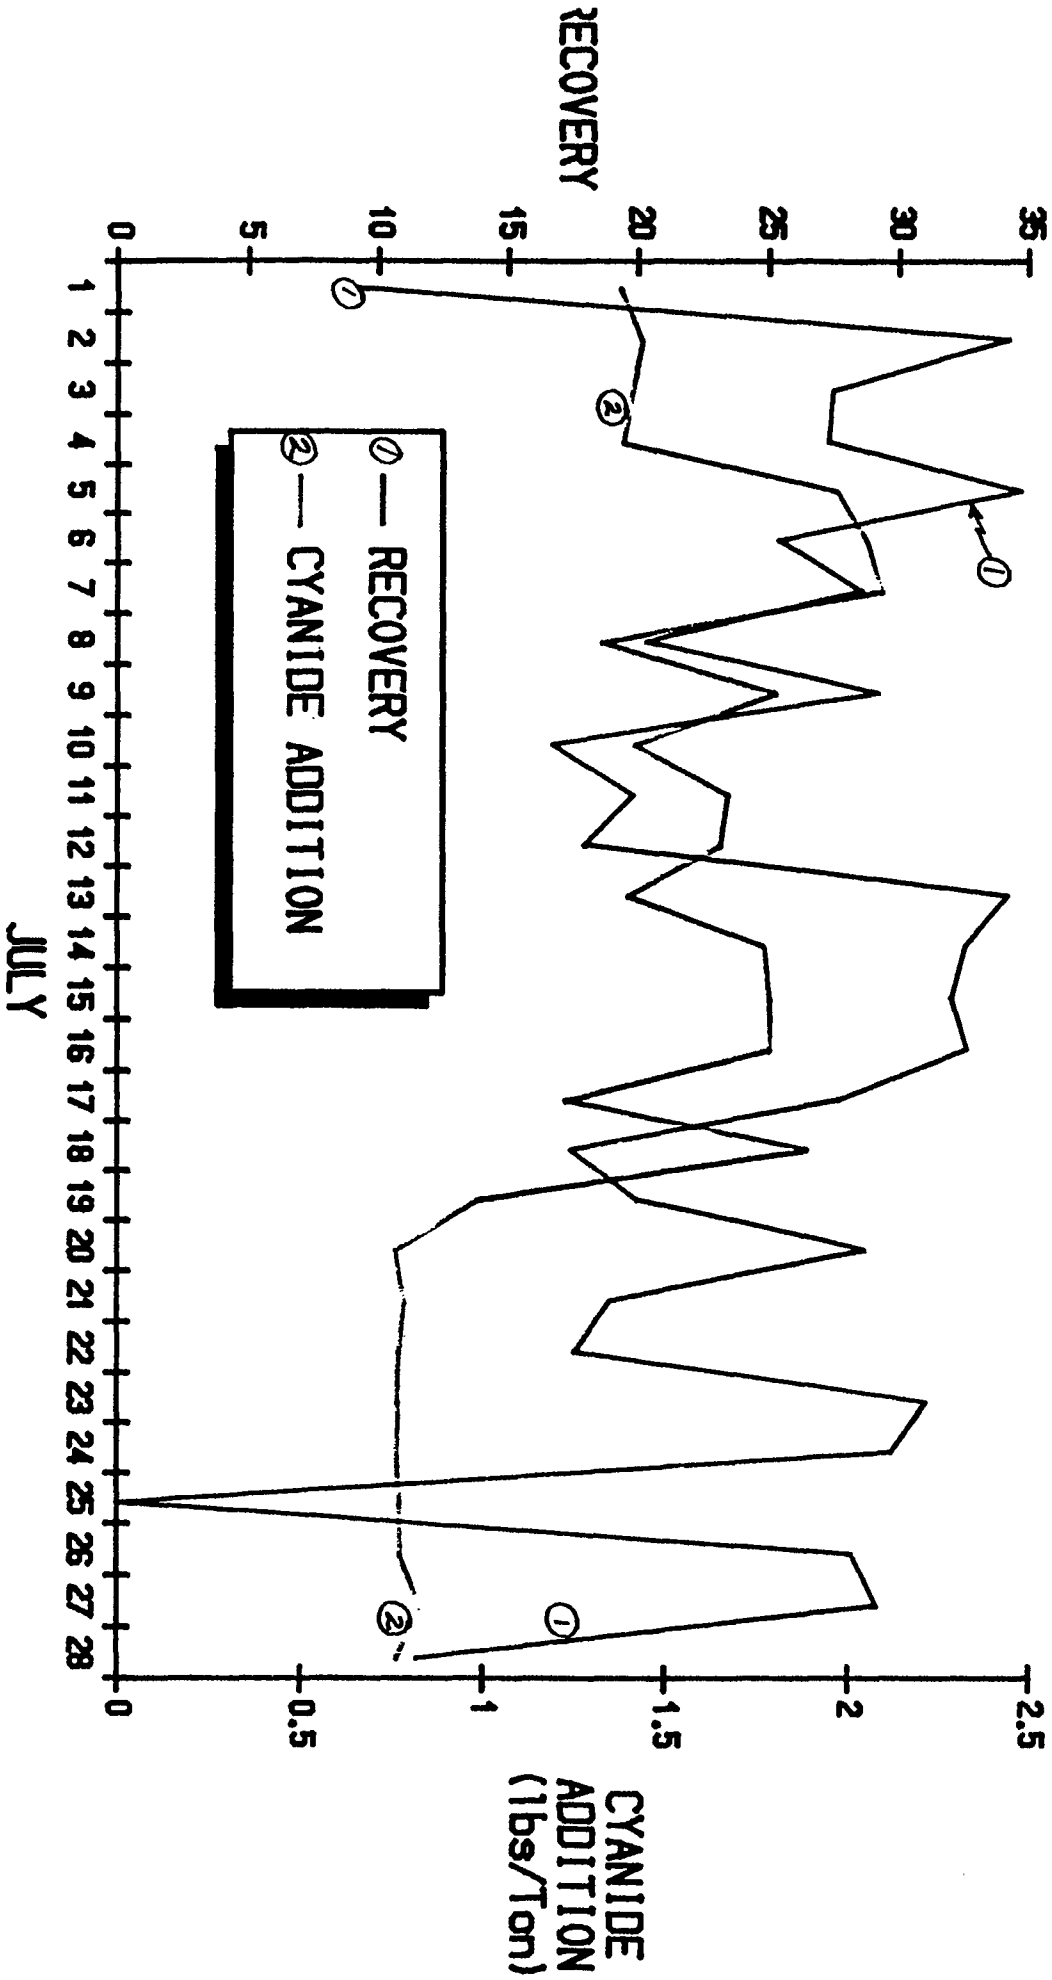
Fig 3 CYANIDE ADDITION/RECOVERY RELATIONSHIP
TRP 1988

FIG. 3 compares cyanide addition and recovery. Some short term trends appeared but when the addition rate was cut these trends were not maintained.
