G I A N T
YELLOWKNIFE MINES LIMITED

MEMO TO: S.E. El-Alfy
CC: J.S. McAlpine; G. Doerksen
FROM: Don Cooper
DATE: October 11, 1988
SUBJECT: TRP - PLANT MONTH END REPORT - SEPTEMBER 1988

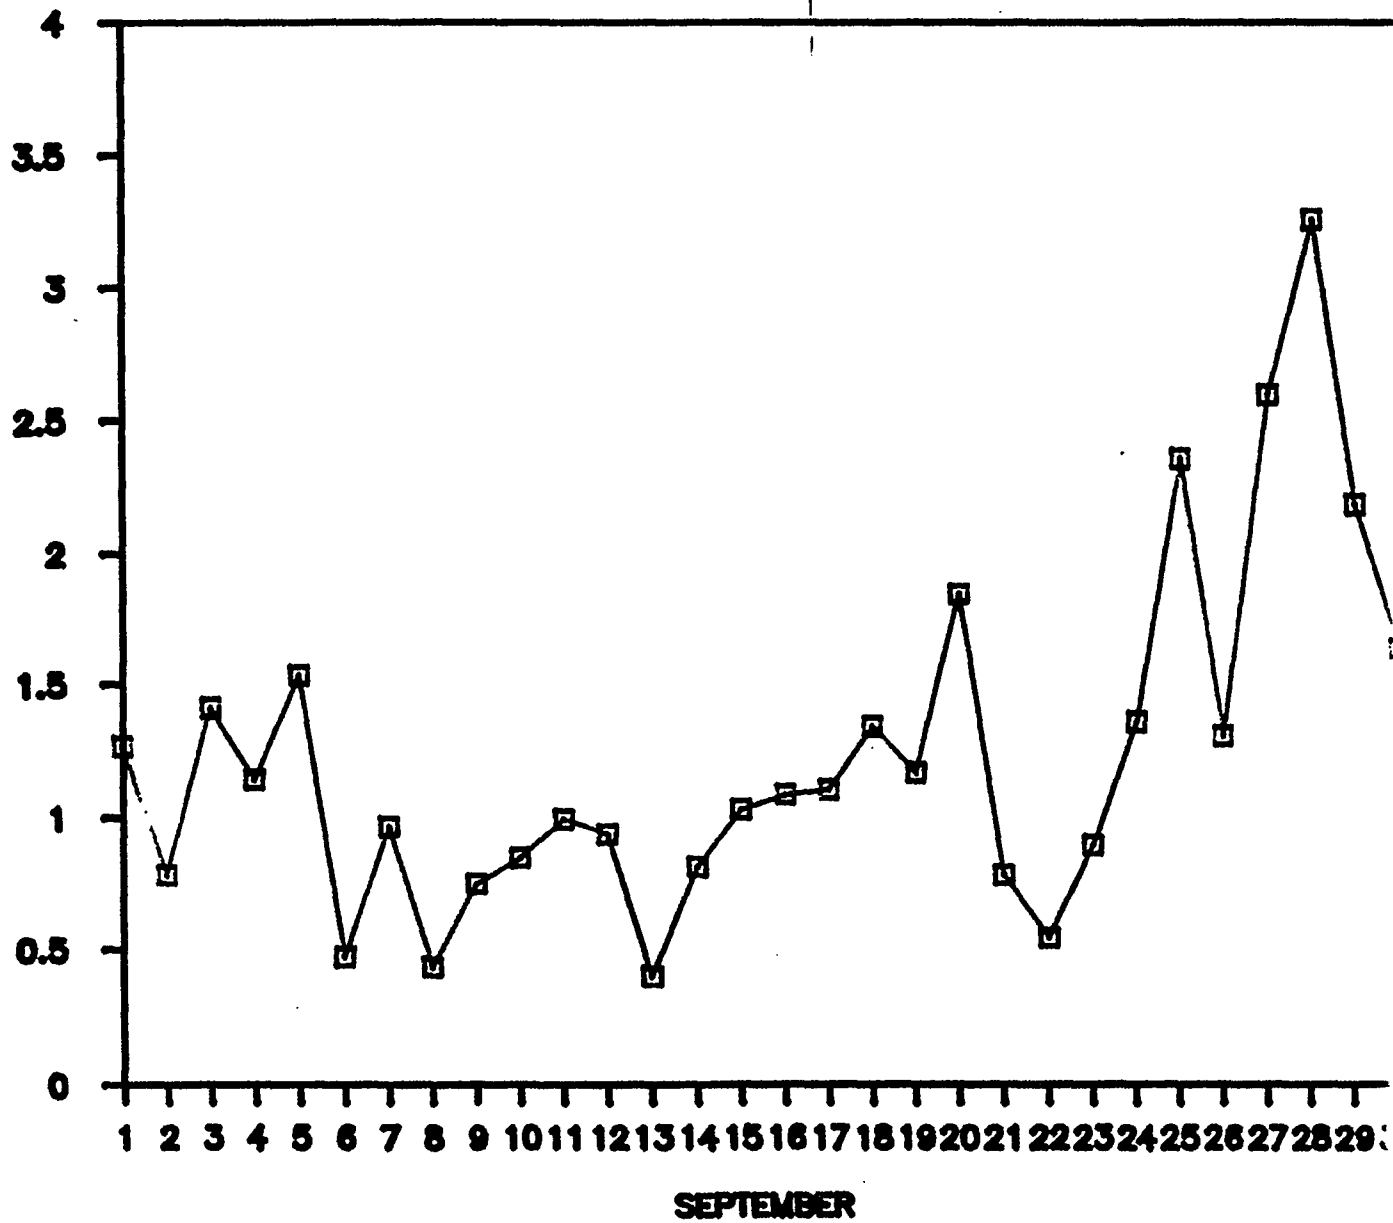
SEPTEMBER CIL CYANIDE CONSUMED lb/ton

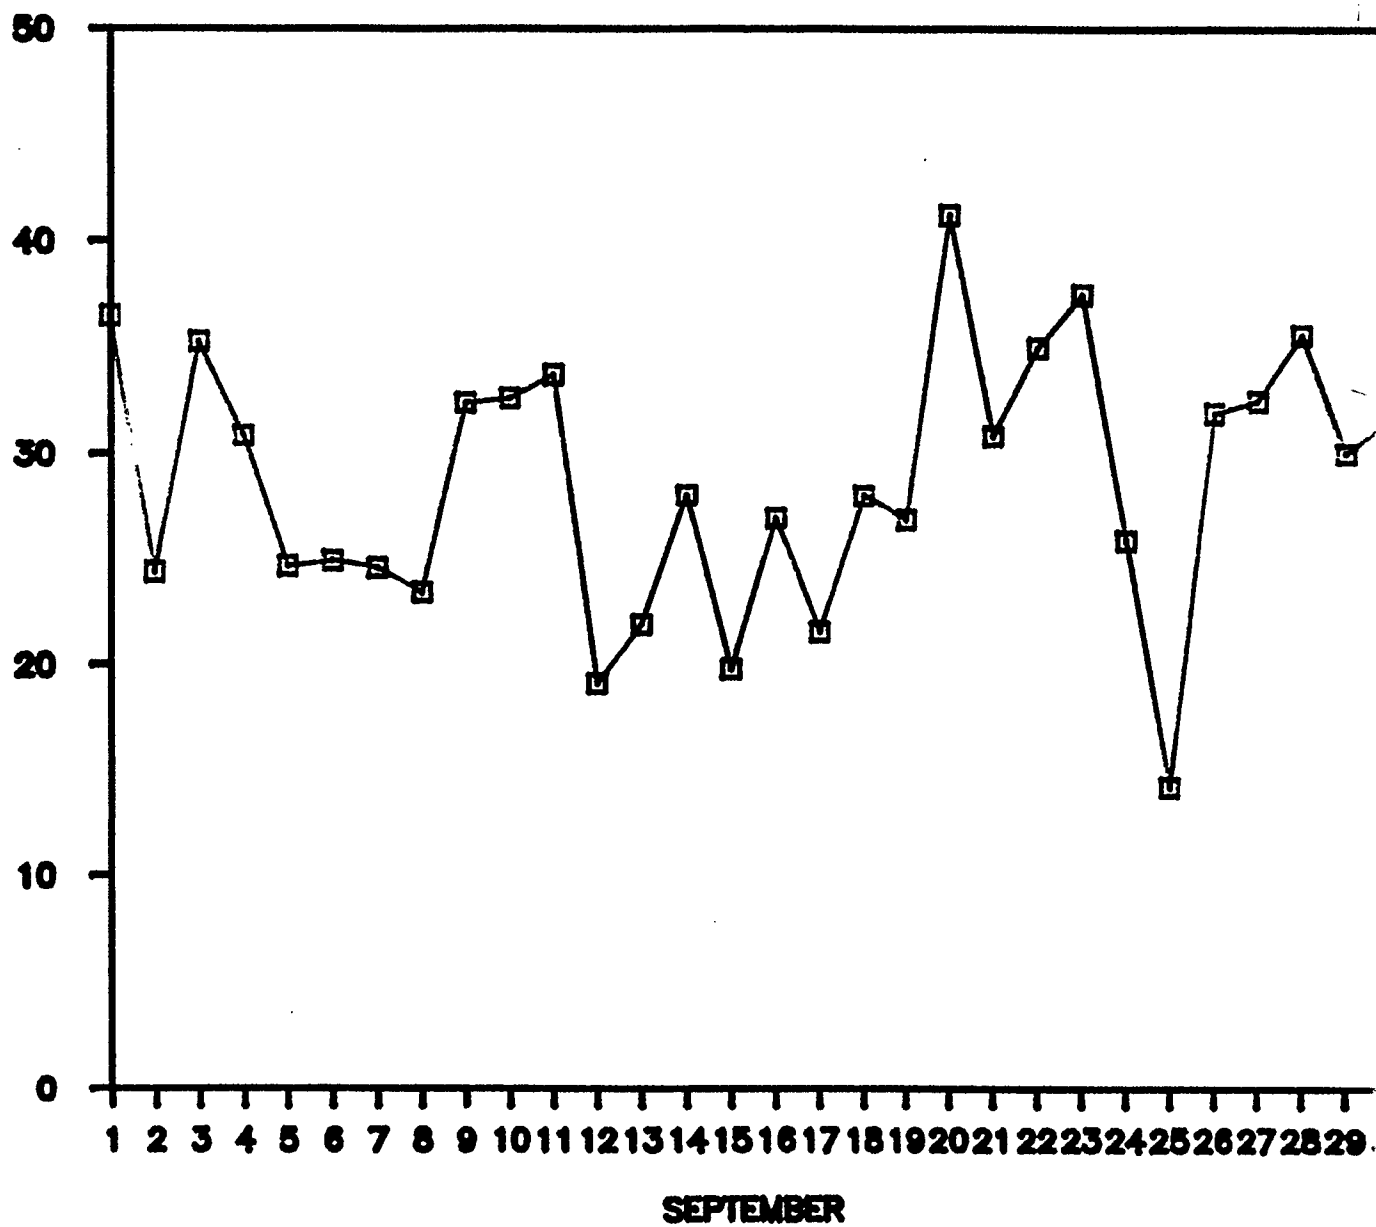
SEPTEMBER CIL RECOVERIES

Carbon adsorption in the CIL system has improved considerably with the increased stripping rate, new carbon addition and more even carbon distribution in the CIL tanks. Adsorption MTD averaged 89.40% while it roughly averaged 93% for the latter half of the month. Fresh carbon initially purchased was 6 X 12 type while the extra 60 tonnes purchased was 6 X 16. By month end the carbon density in the CIL tanks was about 19.55 grams per litre.
