# The Occurrence of Arsenic and Heavy Metal Contamination from Natural and Anthropogenic Sources in the Cobalt Area of Ontario

A thesis submitted to the Faculty of Graduate Studies and Research in partial fulfilment of the requirements for the degree of Master of Science

Carleton University Ottawa, Ontario May, 1993

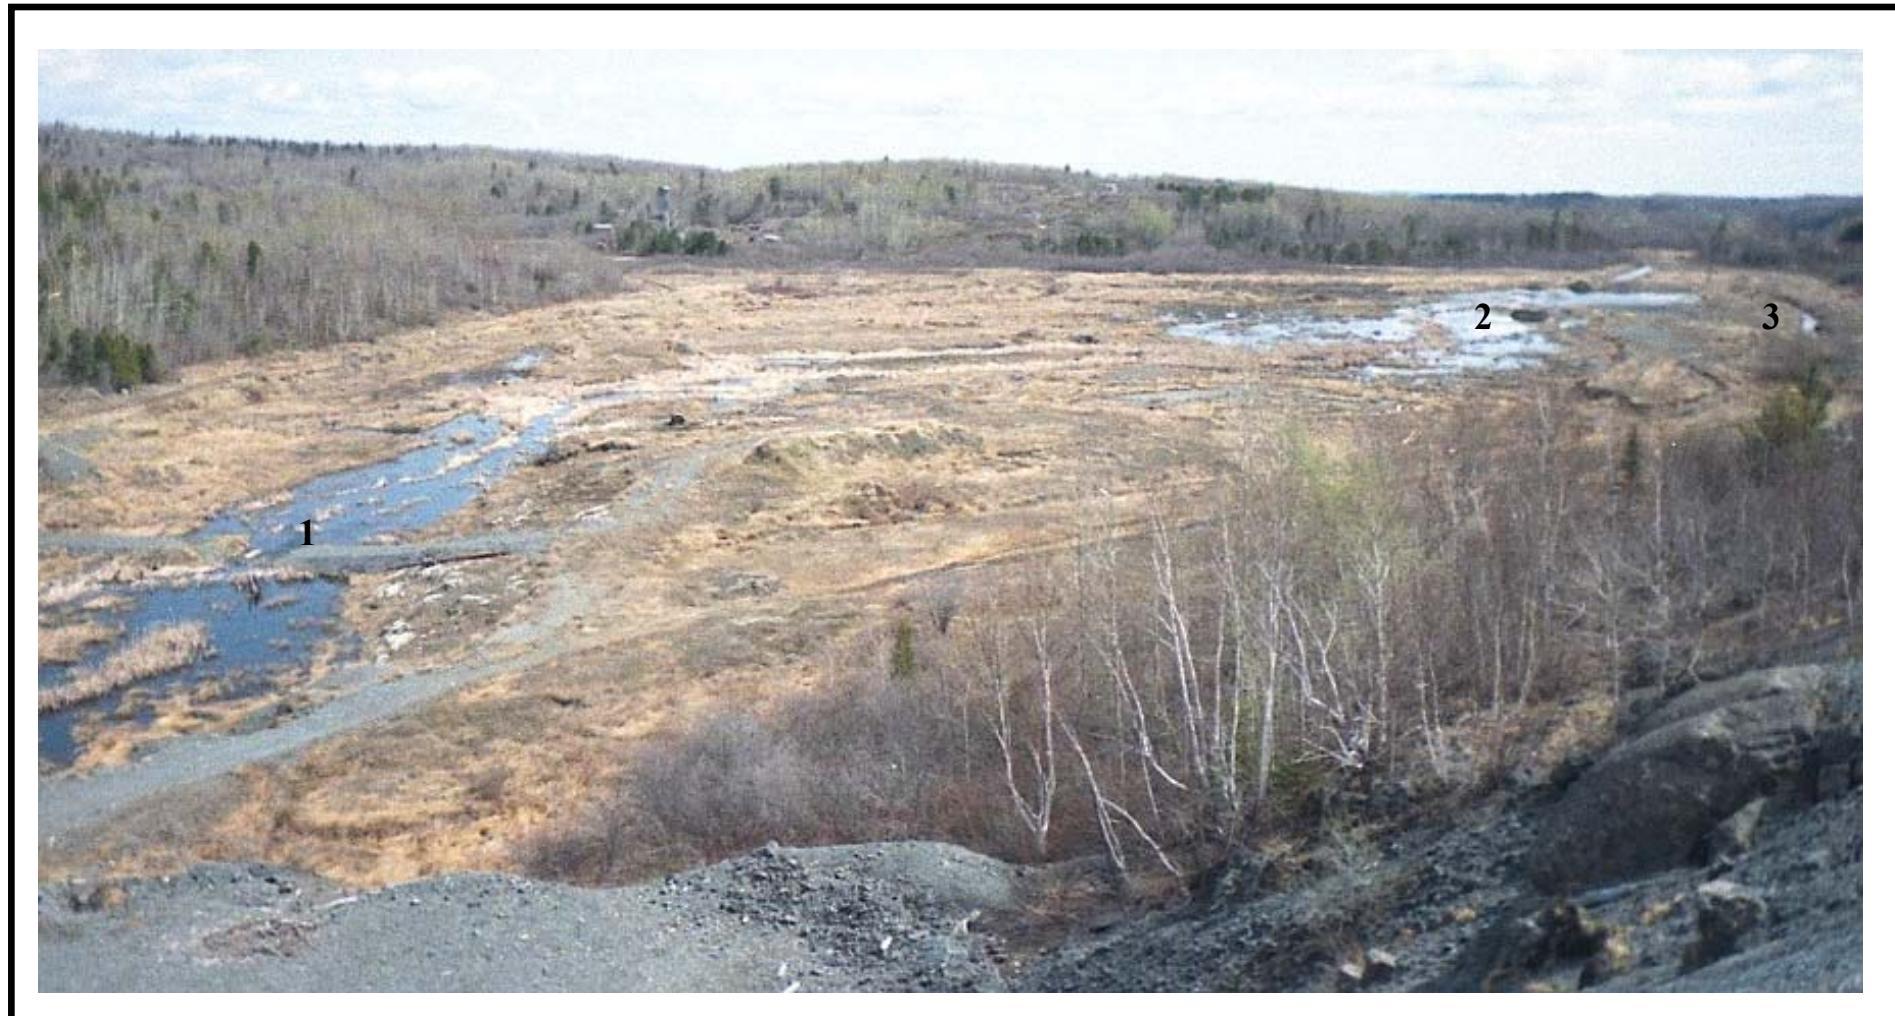
Plate 2.1

**Note:** Taken in May 1992. Sasaginaga Creek is seen on the left side of the photograph, and the sewage outfall into the creek is about 750 m upstream of point 1. The confluence of Sasaginaga Creek and Mill Creek is downstream from a large open area (2). Mill Creek (3) can be seen on the right side of the photo.

Anderson (1985) estimated that more than 200,000 tons of tailings have accumulated on this property. Raw sewage from the town is discharged into Sasaginaga Creek and flows through this area (see Plate 2.1).

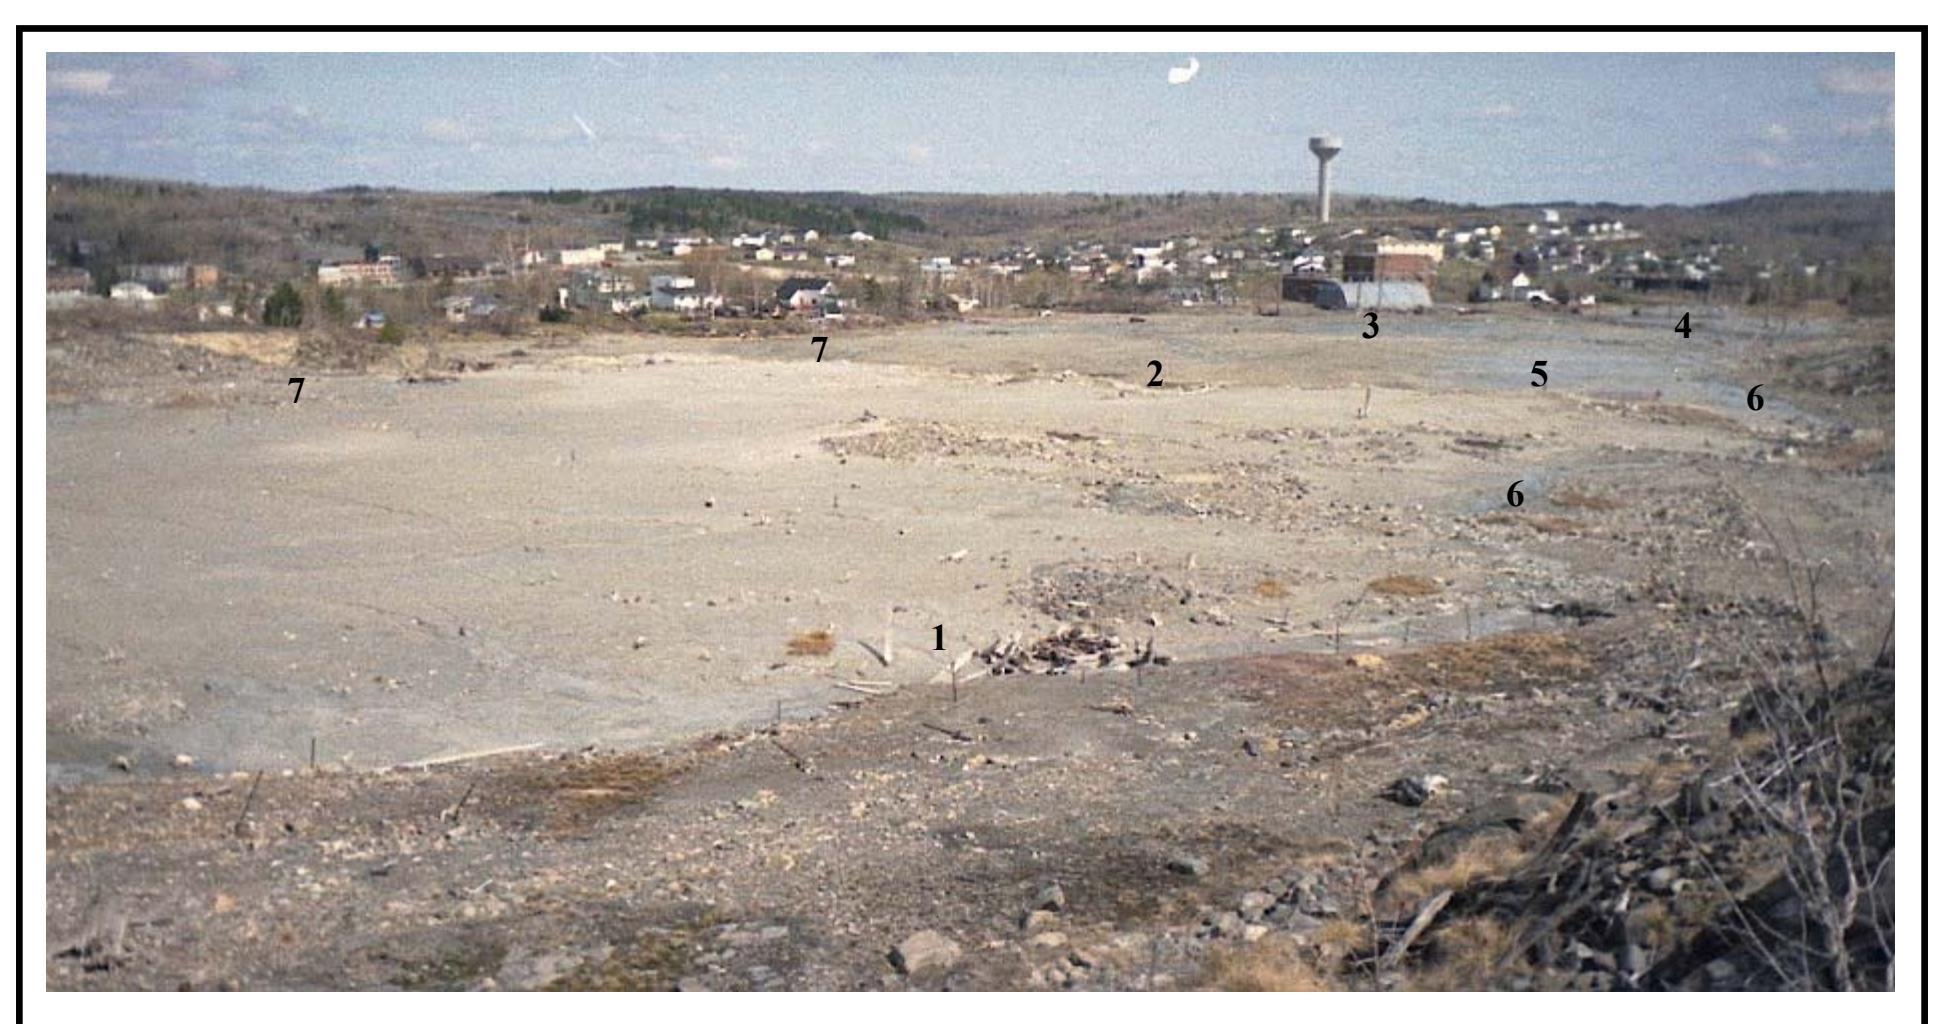
**Note:** Taken in May 1992. In the foreground, the remains of a mine headframe can be seen (1). At this location, tailings now fill the trench worked from this headframe, and the depth of tailings is not known. It is not known when this headframe ceased operations. Three dams were built to contain the tailings. Dam #1 can be seen (2). Dam #2 and dam #3 are difficult to see in this photograph, but they are at locations 3 and 4. Note the water on the surface of the tailings at location 5, and the stream flowing along the eastern edge of the tailings (6). A stream also flows along the western edge of the tailings (7). The streams discharge from the tailings at location 3.

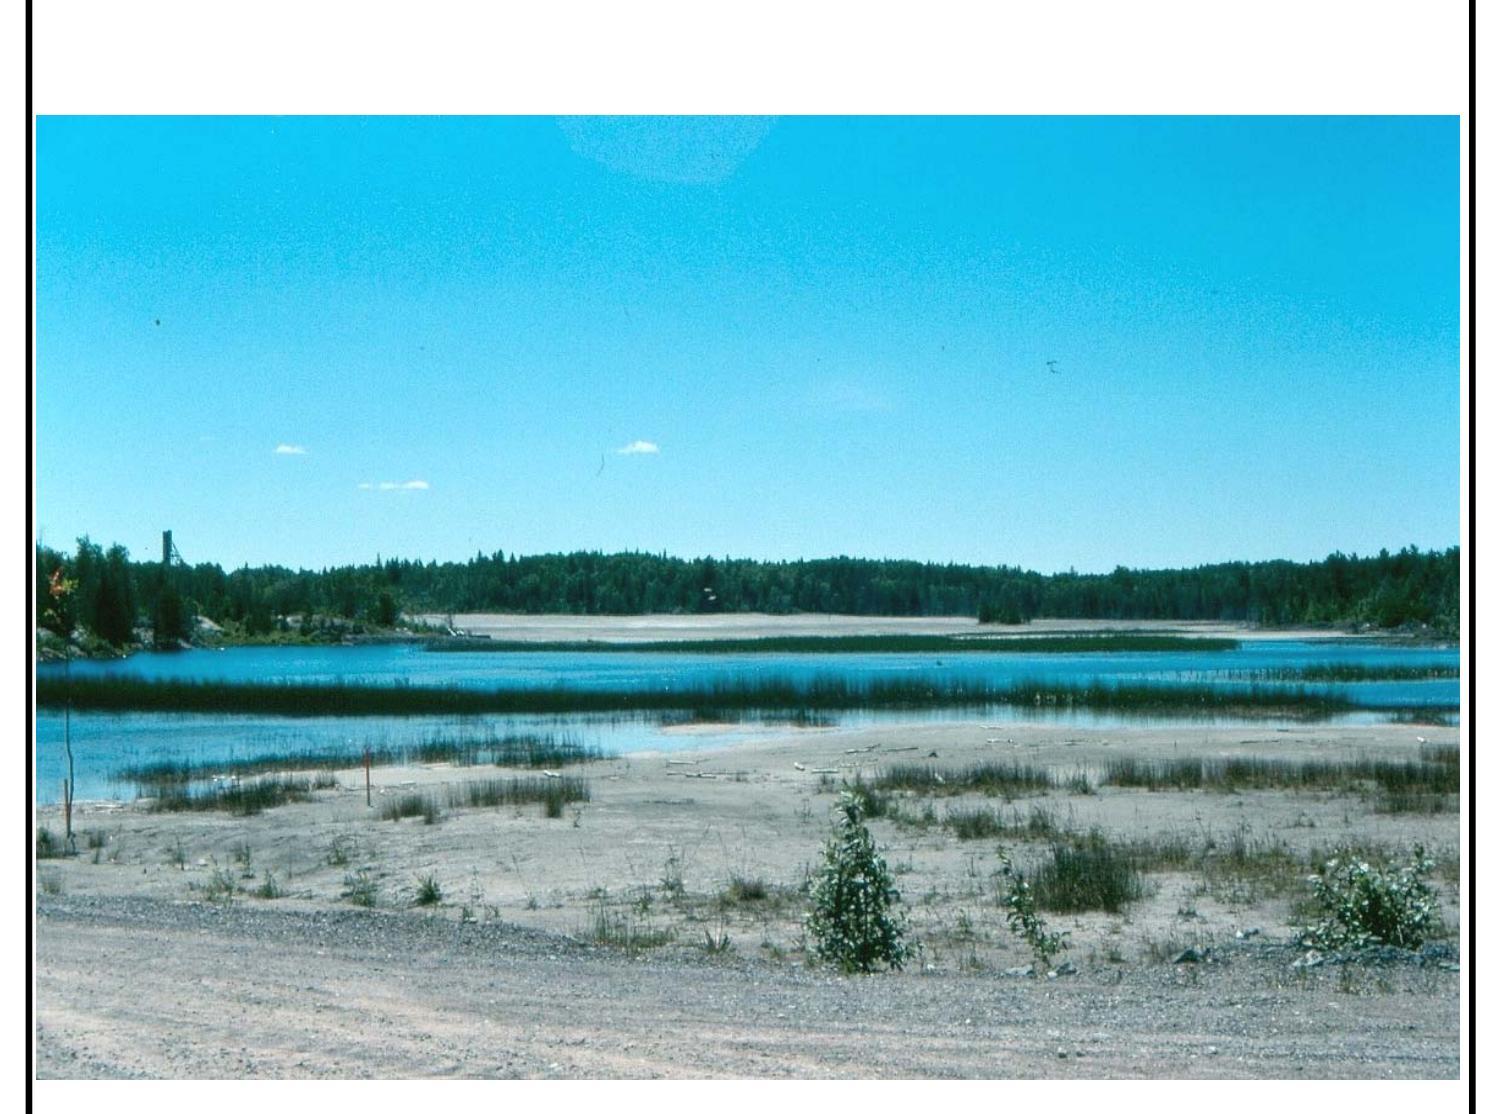
Cart Lake tailings, looking south, taken in June 1991. It is about 900m from the point where this photo was taken, to the south end of the tailings. The headframe on the left side of the photo (1) marks the location of the Silverfields mill, which produced these tailings. Photo by the author.

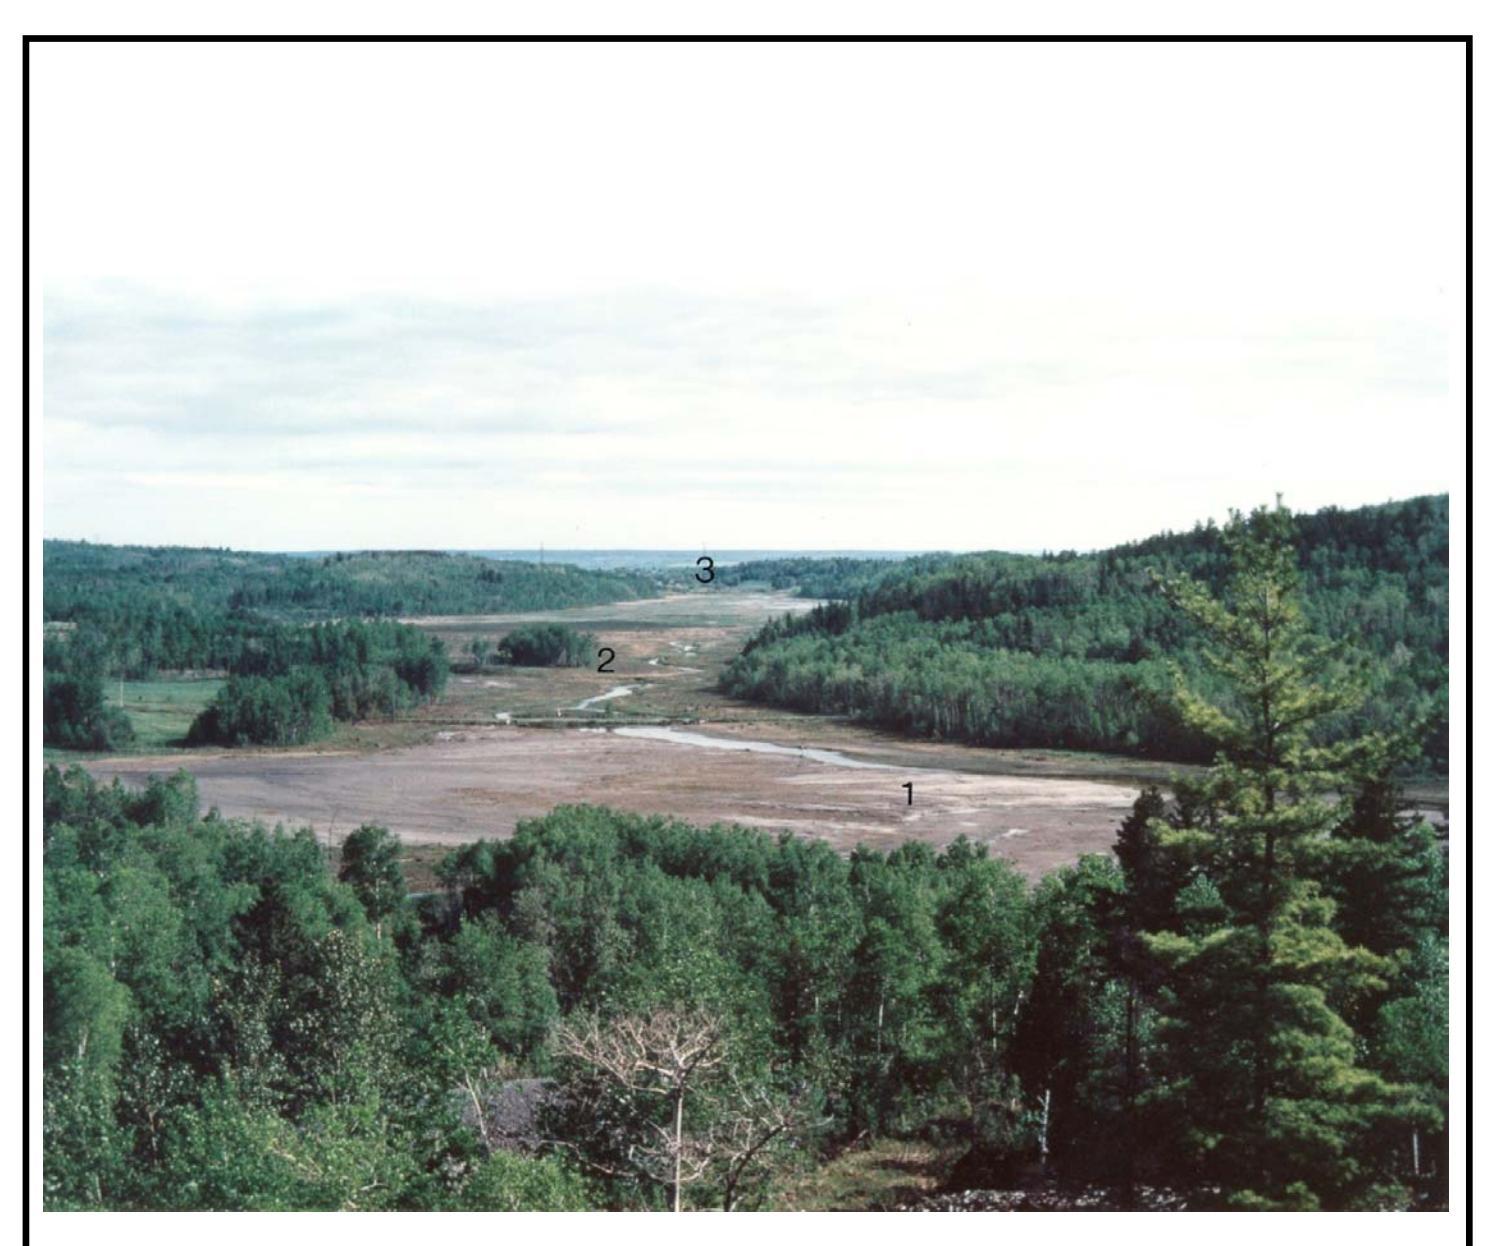
The Crosswise Lake tailings, looking north, taken in May, 1991. Peterson Creek can be seen flowing across the tailings (1) and Mill Creek can also be seen (2). The northern limit of tailings migration is at 3, about 2.4 km from the location where the photo was taken. Photo by the author.

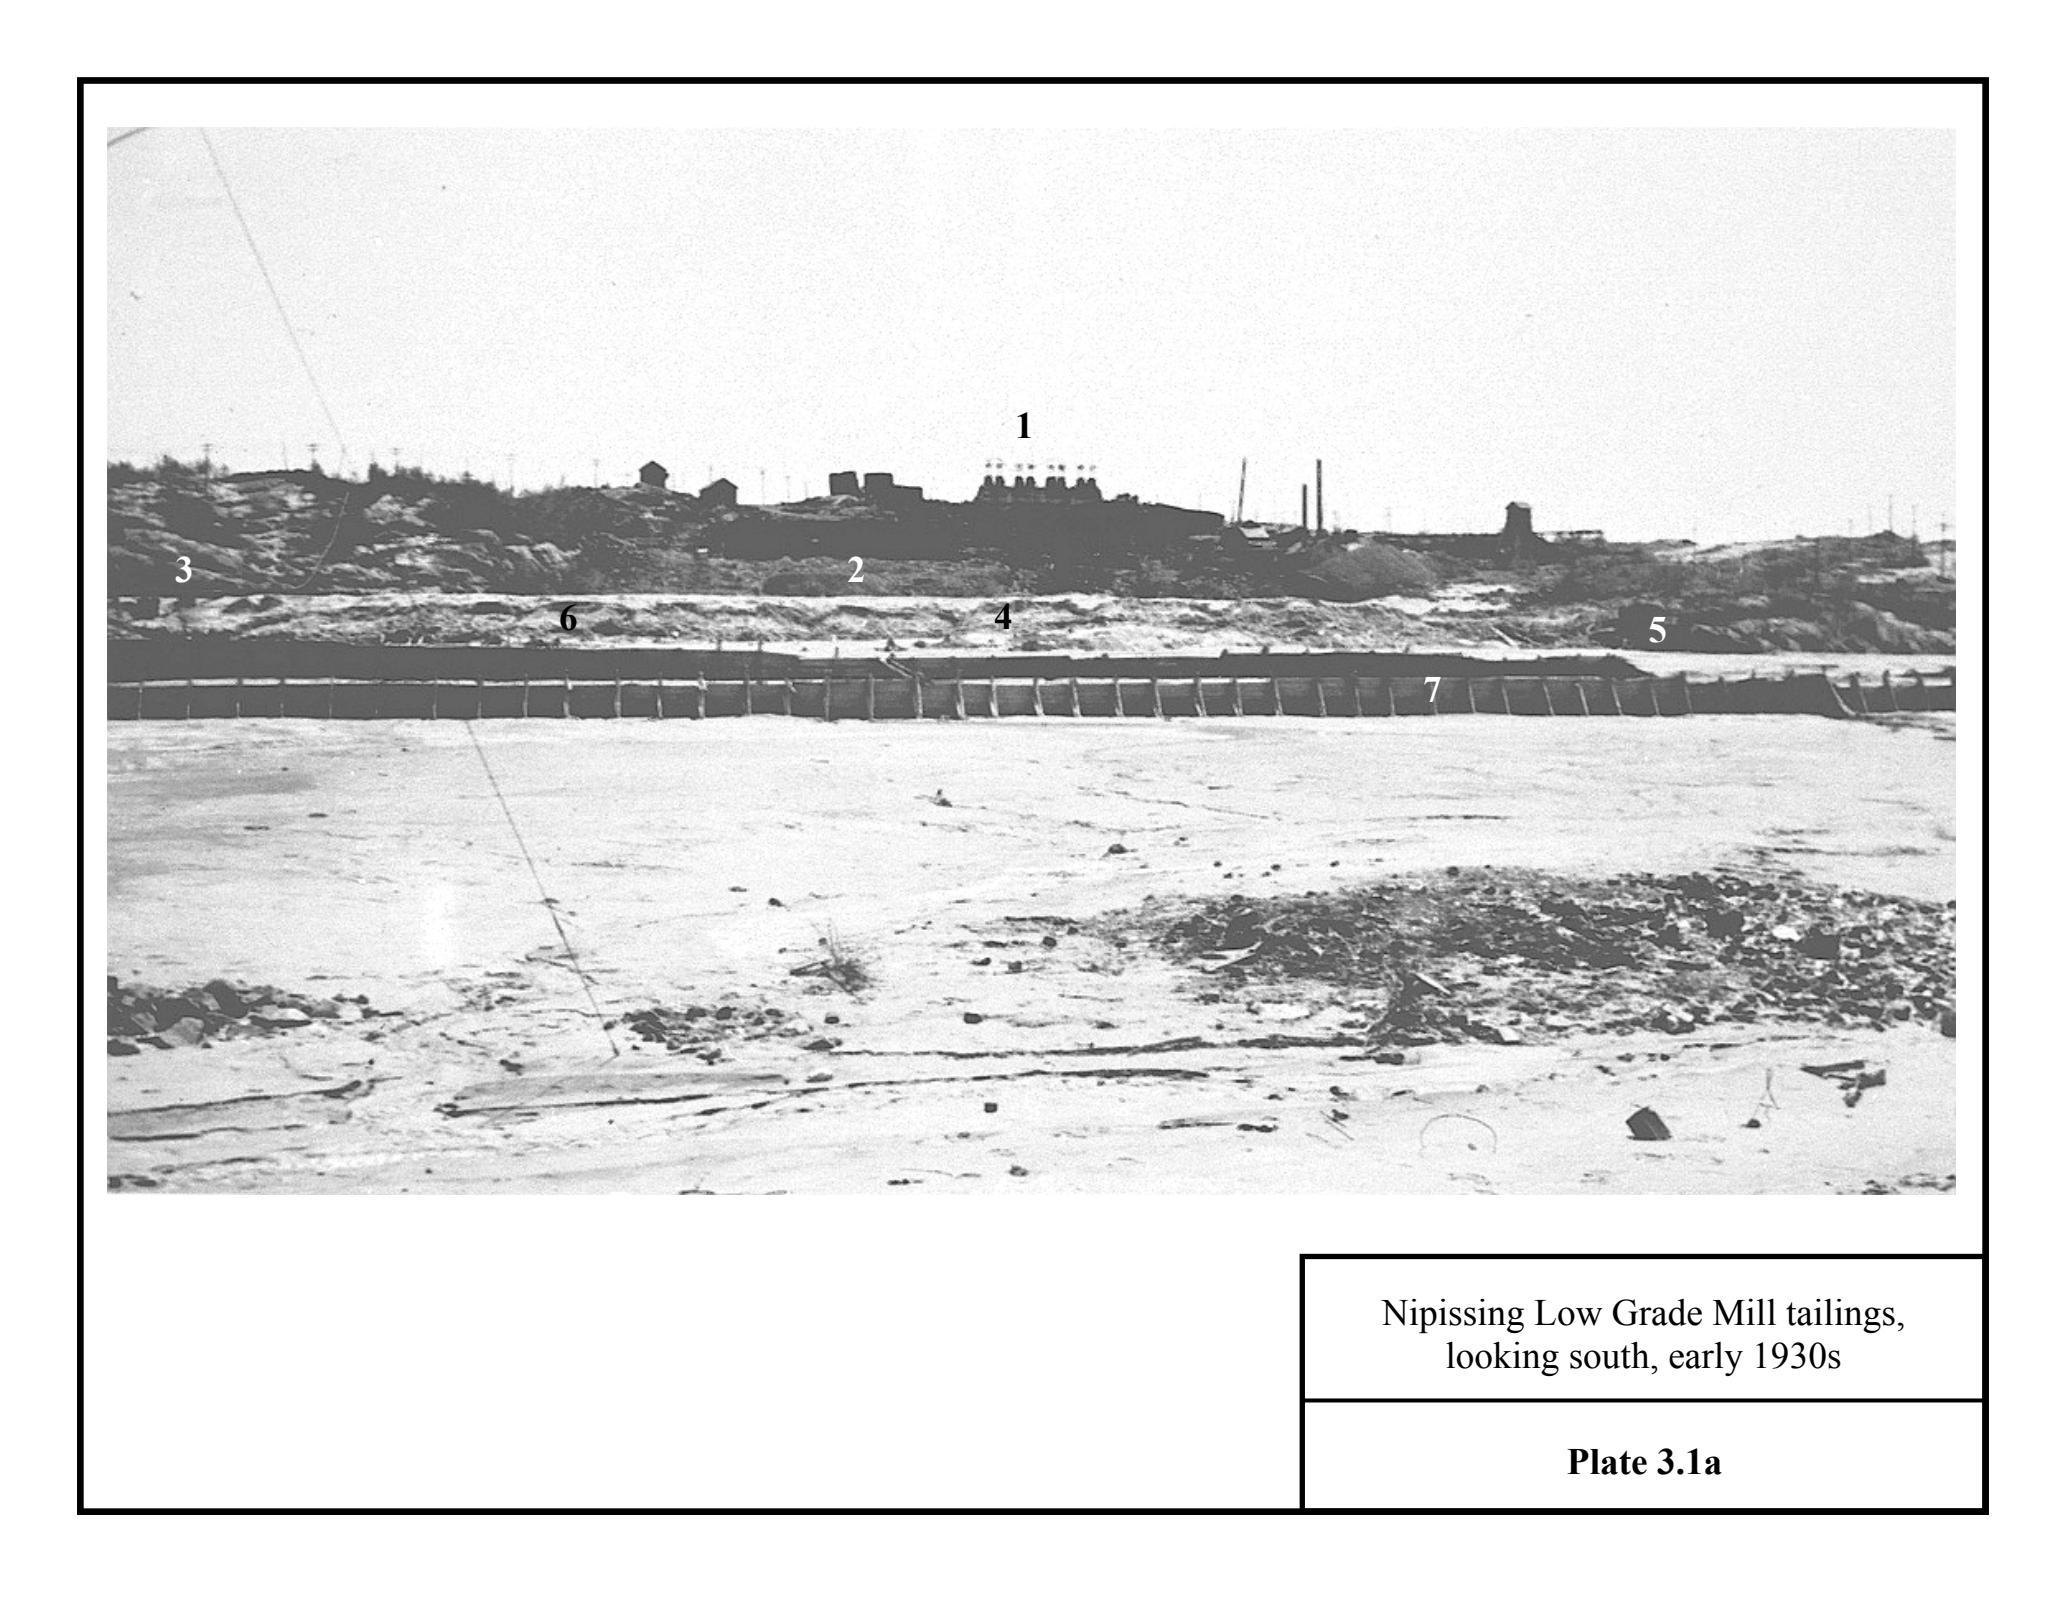
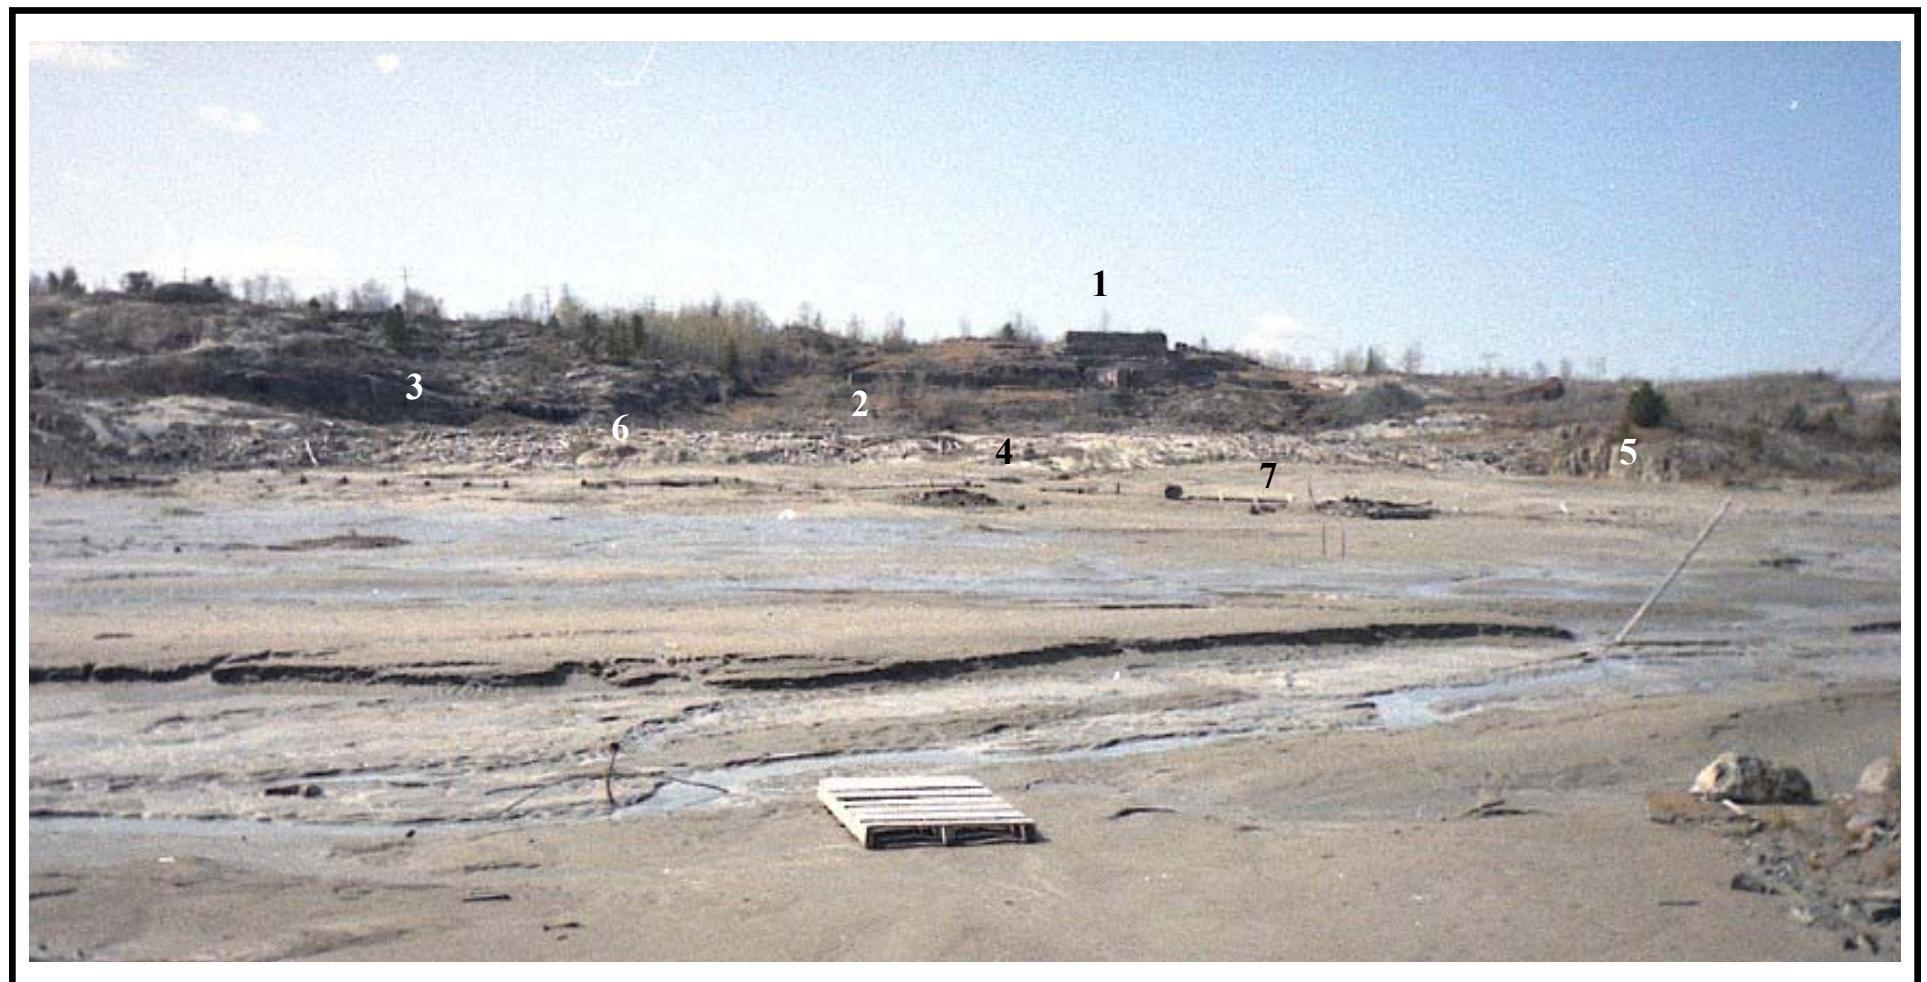
The Nipissing low grade mill tailings, looking south towards the mill foundation (1). Plate 3.1a was taken in the early summer of 1933 or 1934 (photo courtesy of the Cobalt Mining Museum). Plate 3.1b was taken from nearly the same location in May, 1992 (photo by the author). Dam #1 is seen in both photographs, and a comparison of the two photos shows how much the condition of the dam has deteriorated. In Plate 3.1a, tailings can be seen at the edge of the dam (2) which in Plate 3.1b much of the dam at the same location is gone. A comparison of the level of the tailings with a ridge along the eastern edge of the tailings (3) provides further evidence of tailings erosion. Just north of dam #1m a boulder on a rock outcrop (4) provides a reference point to show that tailings erosion has occurred

A photograph taken looking south towards the NLGM in the summer of 1934 shows the tailings. In Plate 3.1, this photograph is compared with a photograph taken from nearly the same location in May, 1992. From a comparison of these two photographs it is clear that dam #1 has deteriorated considerably, and a significant amount of tailings has been removed from the area south of dam #1. Features between dam #1 and dam #2 are not as clear, but in this area, too, it is evident that tailings have been removed.

In June 1991, a levelling survey was conducted along dam #1. The highest point on the existing dam is 314.21 m.a.s.l.. Remnants of wood from the dam can be found moving up the hill east of the tailings, so the level to which the dam previously extended can be estimated. The highest remnants of the dam were found at an elevation of 316.31 m.a.s.l.. Thus, at least 2.1 m of the dam has been removed. From the old photograph in Plate 3.1, it is evident that the tailings

reached the top of the dam. Near the highest remnants of the dam, small amounts of residual tailings occur in bedrock depressions. These observations, and the fact that tailings were deposited as a slurry, provide evidence that the tailings south of dam #1 were formerly level with the top of the dam.

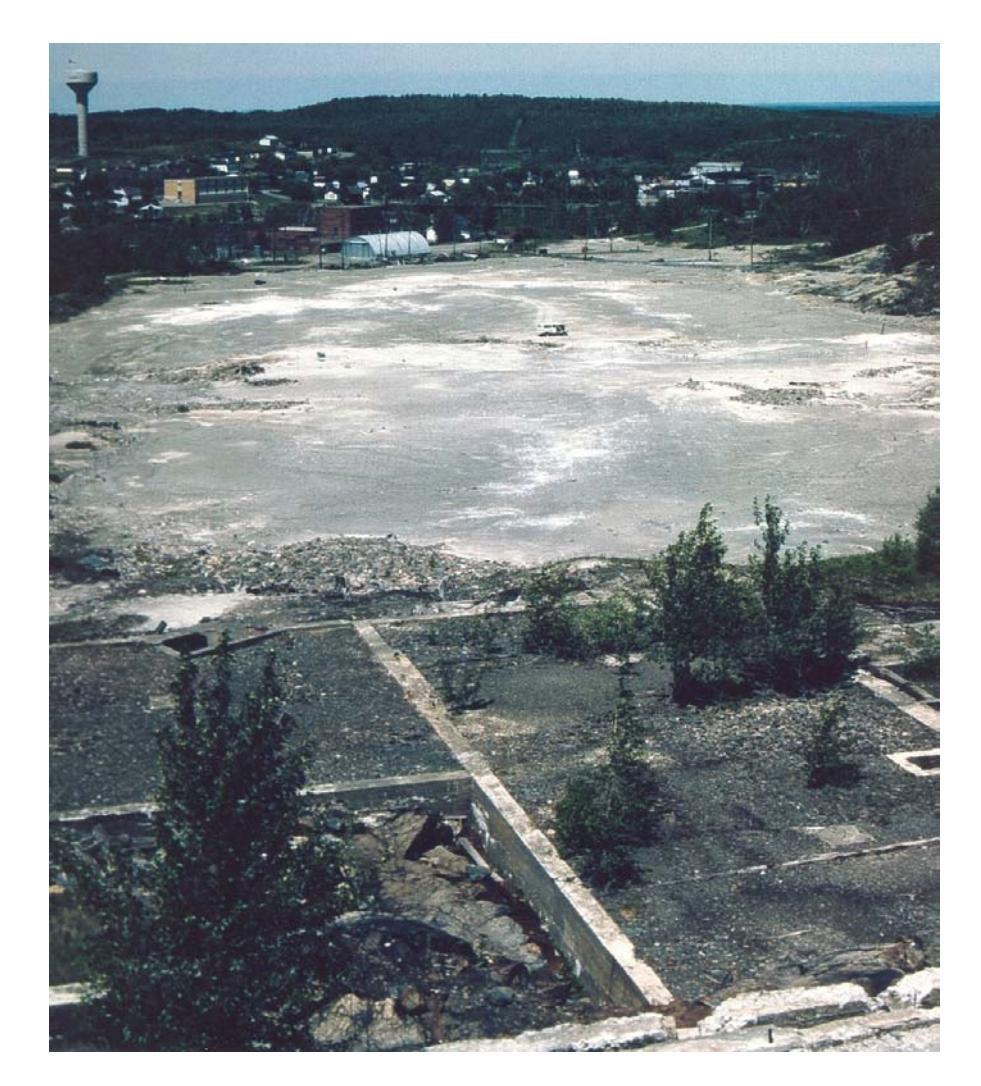
NLGM tailings from mill foundation

The Nipissing low grade mill tailings, looking north from the mill foundation. The light coloured areas on the tailings are surface crusts. Photo by the author.

the tailings (see Plate 3.2). These crusts are water soluble, and are redissolved in heavy rains. South of dam #1, and in the area between dam #1 and dam #2, the crusts are white to light grey, hard and brittle. Different textures occur: some crusts are very thin (< 1 mm), and occur around desiccation cracks in the tailings surface; some crusts are thicker ( $\approx$  1 to 1.5 mm), and occur as flaky layers over large areas of tailings; and other crusts occur as scale like patches up to a few centimetres in diameter. North of dam #2, and just south of dam #2, in areas where the tailings surface is flatter, thicker (up to 1 cm) crusts occur which range in colour from light grey to orange to reddish brown. These crusts tend to have a powdery or blister like appearance, and they crumble when touched.

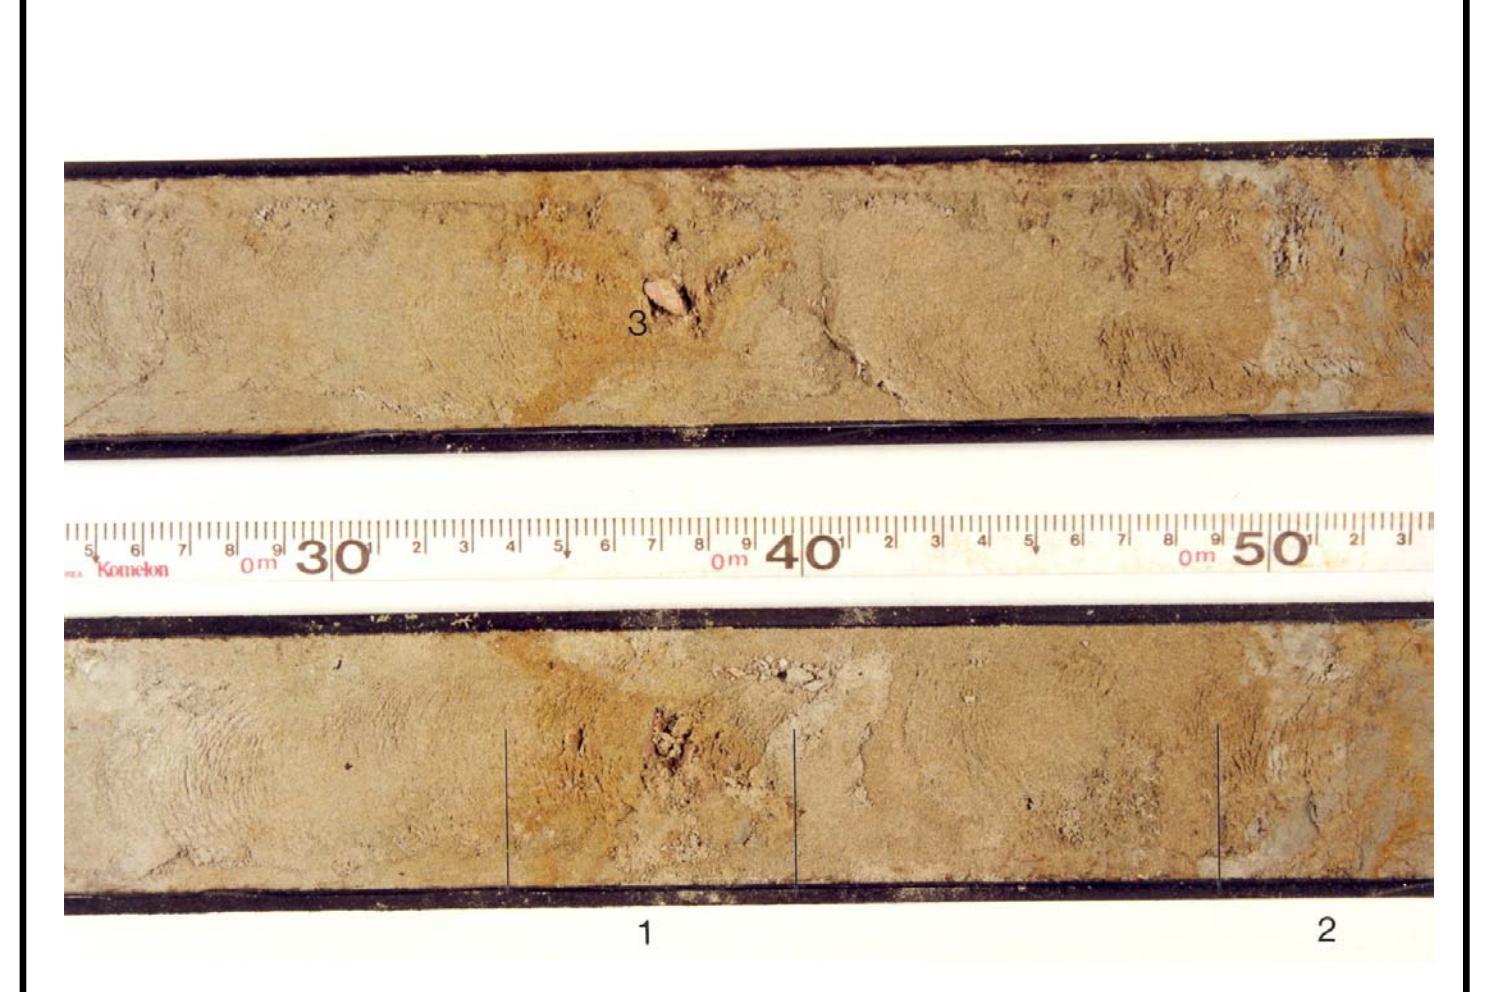
Altered tailings in a core collected near piezometer P26 in the Nipissing low grade mill tailings. The top of the core is to the left, and the rule is for scale only and does not indicate distance from the top of the core. Two areas of alteration are evident, in the mide section of the core (1) and at the bottom of the core (2). The small pebble in the core (3) is coated with a thin layer of erythrite. Photo by the author.

In the alteration zones the tailings are pale rusty to greenish in colour. The uppermost 10 cm of the tailings are generally unaltered, and below this unaltered zone the intensity of alteration is variable, with unaltered tailings grading into progressively more altered tailings with increasing depth within the alteration zone. Altered tailings may alternate with unaltered tailings within the uppermost 50 cm of the tailings. In the trench, the alteration zones in the top 25 cm were continuous across the face, a width of about 1.5 m (see Plate 3.3).

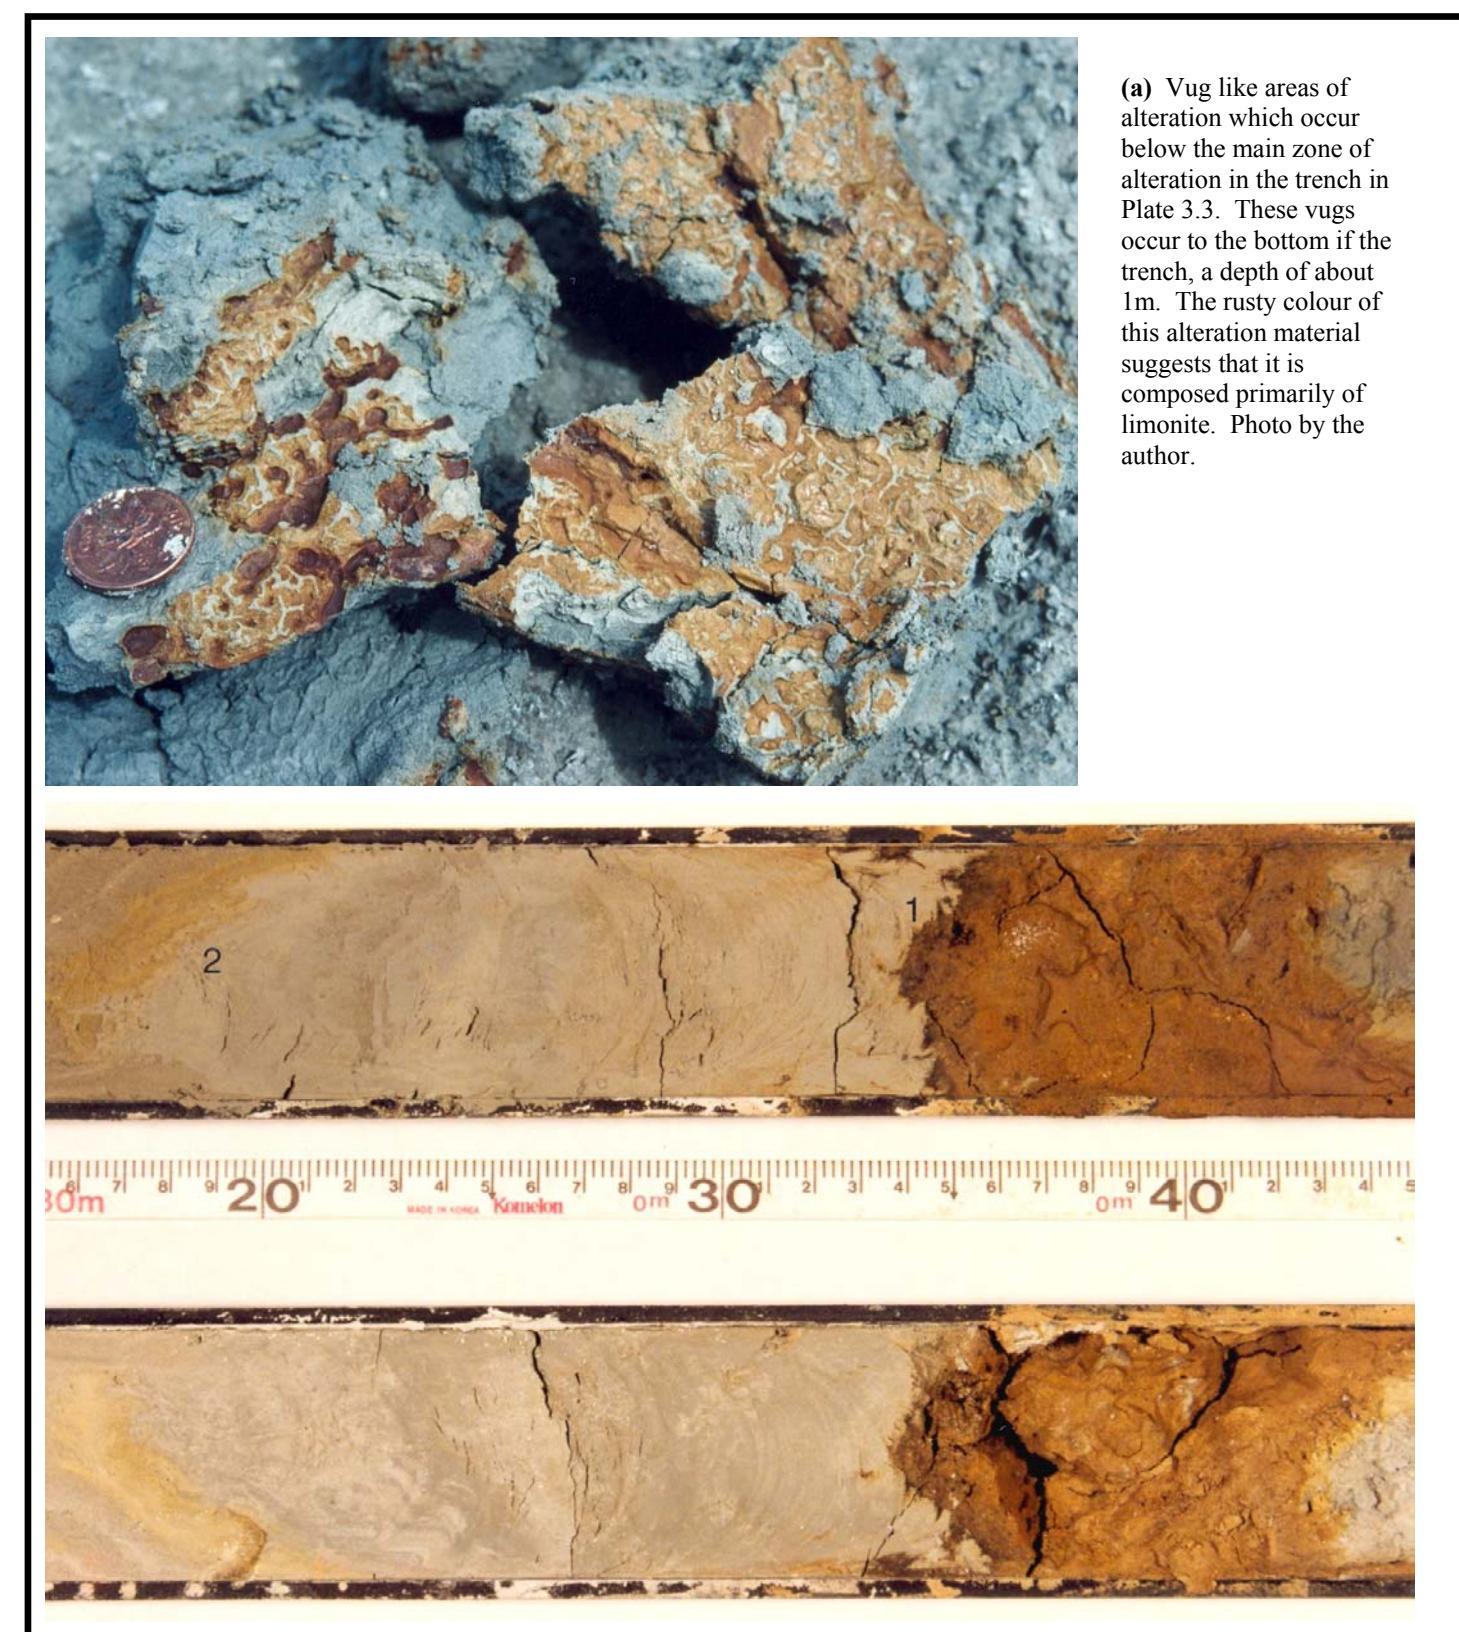
(b) Intensely altered tailings in a core taken near piezometer P51 at the Nipissing low grade mill tailings. The top of the core is to the left, and the ruler is for scale only. When the core was opened this material was gel-like. The colour suggests that the alteration material is composed primarily of limonite. At the top of the zone (1) the material is darker in colour. And small black blebs, likely composed of wad, occur in the limonite. Also note the less intense area of alteration further up in the core (2). Photo by the author.

In one core, taken at the northeast end of the tailings deposit, at the edge of an area which is wet throughout the year, an extremely intense alteration zone occurs at a depth of 32 to 42 cm (see Plate 3.4). The top 1 cm of this zone is dark brown to black, and distinct, black grains or aggregates of grains are present. The next 9 cm of the alteration zone is an intense rust colour, with some scattered black grains, especially near the top and bottom of the zone. When the core was opened, this rusty material was gel like. The rusty material is limonite, while the black material is likely wad. In this core, only one small area of alteration was observed above this zone, and alteration below this zone was limited.

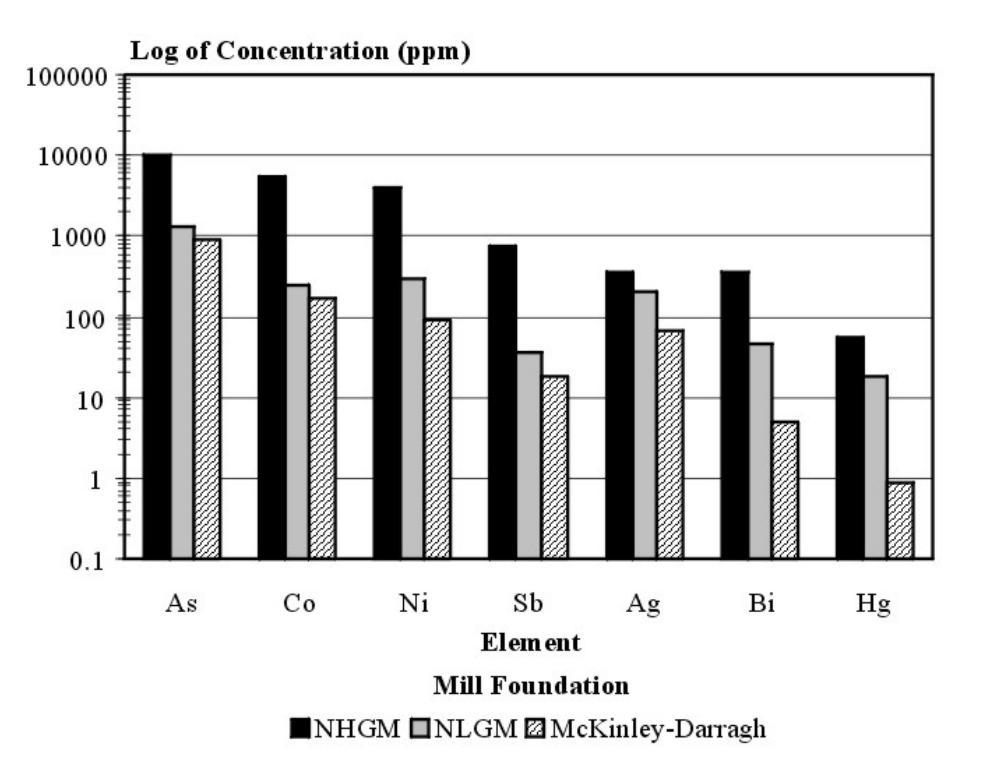
**Figure 3.10:** Concentrations of As and metals in concrete from the NHGM, NLGM and McKinley-Darragh foundations

The trace element concentrations in concrete from mill foundations, and other solid material collected in the Cobalt area, are given in Table 3.5. Of the three concrete samples, the sample from the NHGM contains the highest concentrations of As, Sb, Cl, SO<sub>4</sub>, Hg, Co, Ni, Bi and Ag (see Figure 3.10).

Concrete samples were collected because of concerns about Hg contamination. The Hg concentrations in these samples range from 0.90 ppm in concrete from the McKinley-Darragh mill foundation, to 56.06 ppm in concrete from the NHGM foundation. The Hg concentration in the NHGM foundation is slightly higher than the mean Hg concentration in samples from the NLGM tailings, but much lower than the mean Hg concentration in samples from the NHGM tailings.

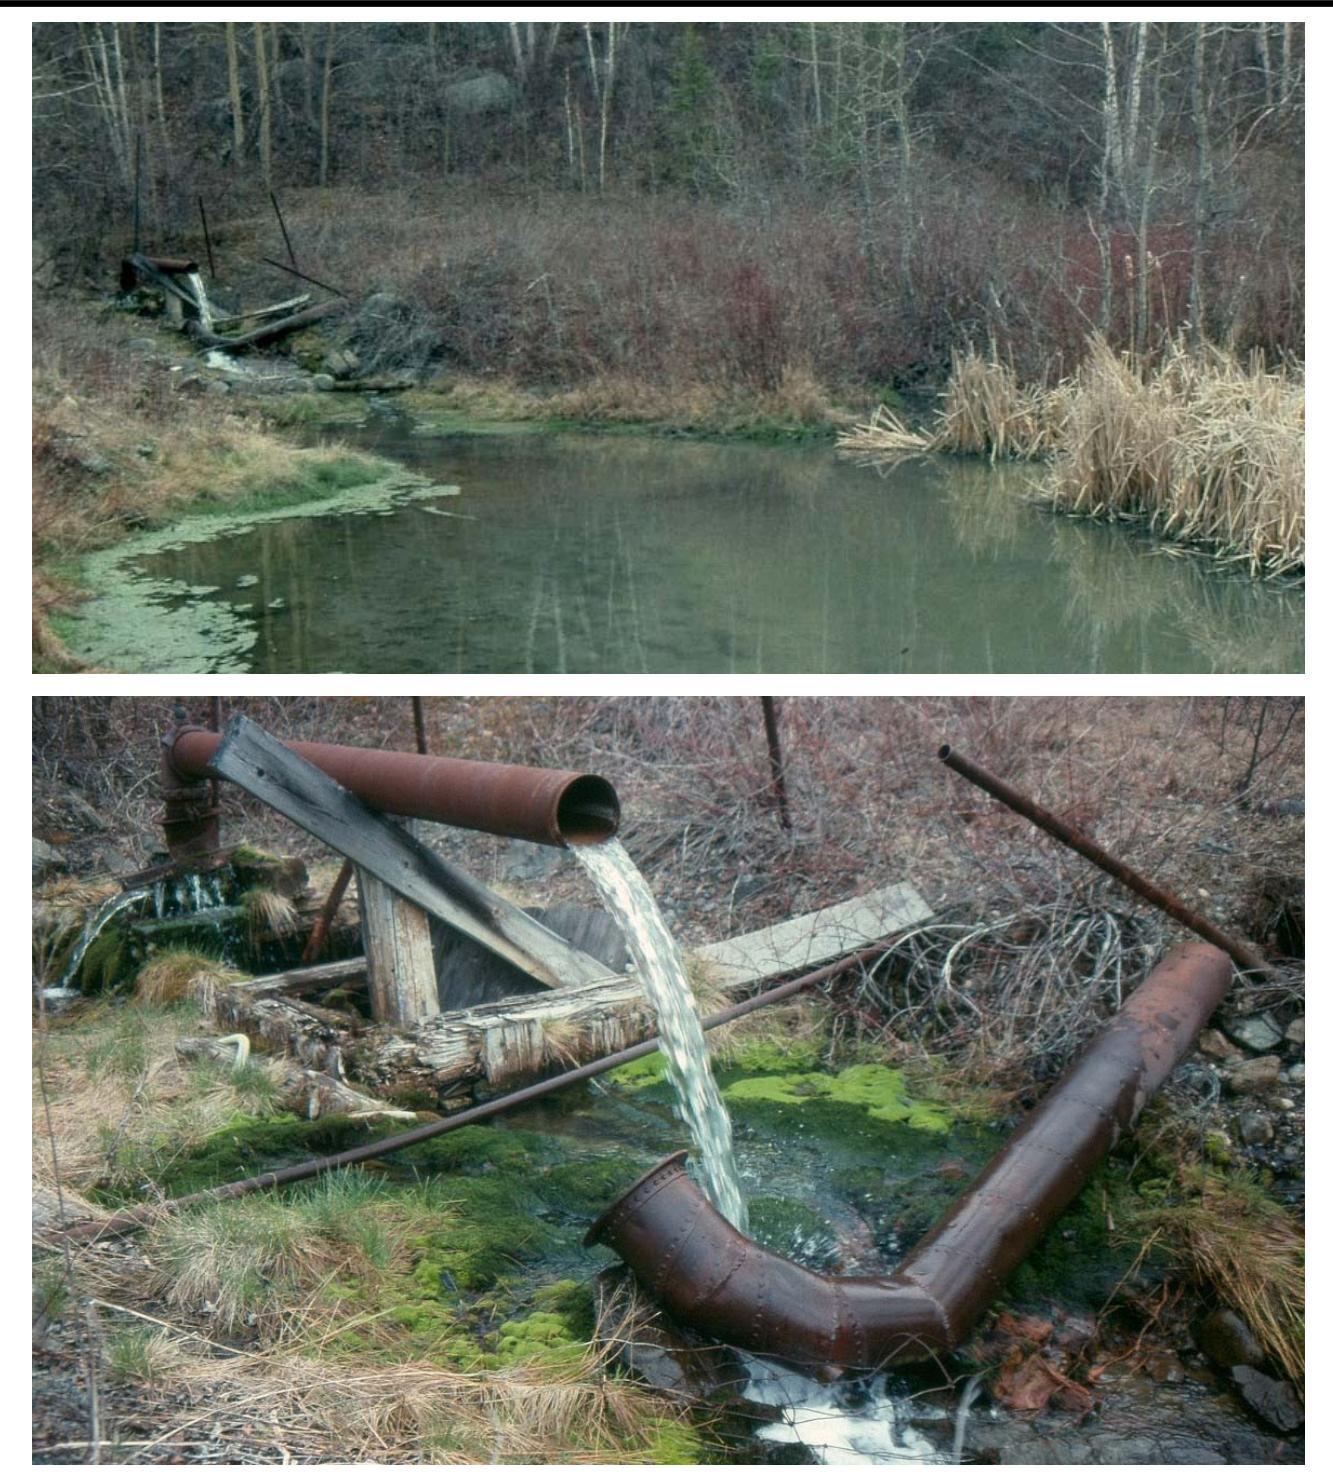
Groundwater discharging from a mine shaft adjacent to the south arm of Sasaginaga Creek. The pipe is part of a structure which caps the shaft. The pipe is about 15 cm in diameter. The flow from the pipe was not measured, but from the photo it is evident that the volume of water discharging is significant. In addition to the water coming from the pipe, some groundwater also discharges around the base of the capping structure (see bottom photo). Photos by the author. Note: original thesis contained only one photo.
