# The Occurrence of Arsenic and Heavy Metal Contamination from Natural and Anthropogenic Sources in the Cobalt Area of Ontario

A thesis submitted to the Faculty of Graduate Studies and Research in partial fulfilment of the requirements for the degree of Master of Science

Carleton University Ottawa, Ontario May, 1993

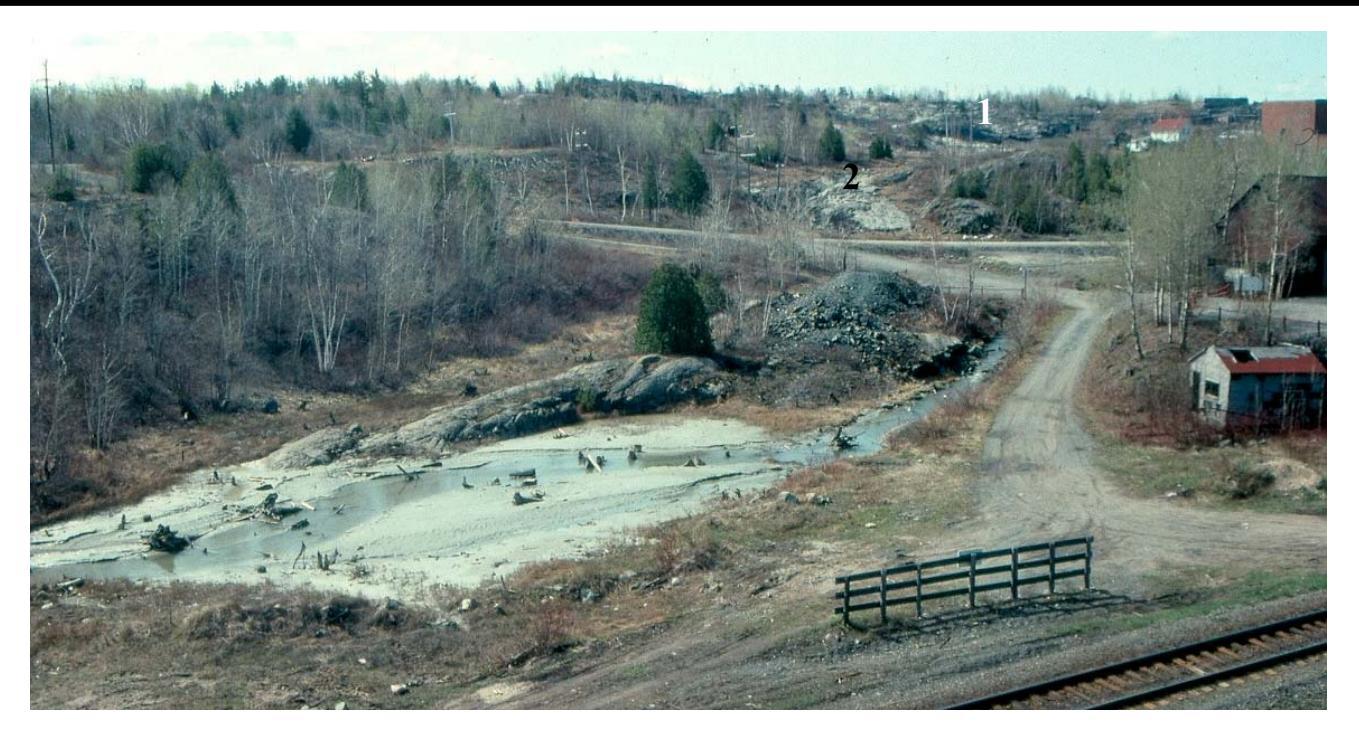
Mill Creek looking south towards the Nipissing low grade mill tailings (1). The discharge from the tailings flows through a fracture in the rock at point 2. By this route, tailings are migrating from the NLGM tailings into Mill Creek. Most of the tailings in the foreground likely originated from the NLGM tailings. Photo by the author.

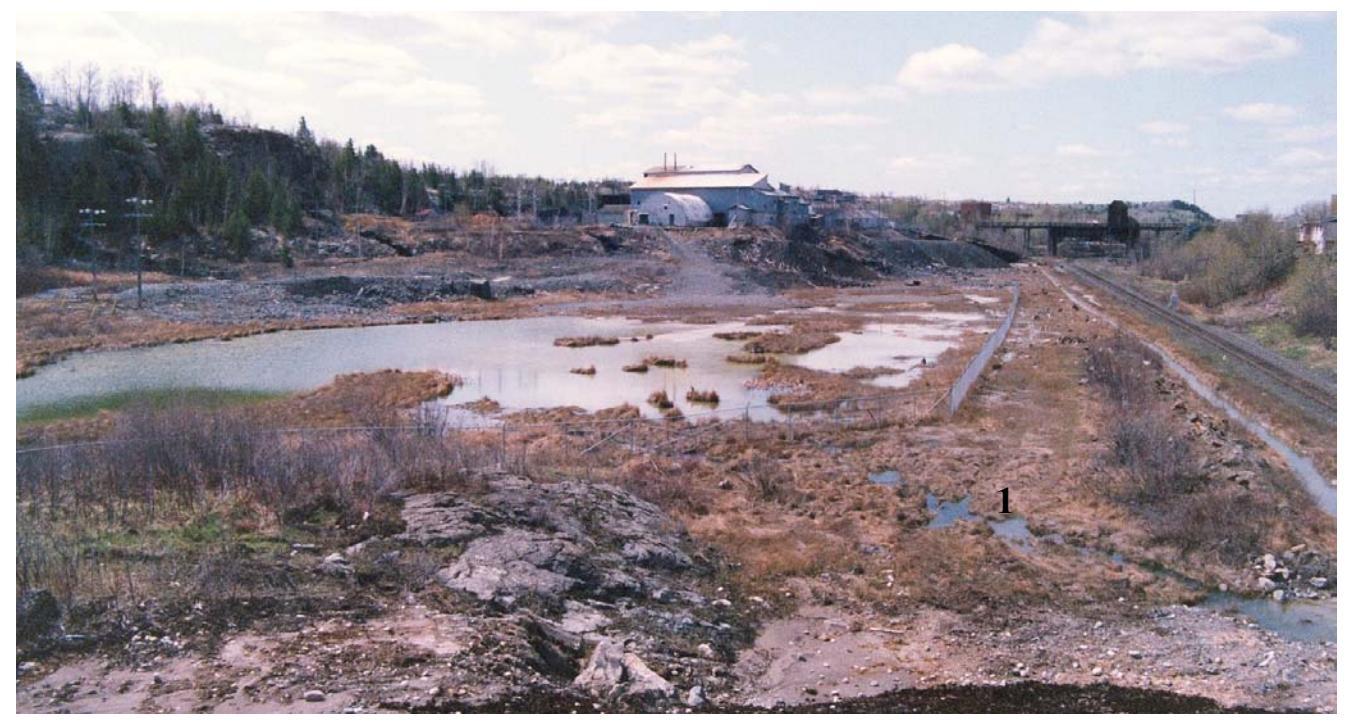
The tailings on the LaRose property, looking south from the Highway 11B bridge at Mill Creek and the railway tracks. Most of the LaRose tailings are submerged under a pond which remains wet throughout the year. This pond discharges into Mill Creek at point 1. Photo by the author

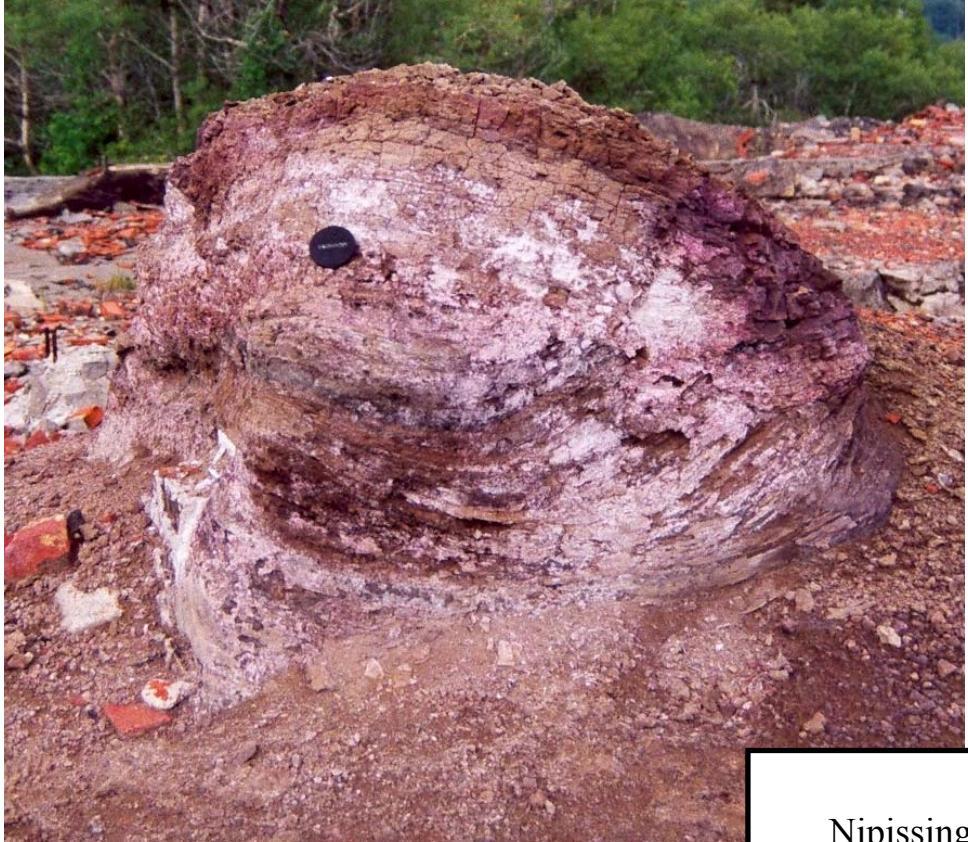
Top photo shows rubble and waste material immediately south of the Nipissing high grade mill foundation. The photo to the left is a close-up the pile that was the source of the sample called Nipissing High Grade Mill "Stuff". The origins of this material are not known, but samples contained over 200,000 ppm of arsenic. Photos taken by the author in 1993 or 1994.

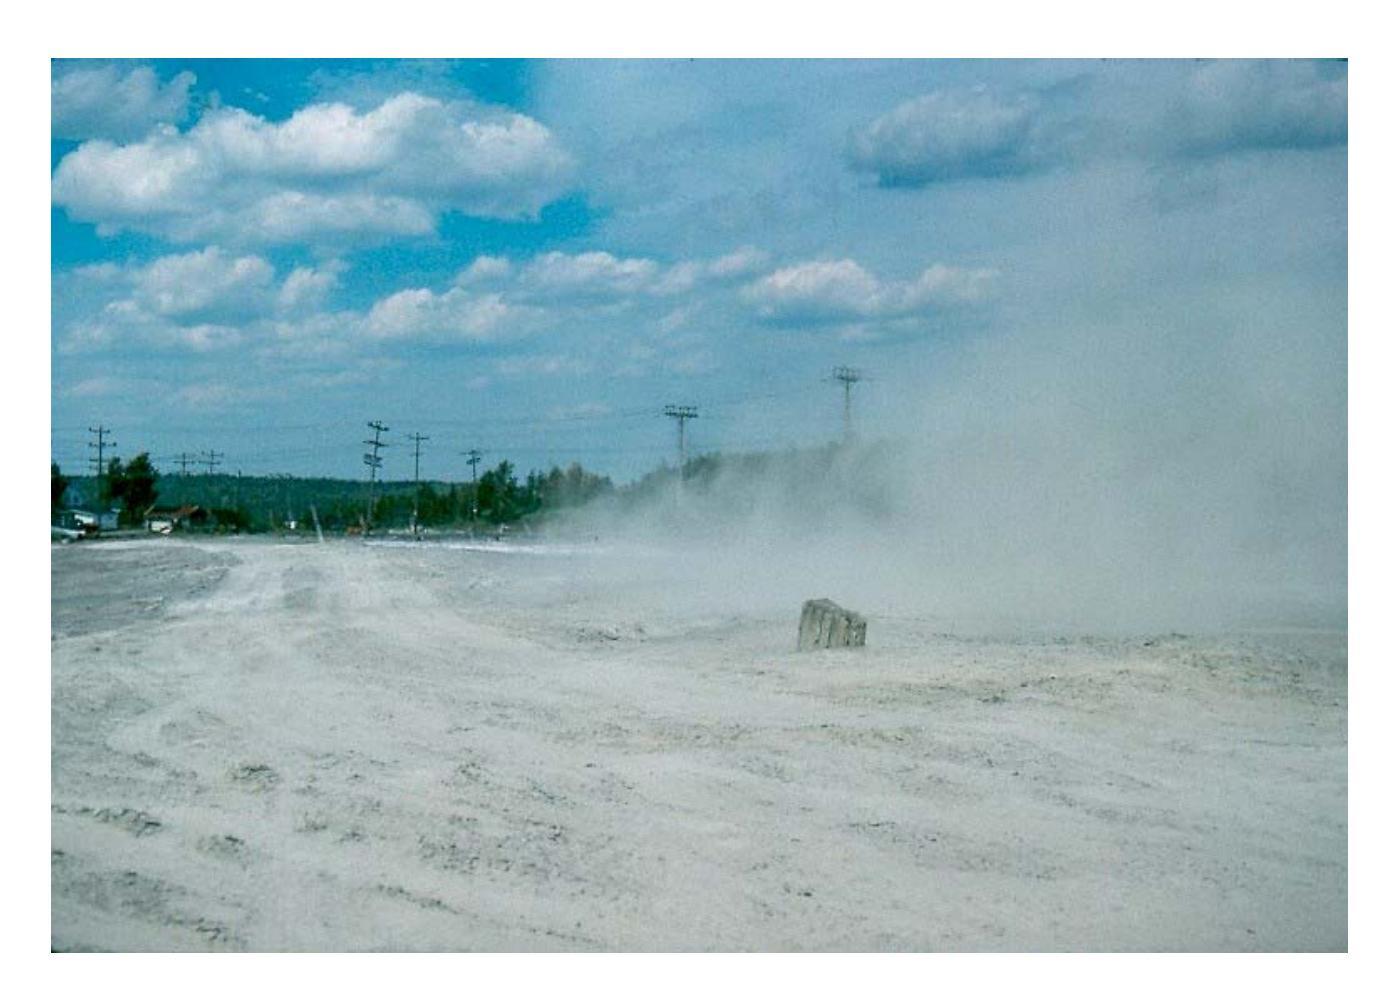
This photo, taken by the author in 1991, illustrates dust blowing from the Nipissing low grade mill tailings. Photo is taken looking north, with the tailings blowing to the east. Note the home in the background. Homes are also located close to the tailings on the west side, and over the hill to the east, less than 1 km away. See a further discussion of dust problems in Section 5.4.1, and related recommendations in Section 6.2.1.

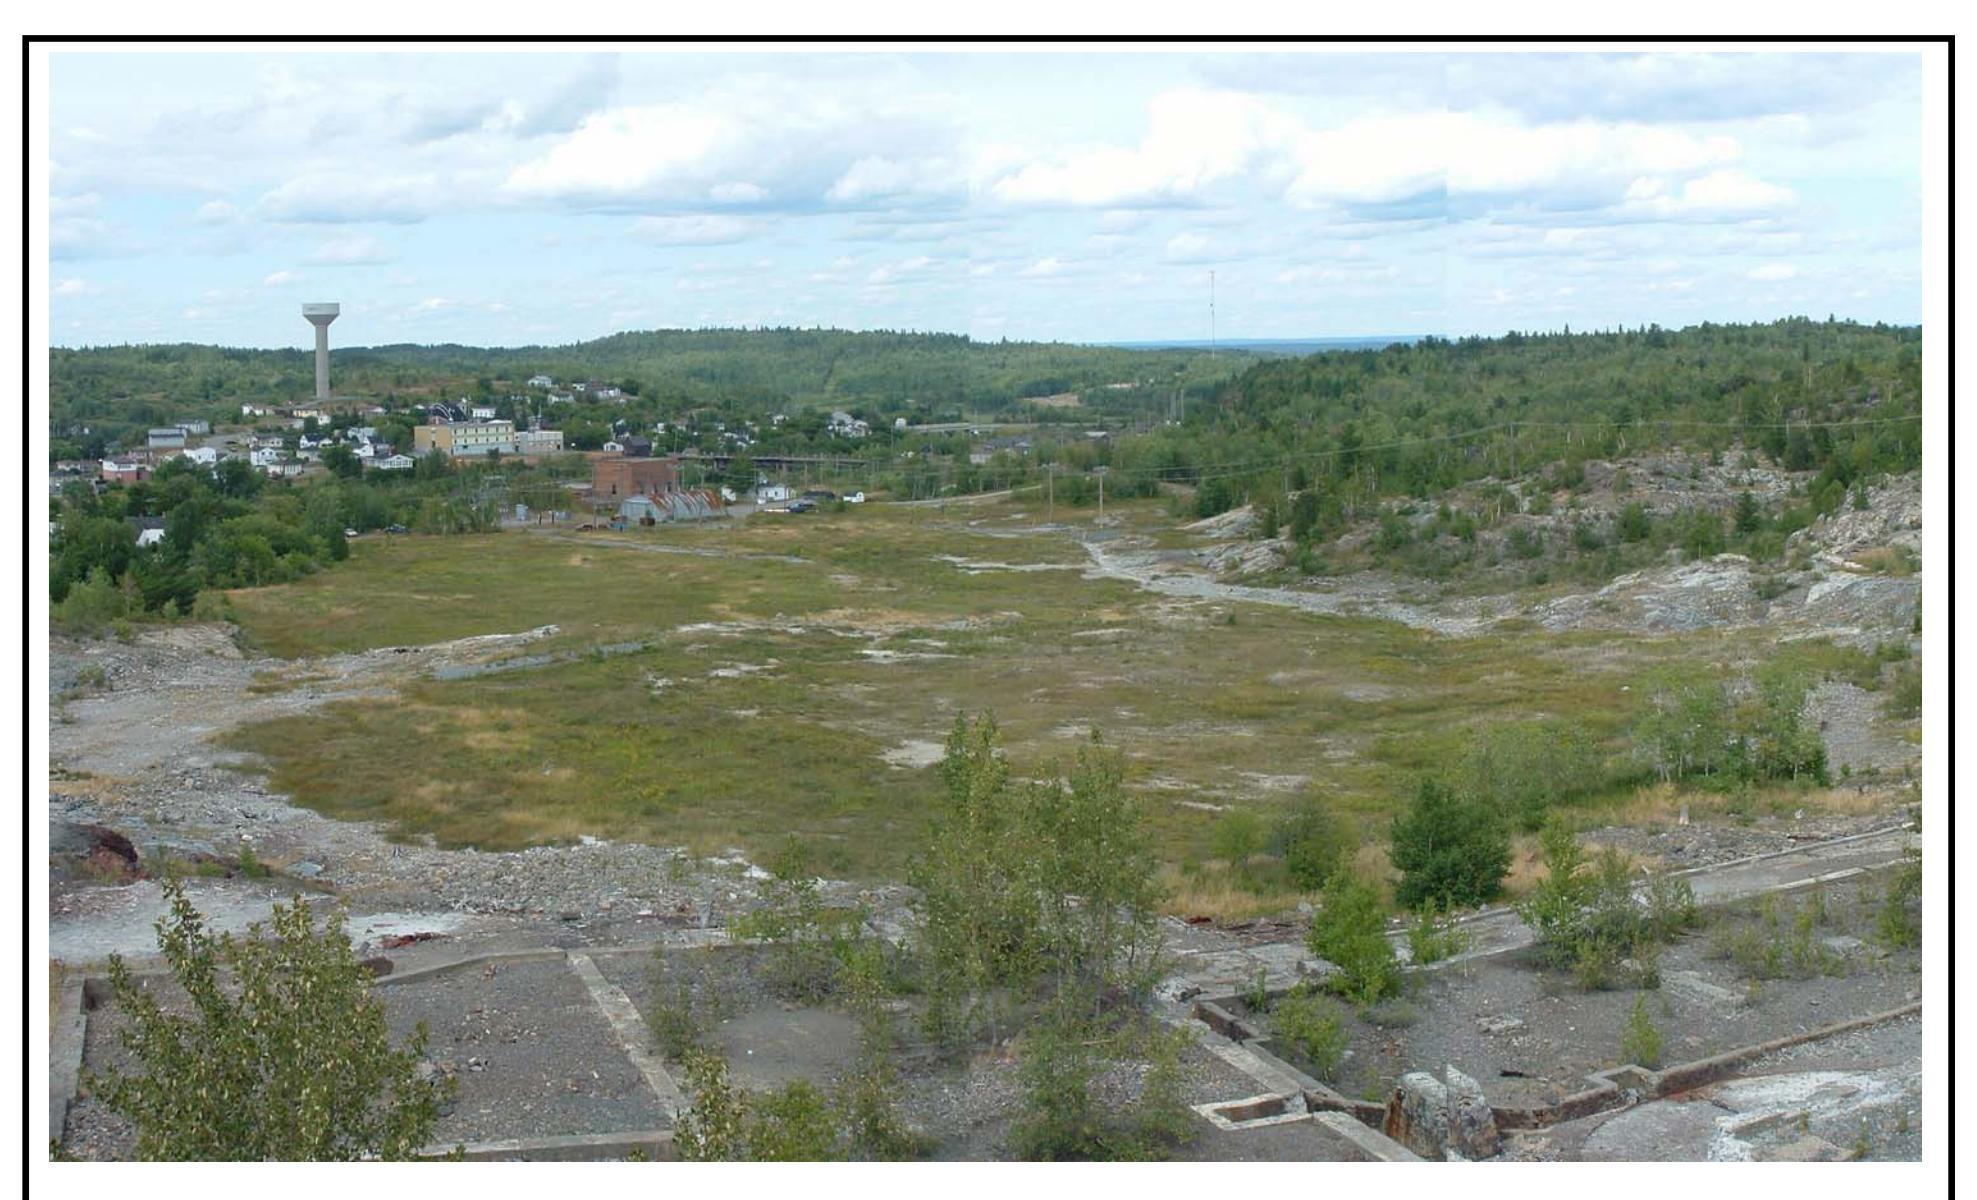
This composite photo shows the results of the efforts to revegetate the Nipissing low grade mill tailings. Compare this view with Plate 3.2a. Tailings were revegetated in the late 1990s. However, no effort appears to have been made to add any cover material over the tailings, and in bare areas, crusts like those described in section 3.5.2 are still evident. Thus, while the revegetation has likely helped to reduce dust from the tailings, further study is required to assess whether or not water quality has improved as a result of the revegetation efforts.

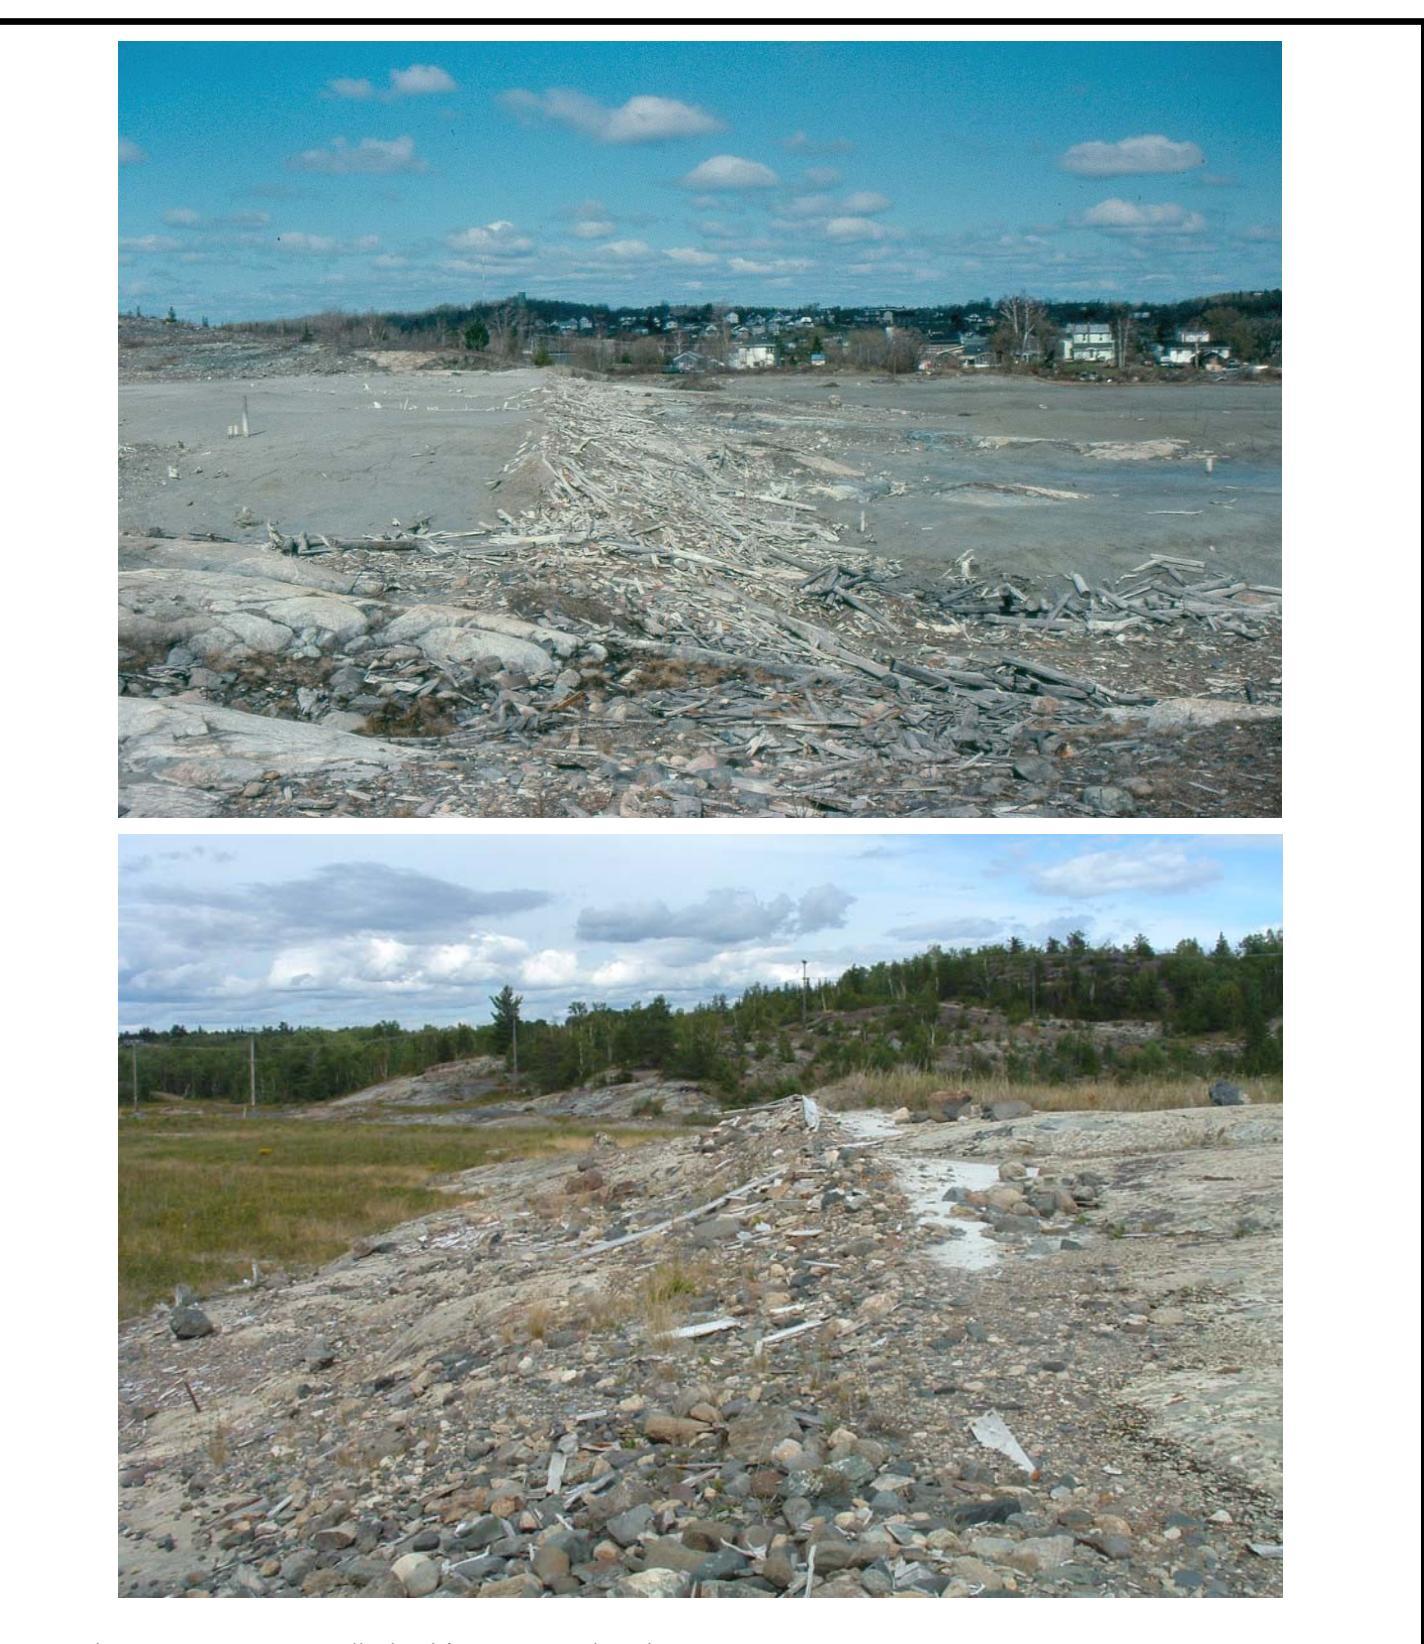
Top photo: NLGM Dam #1 looking west, taken by the author in 1991. See also Figure 2.4. Bottom photo: NLGM Dam #1 looking east, taken by the author in July 2005. Comparison of these photos suggests that some of the

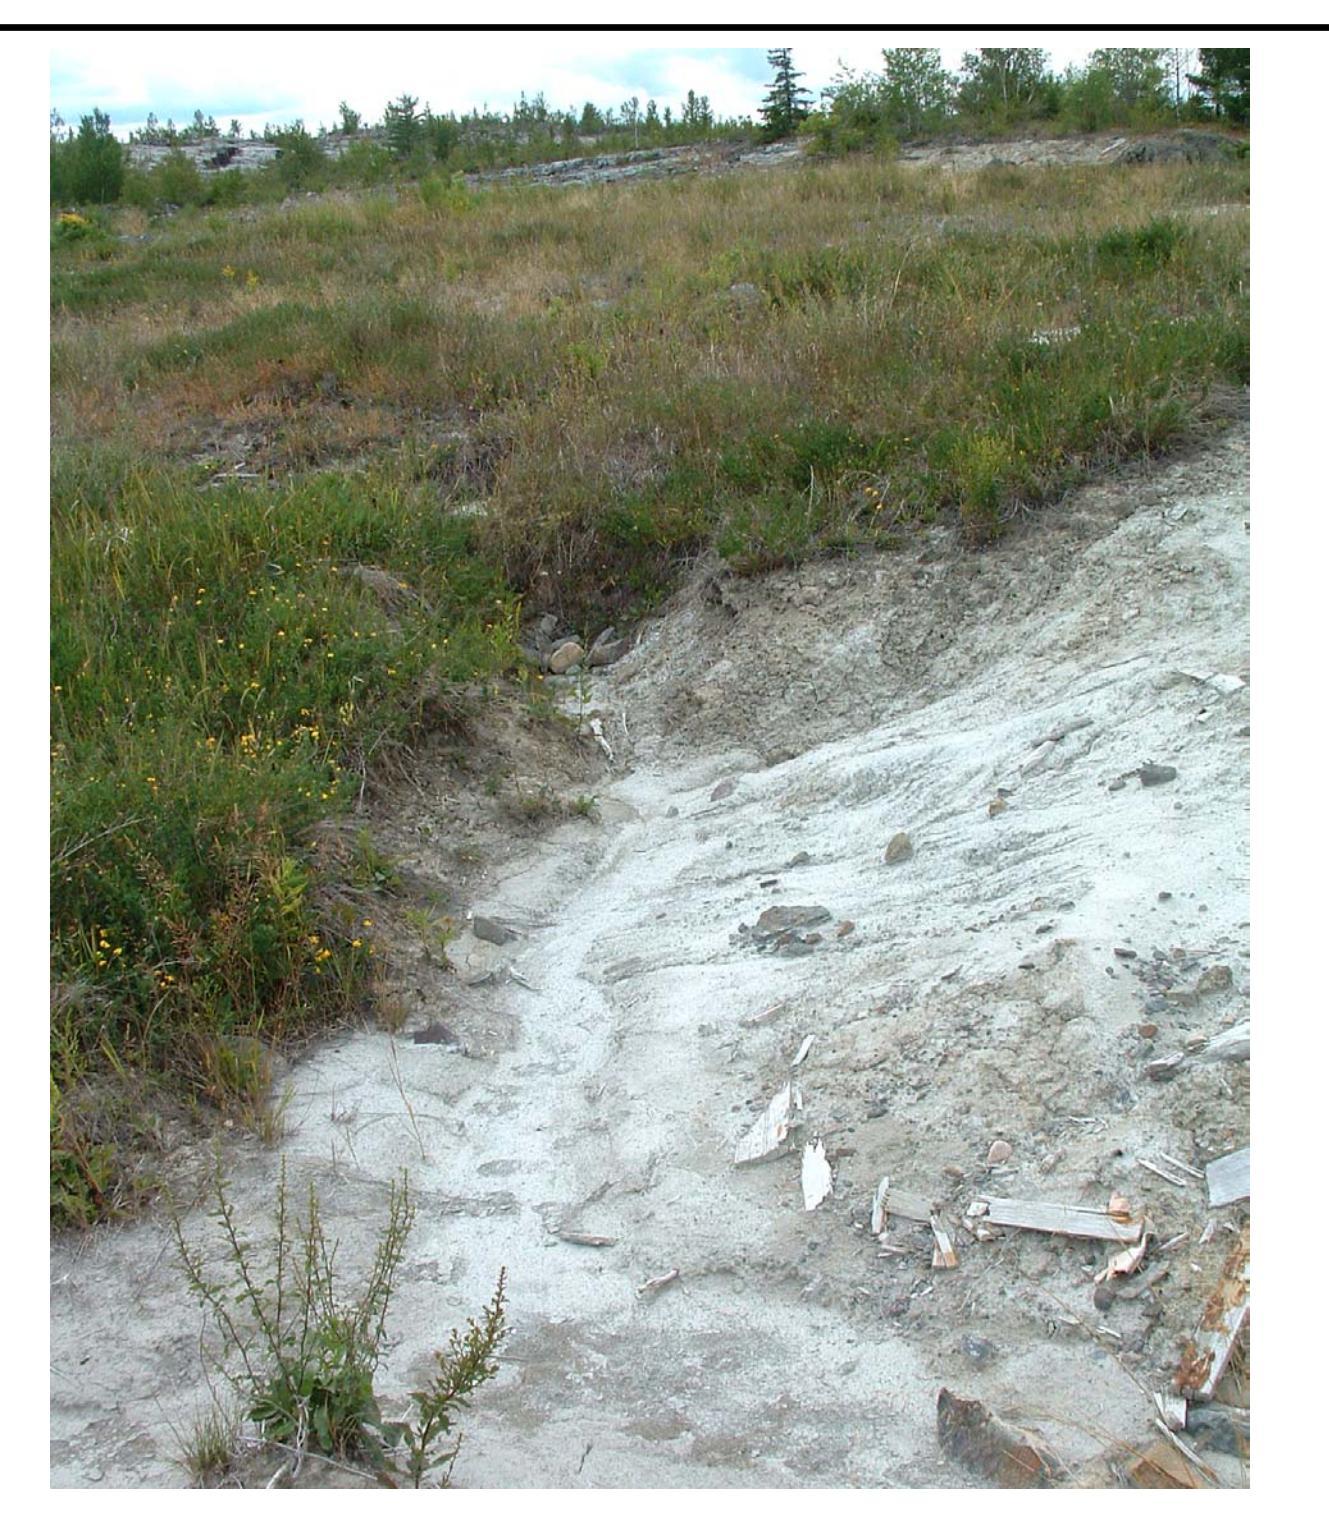
This photo illustrates ongoing tailings erosion on the NLGM tailings, just above Dam #1. When tailings were revegetated there appears to have been no effort to recontour the tailings or take other steps to help reduce erosion during spring runoff or high rainfall events. As a result, some transport of tailings and contaminants is likely continuing, and the long term success of the revegetation efforts may be questionable. Revegetation efforts were not in accordance with what would be considered best practice.

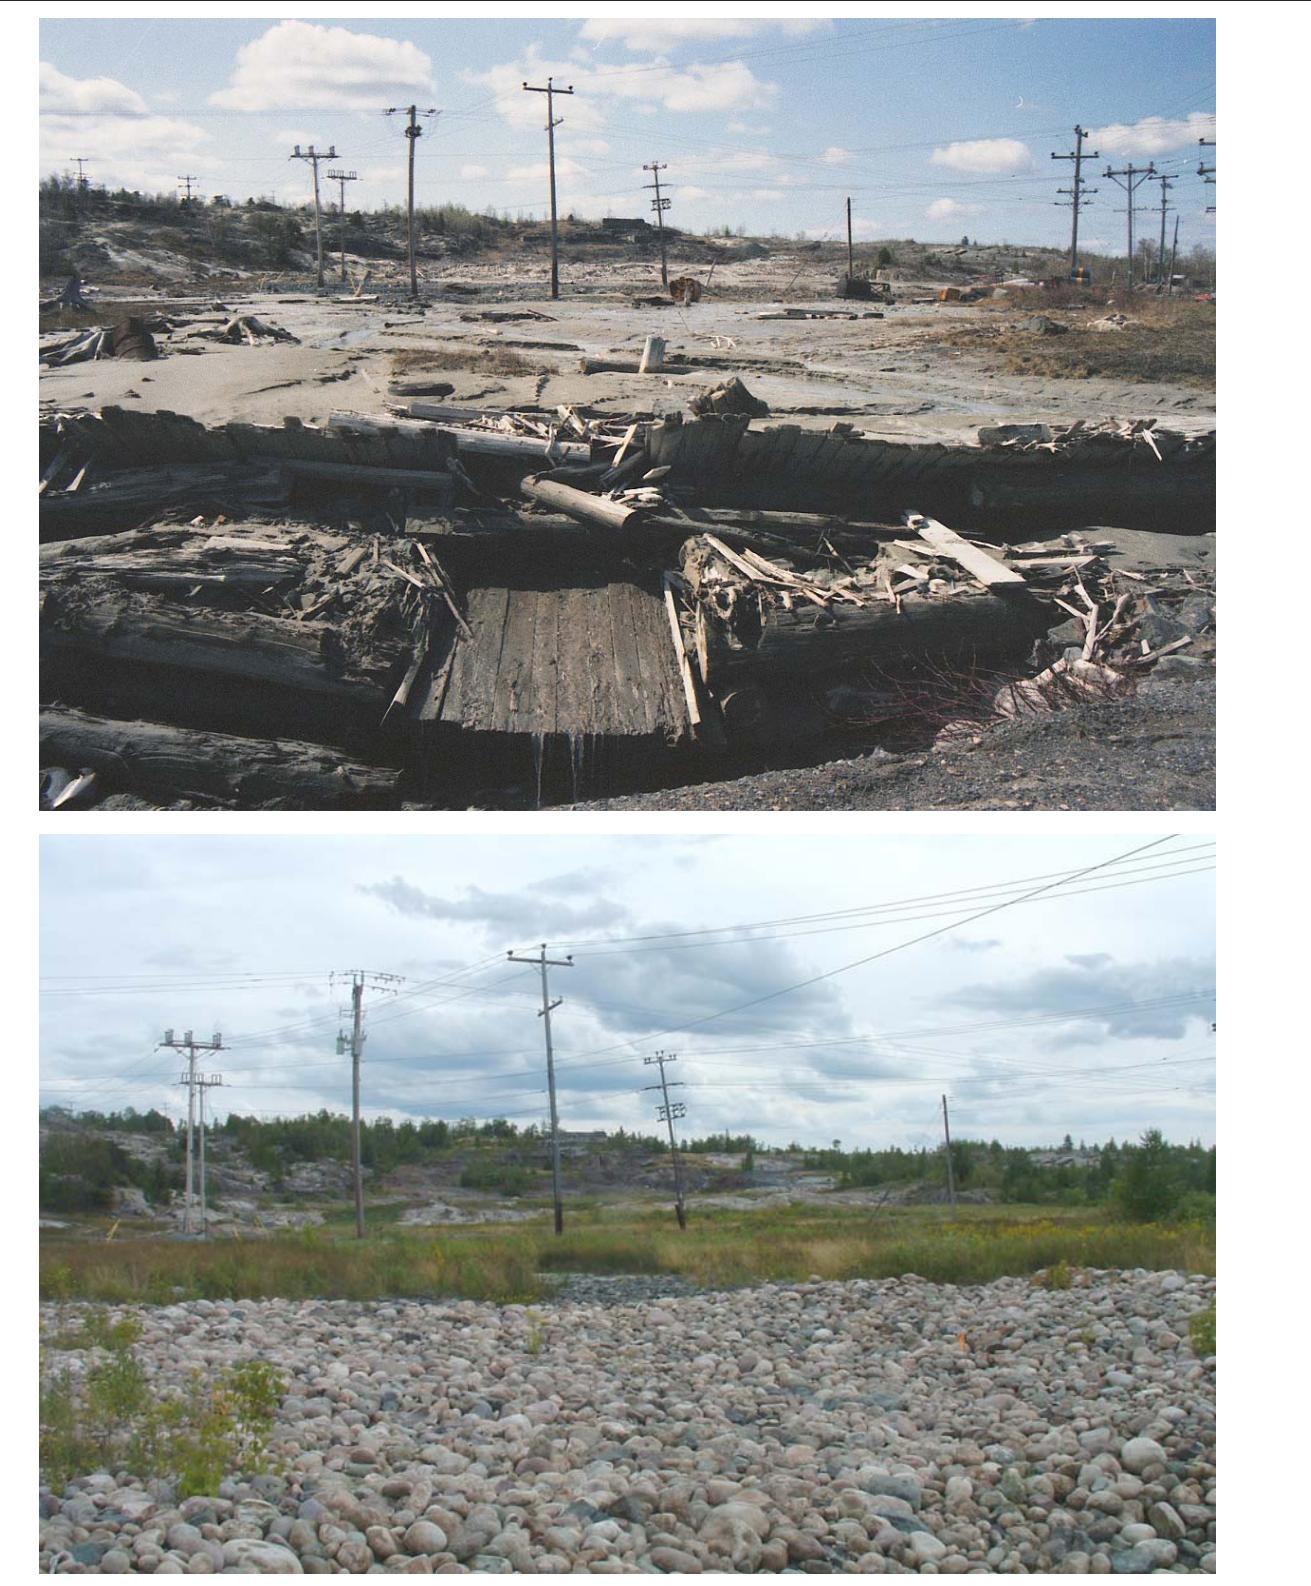
Outlet from the Nipissing low grade mill tailings, looking south. This is the location of surface water sampling station #1. The top photo was taken in 1992, the bottom photo in 2005. As part of reclamation work on the tailings, the dam in the top photo (Dam #3, see Figure 2.4) has been removed. Riprap has been added. Culverts under the road carry runoff water down to Mill Creek.

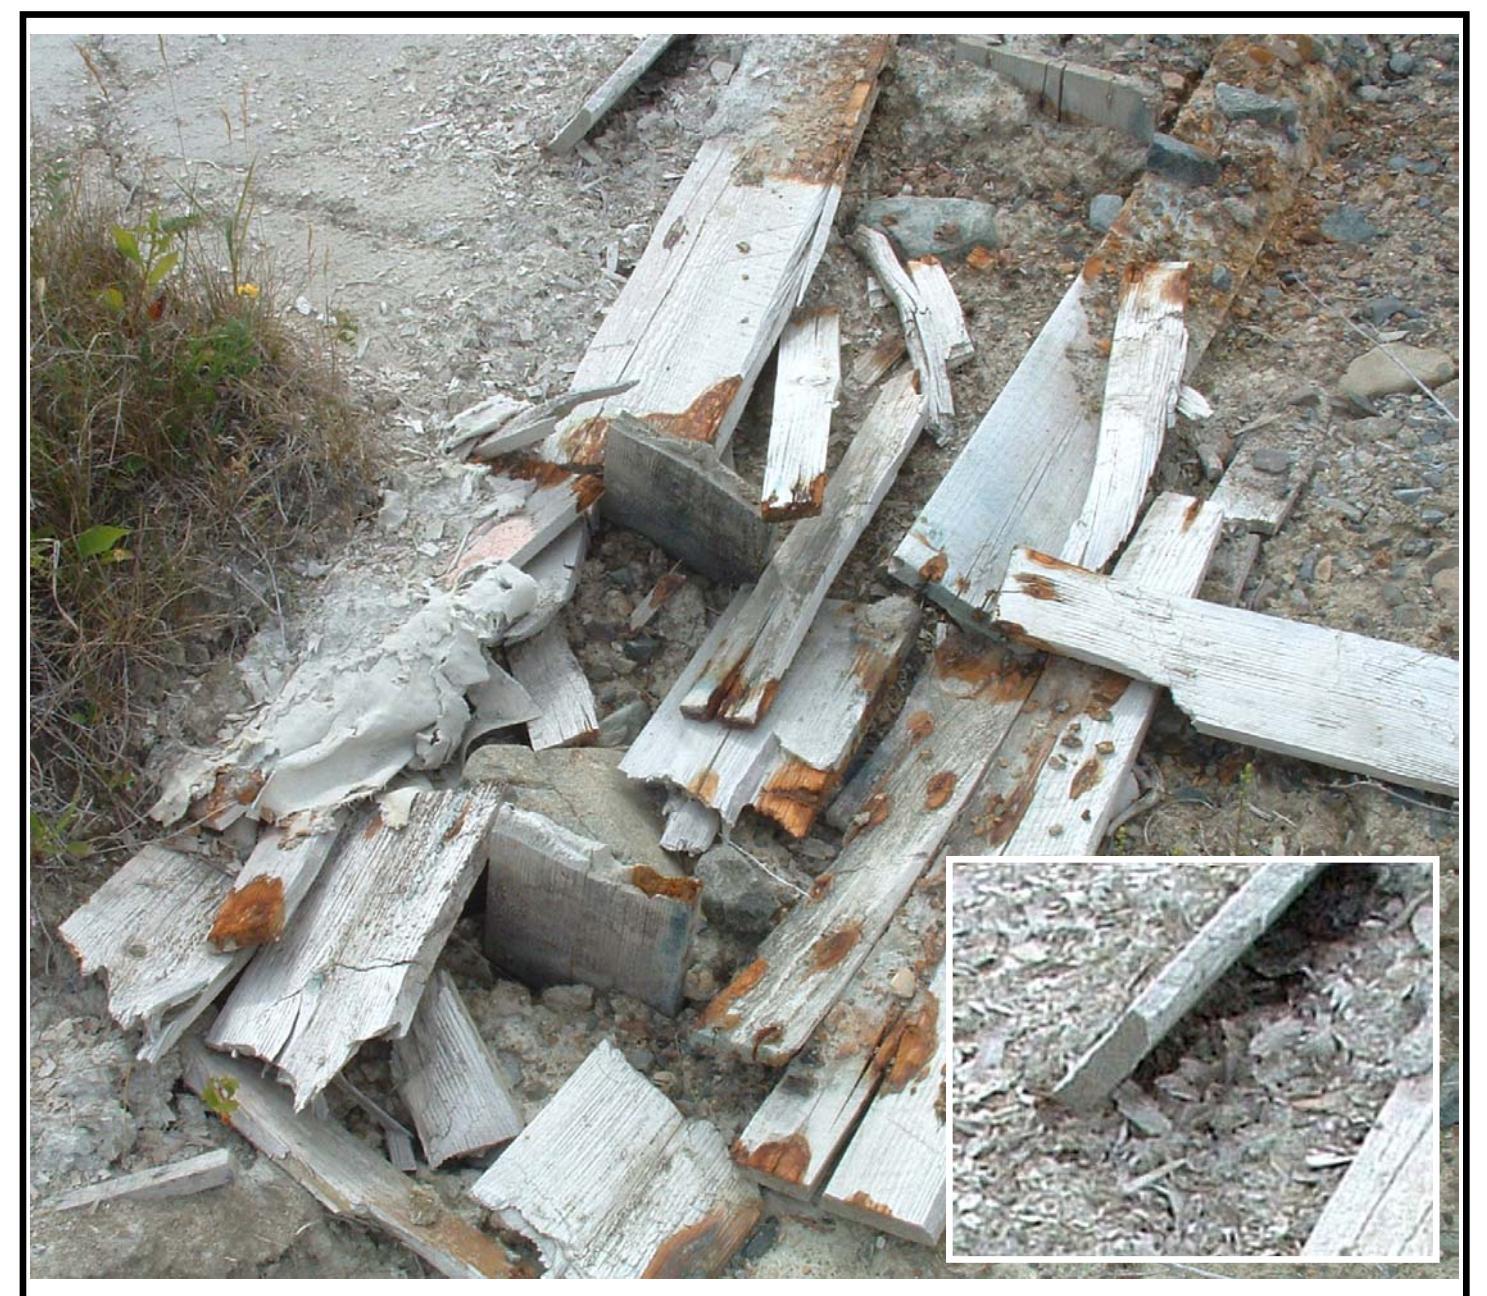
This photo illustrates the condition of wood used in the construction of Dam #1 on the NLGM tailings. At the top of the photo, sawdust and wood shavings are visible. This area is enlarged in the inset photo, bottom right. Observations of the dam during this study suggested that it was constructed at least in part of wooden boxes, and that sawdust and wood shavings were used as fill material. At the time this study was conducted, in some places along the dam, it was possible to pick of handfuls of sawdust that looked freshly cut. Note also the condition of the fabric.

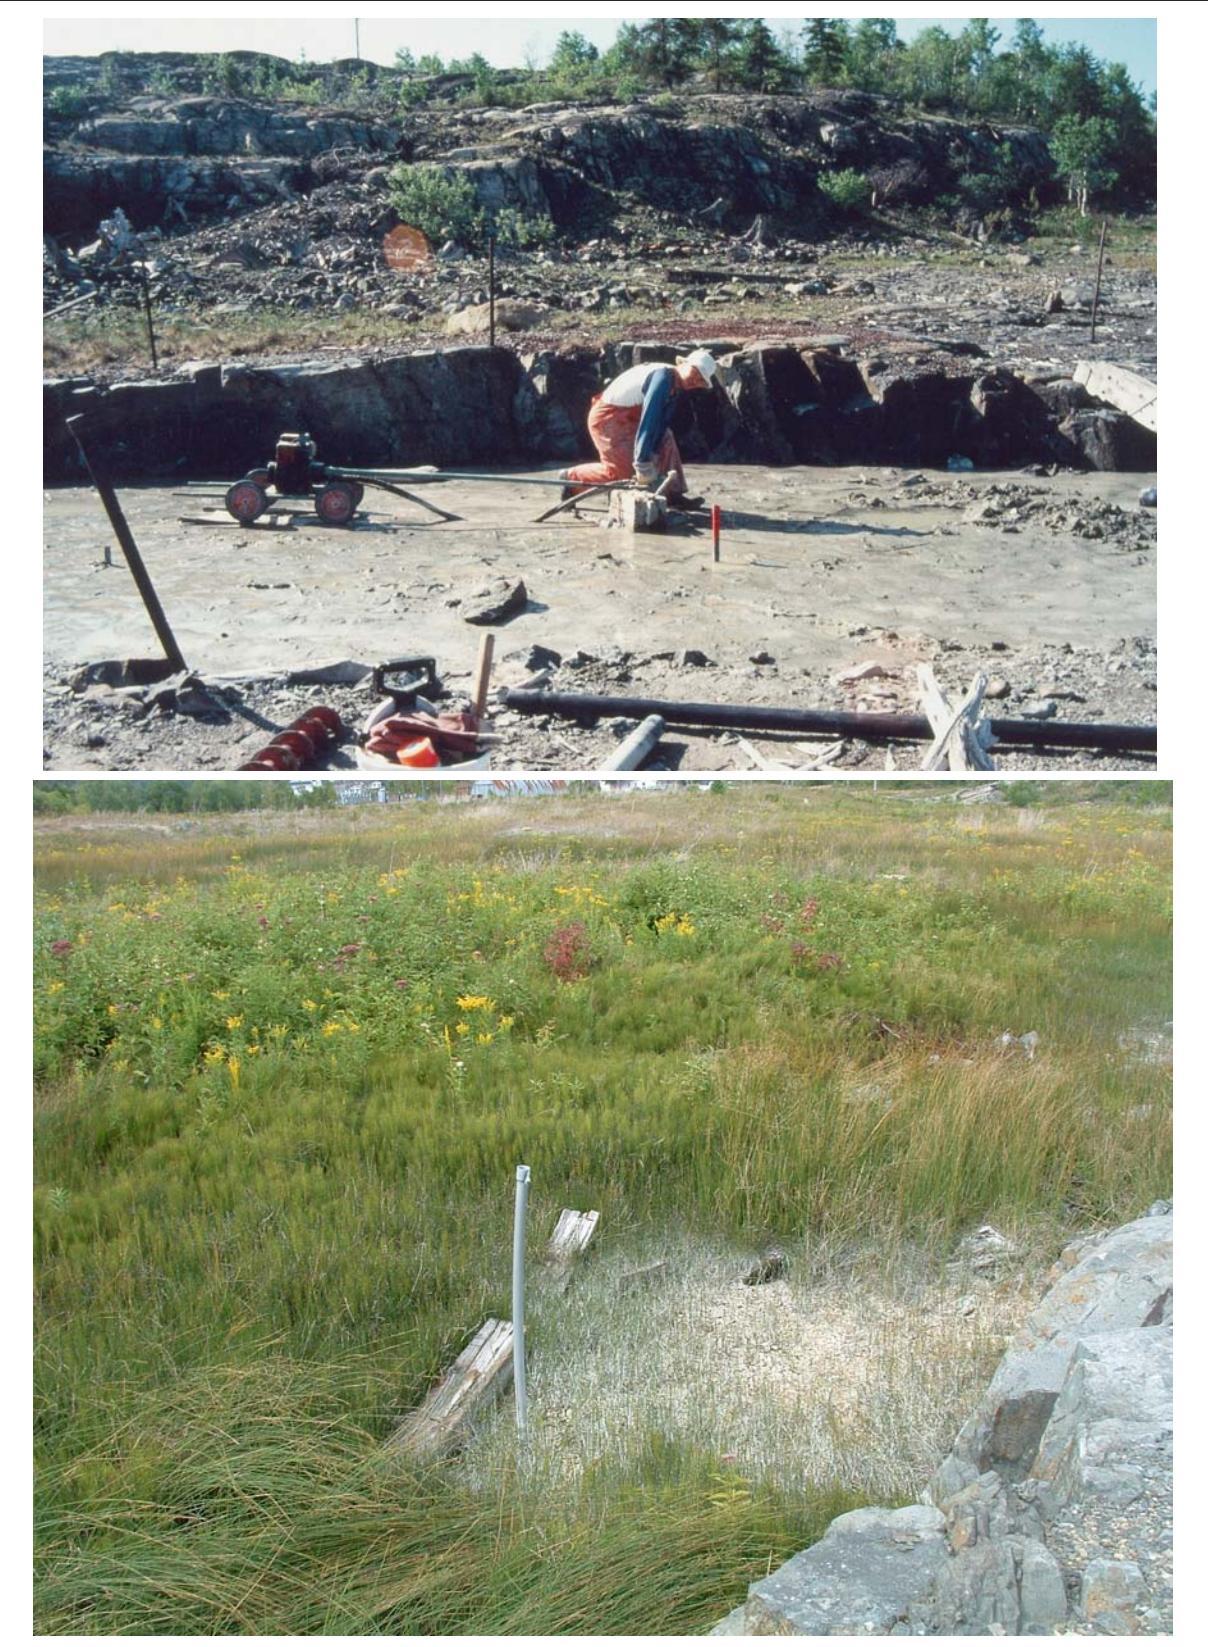
Top photo shows the author drilling a hole to install a piezometer in the Nipissing low grade mill tailings, in the summer of 1991. This is either piezometer #6 or #7 (see Figure 4.2). Bottom photo shows the same location in the summer of 2005, taken from the rock cut in the background of the top photo. At this location, tailings fill an old mine shaft of unknown depth.

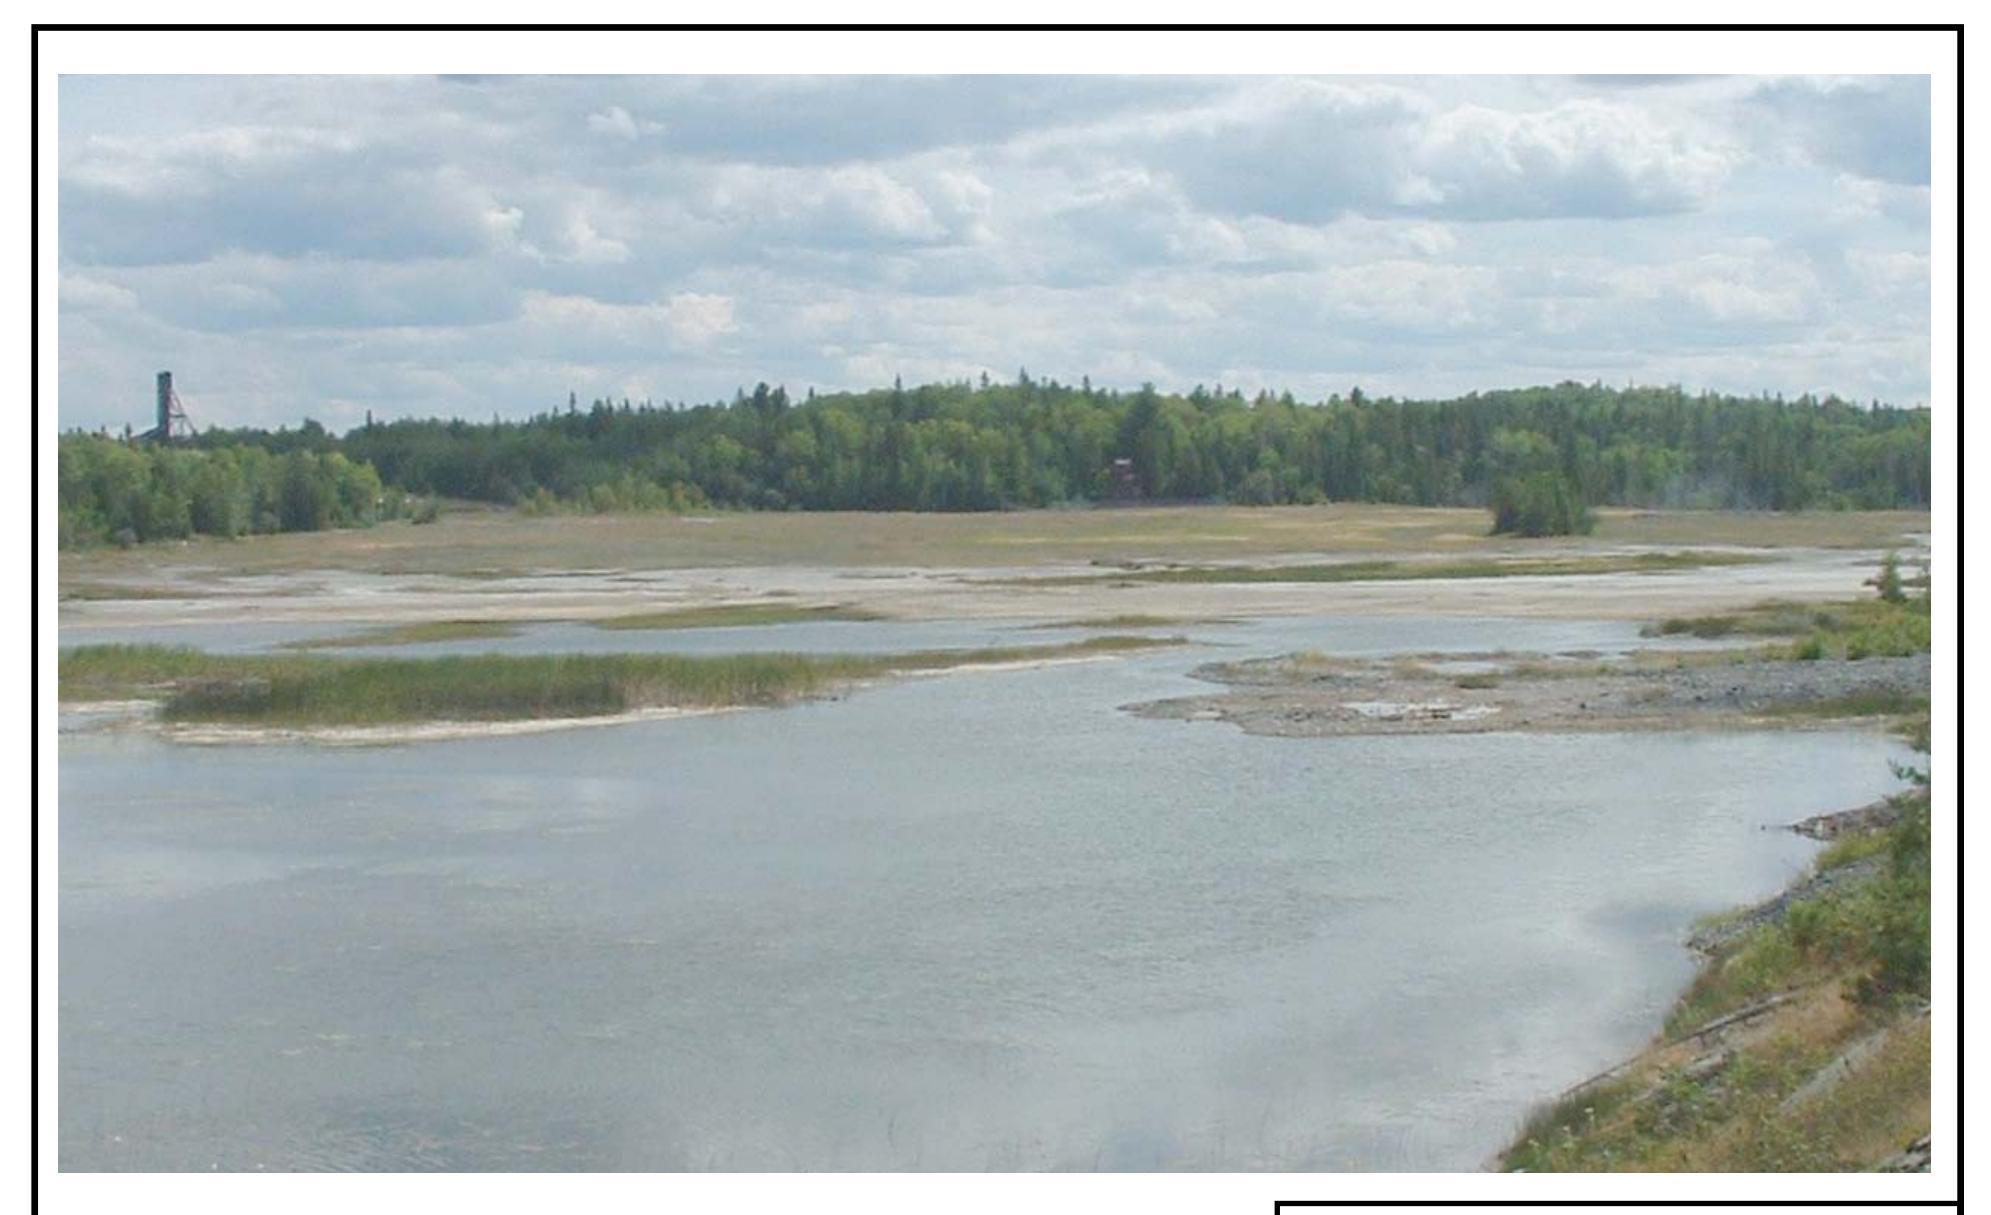
View of the Cart Lake tailings, taken from a lookout on the Silver Heritage Trail on the west side of the lake. Compare this with plate 2.4a, which was taken from the road at the north end of the lake and at a lower elevation. Like the NLGM tailings, efforts have been made to revegetate the Cart Lake tailings. As at the NLGM tailings, this has helped to reduce dust from the tailings, but effects on water quality are not known.

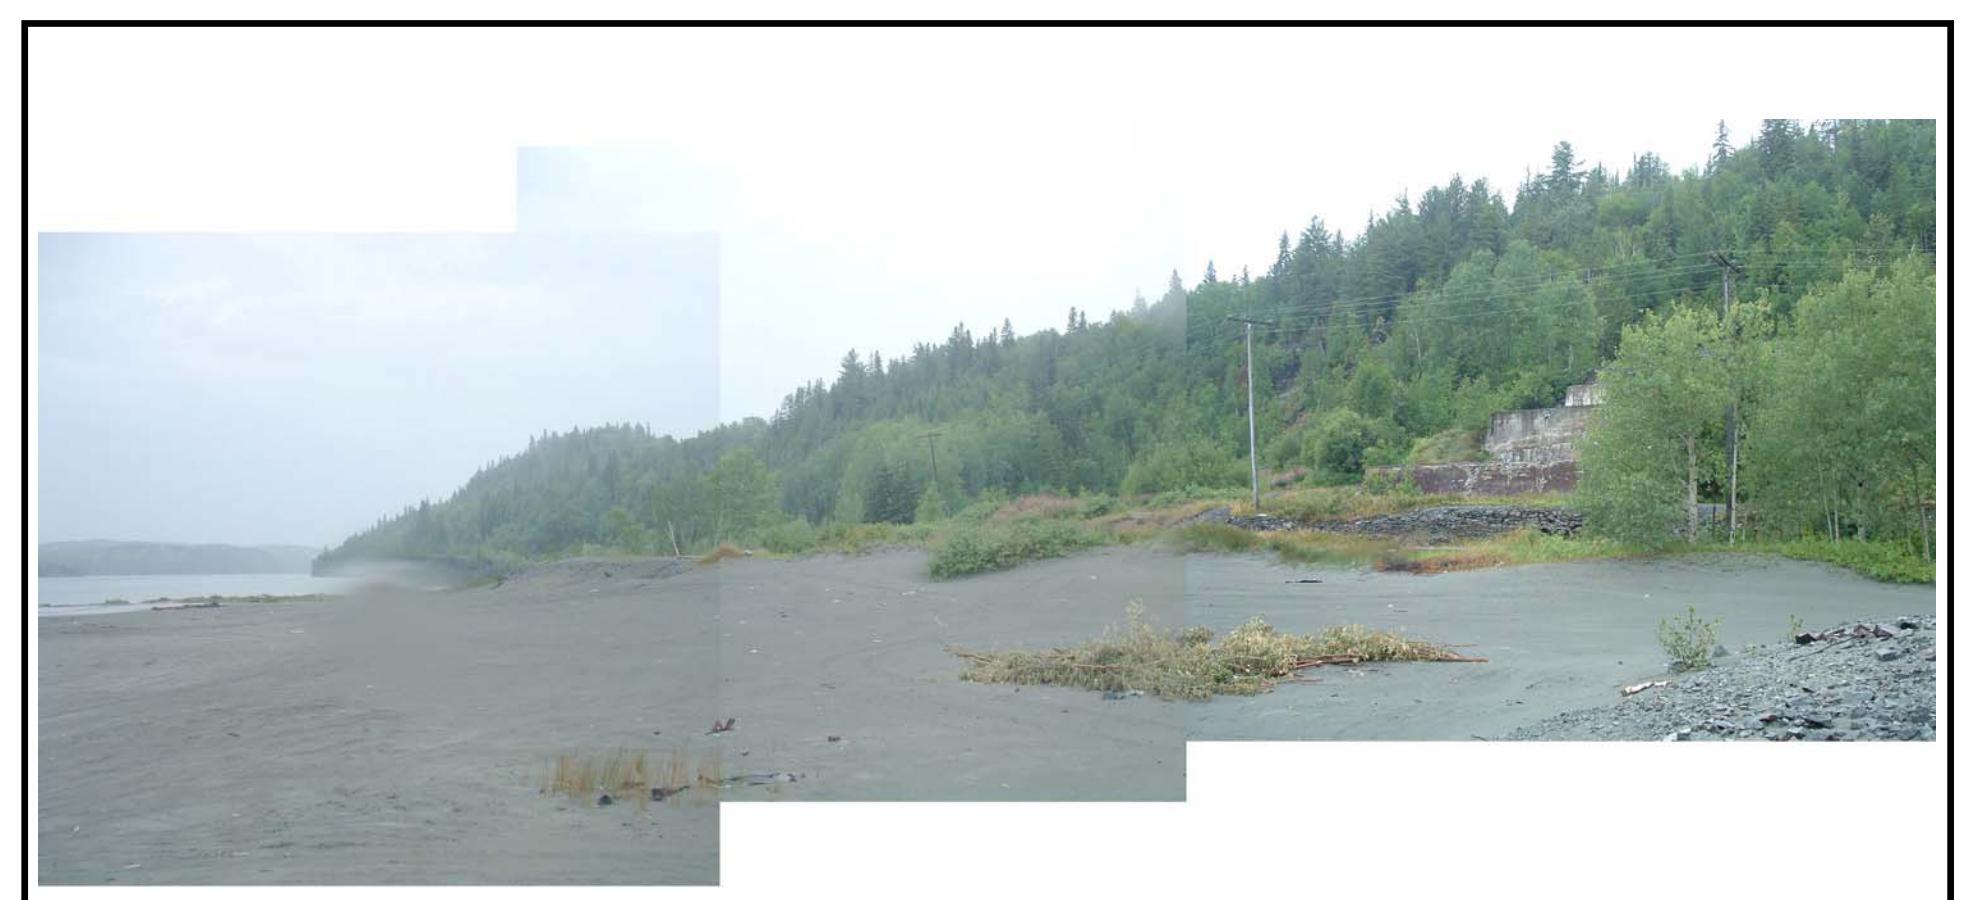
Composite image of the Crosswise Lake tailings, looking southwest. These tailings are located adjacent to the foundation of the King Edward Mill, on the west side of the lake (see Figure 1.3). The main body of tailings in Crosswise Lake extends north from this point (see Figure 2.3).
