Public Works and Government Services Canada

# **Giant Mine Roaster Complex Deconstruction Waste Audit Report-FINAL**

003-DISO Roaster Demo-DISO-RPT-0004-Rev1\_20121128-FINAL

November 28, 2012

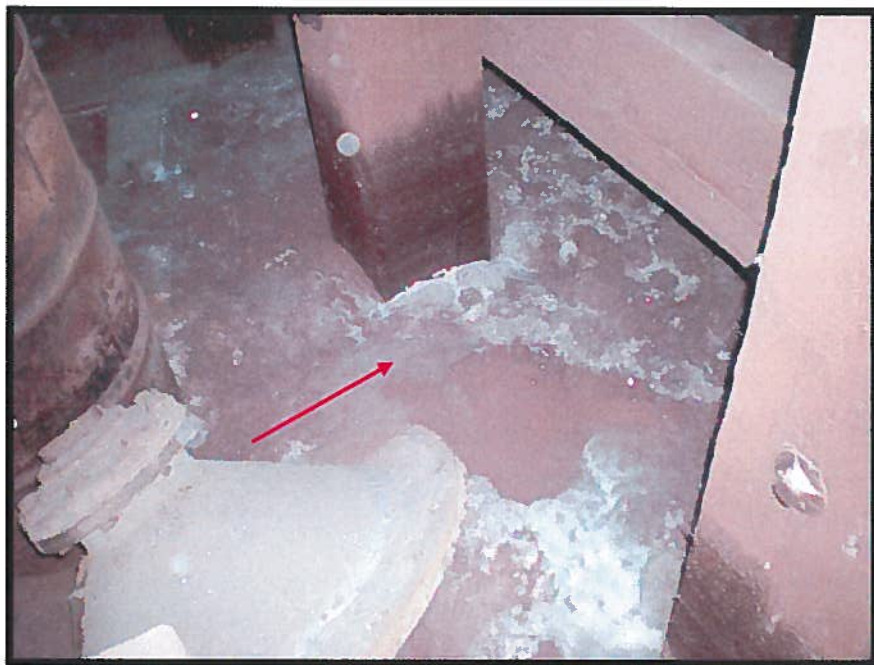
*Photograph 3: Dust Sample Location – Dirt below the Thickener (Sample 07-D).*

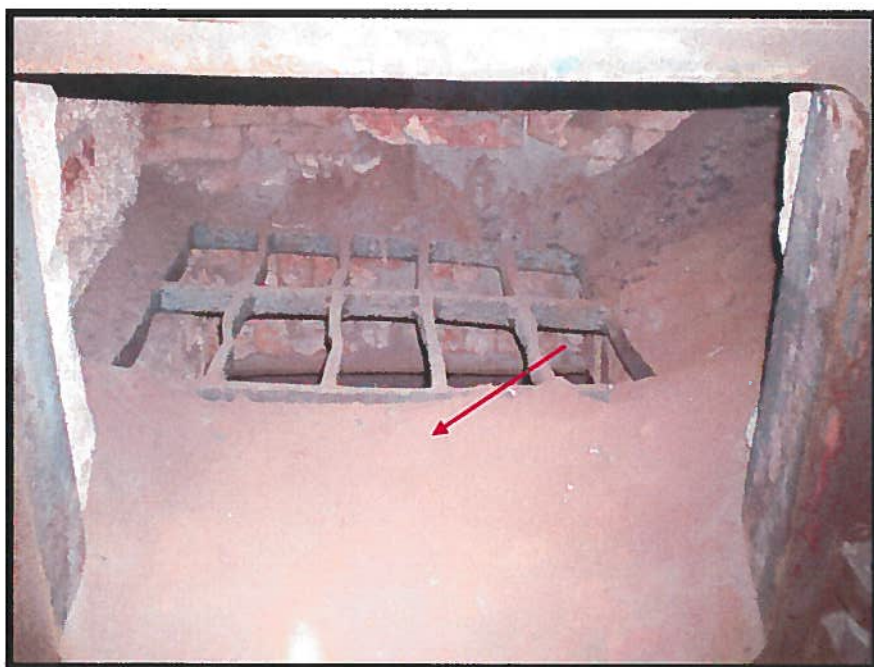
*Photograph 4: Dust Sample Location – Dust from Kiln Furnace (Sample 08-D).*

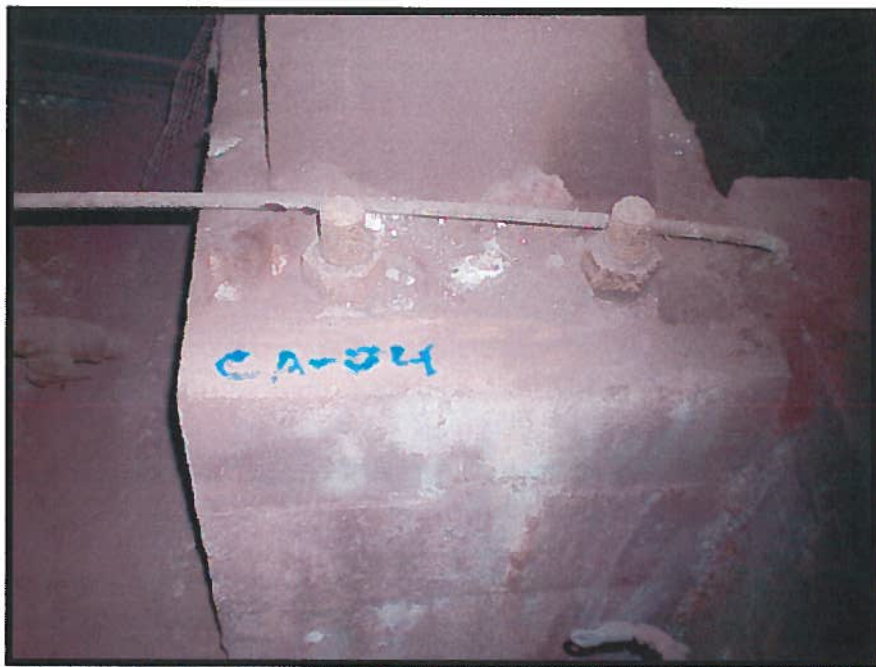
*Photograph 5: Dust Sample Location – North End of Building on Old Equipment Stand (Sample 09-D).*

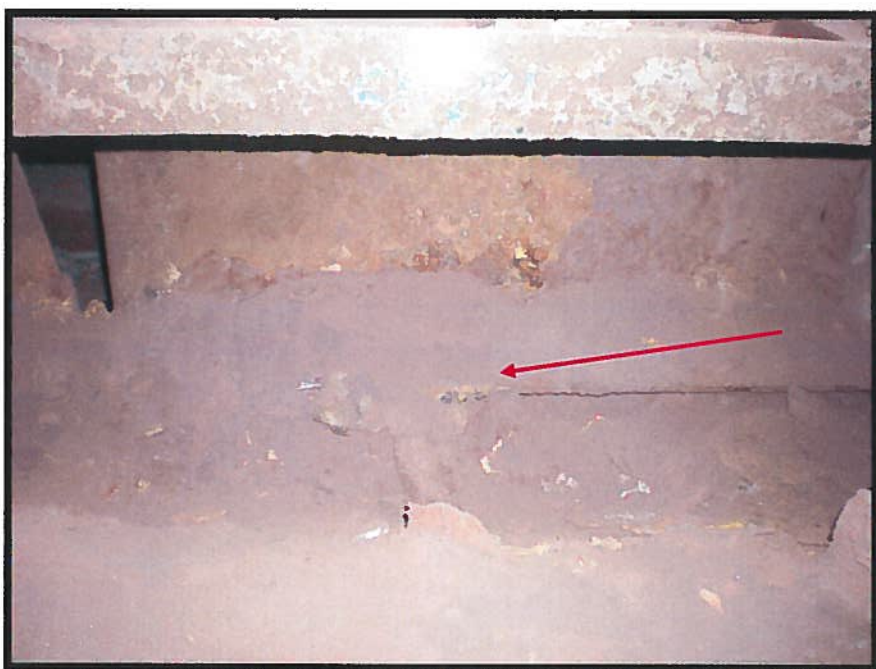
*Photograph 6: Dust Sample Location – Southeast Wing of Building at Beneath Equipment (Sample 10-D).*

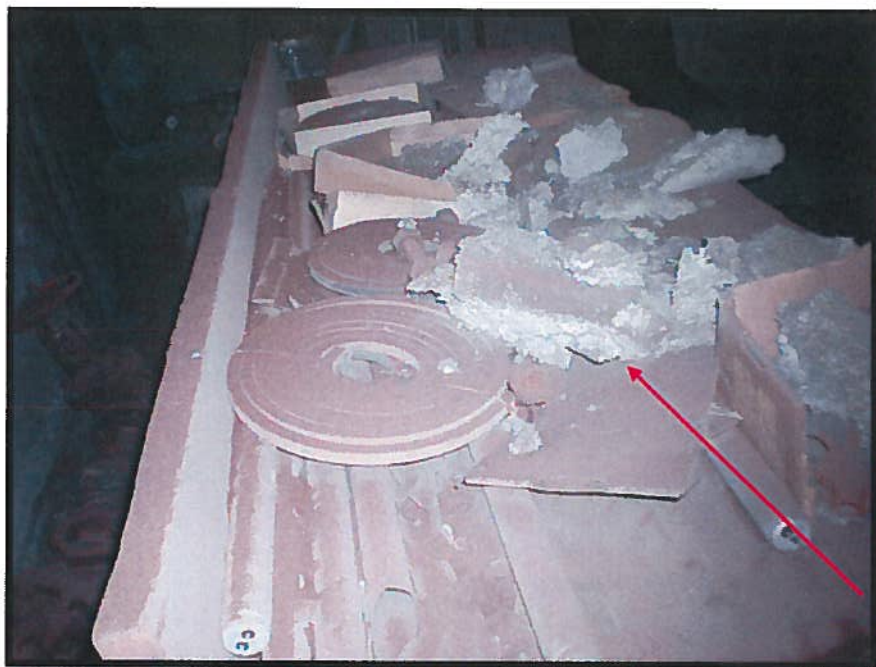
*Photograph 9: Spray Applied Ceiling Insulation Debris on Table (Sample 09).*

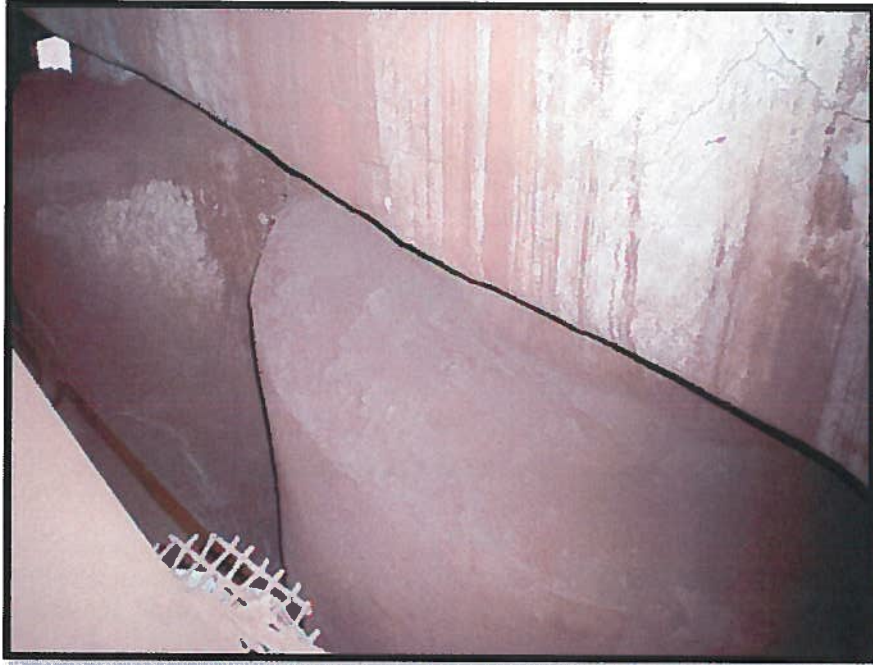
*Photograph 11: Asbestos-Containing Mechanical Insulation (Sample 24).*

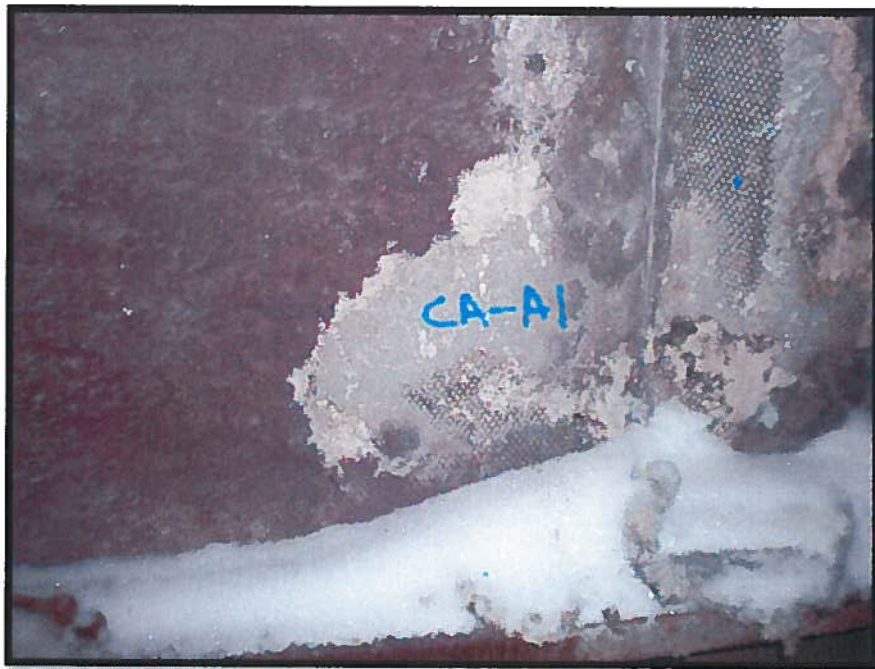
*Photograph 12: Spray Applied Asbestos-Containing Wall Insulation (Sample 25).*

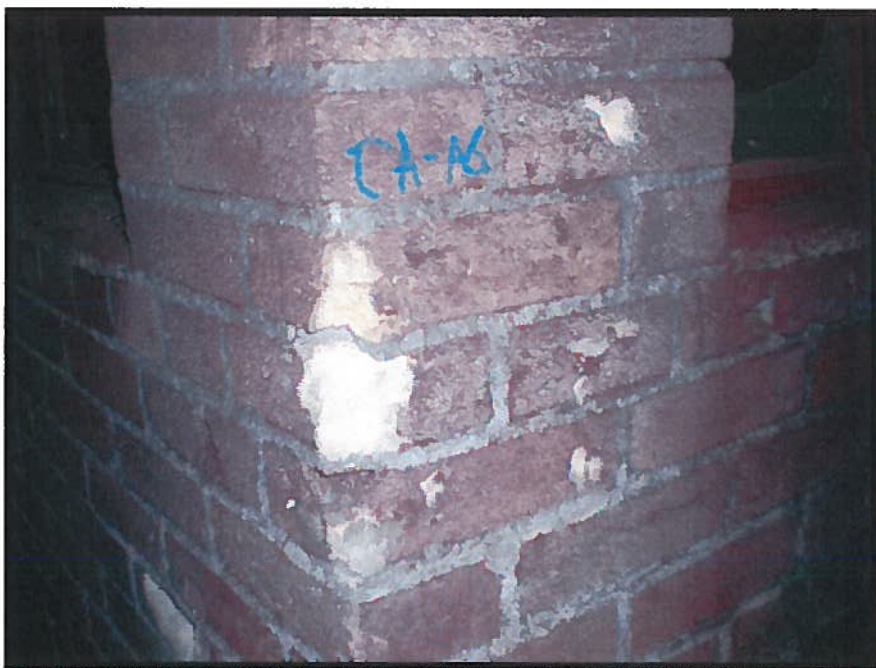
*Photograph 14: Block and Mortar on Control Room (Asbestos not Detected), (Sample 27).*

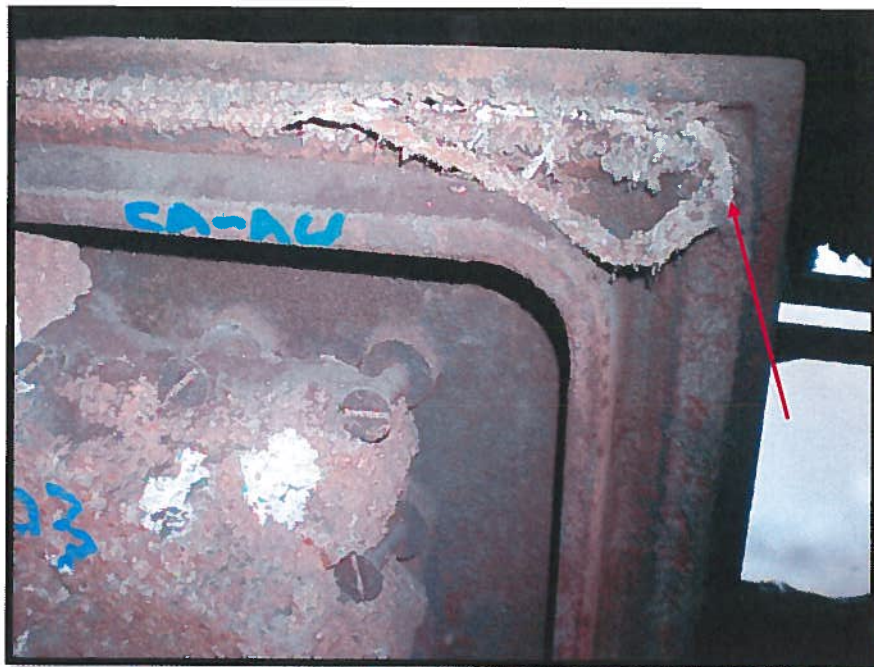
*Photograph 15: Asbestos-Containing Gasket on Furnace Door (Sample 28).*

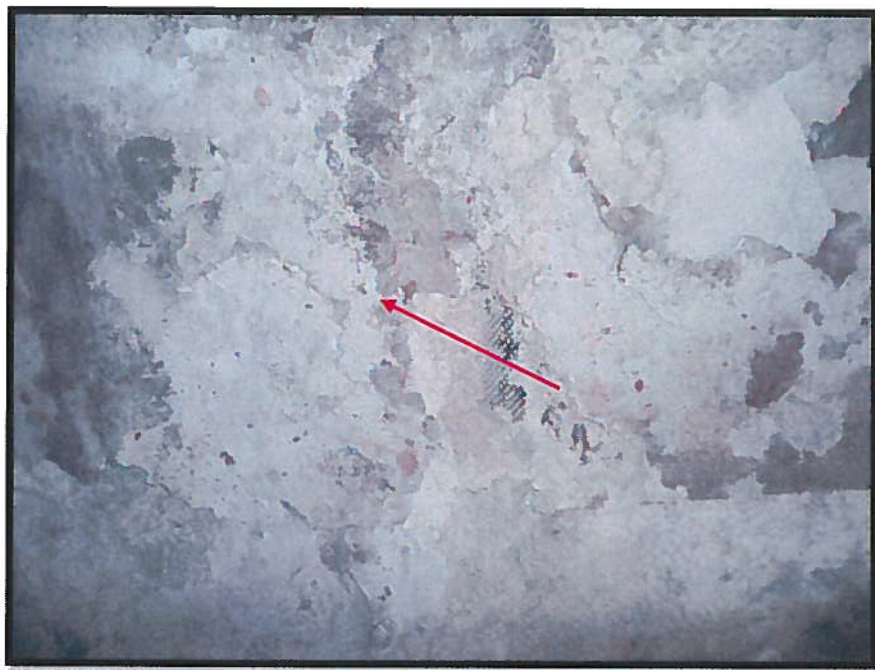
*Photograph 17: Spray Applied Wall Insulation (Sample 30).*

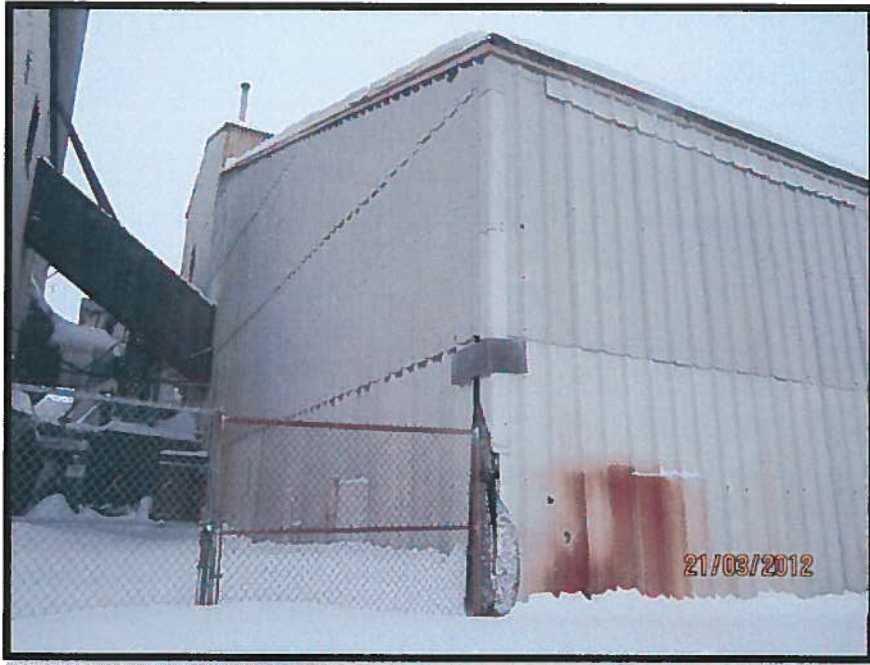
*Photograph 1: Exterior of Dorrcro Roaster (North and West Walls), with typical Asbestos-Containing Exterior Panels.*

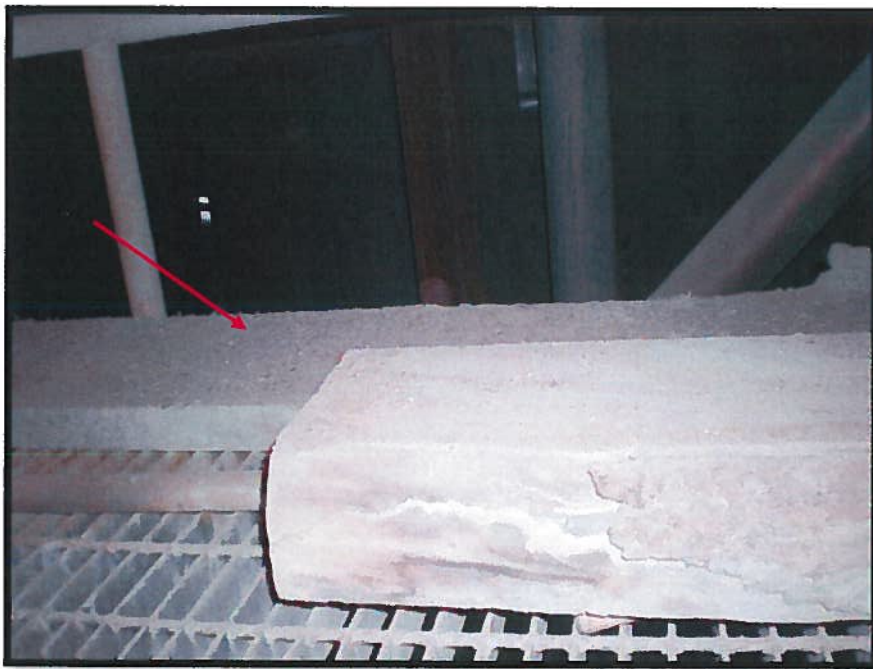
*Photograph 2: Dust Sample Location – Wood Plank on Decking, Main Level (Sample 19-D).*

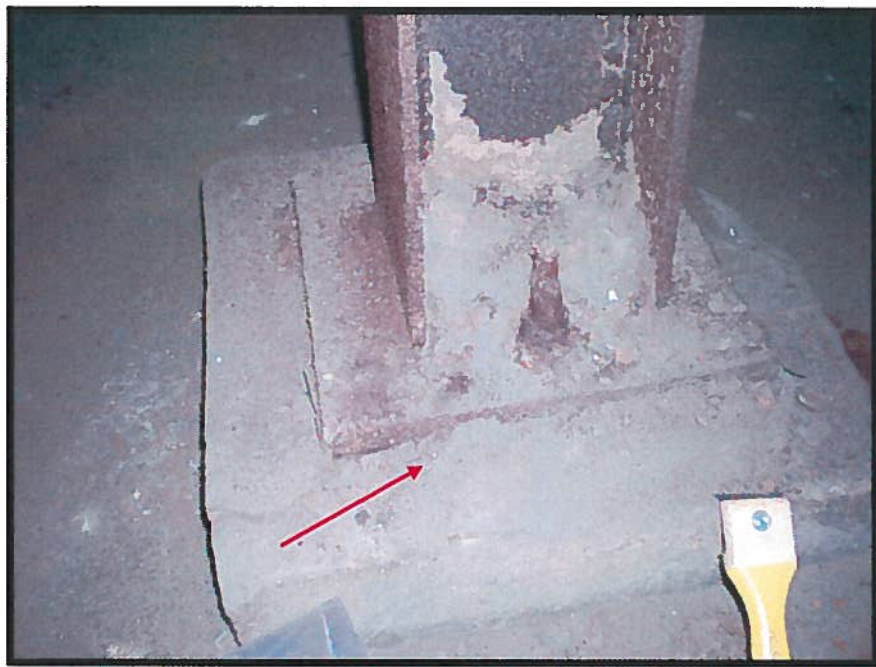
*Photograph 3: Dust Sample Location – Basement Level, Beneath Roaster #2 (Sample 20-D).*

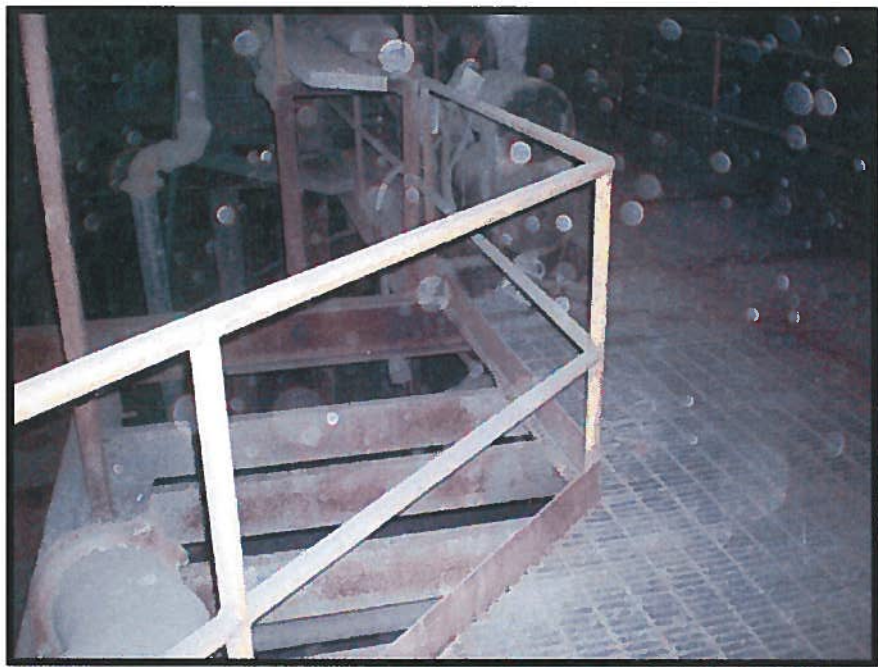
*Photograph 5: Dust Sample Location – Main Level, Handrails (Sample 22-D).*

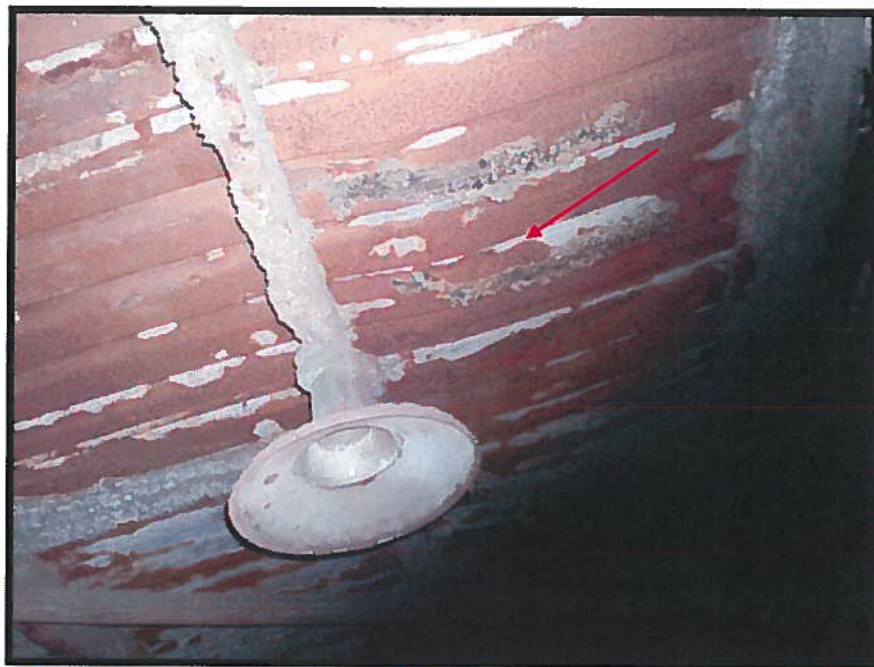
*Photograph 7: Delaminating Ceiling Insulation Materials, Non-Asbestos (Sample 31).*

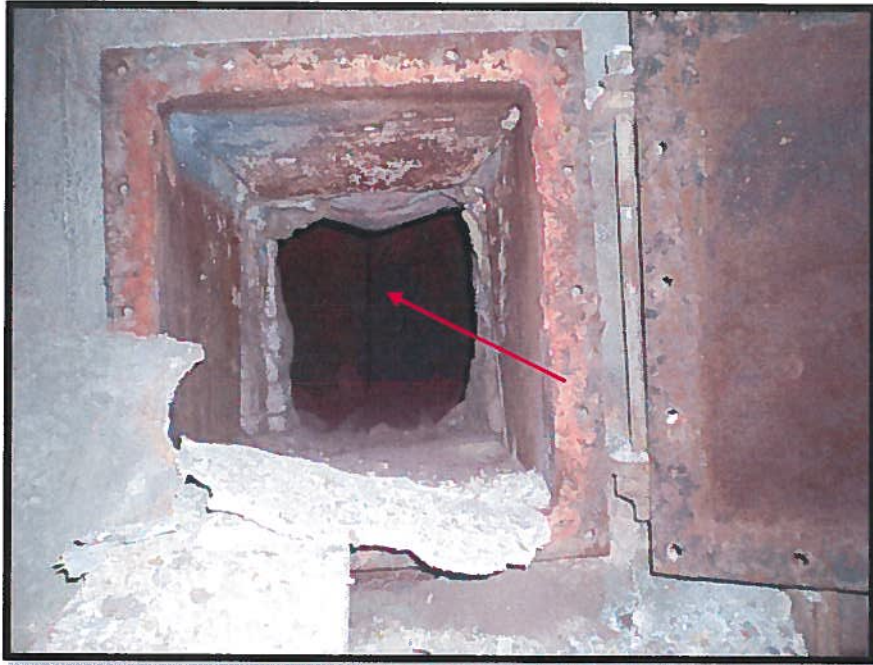
*Photograph 17: Suspect Asbestos-Containing Refractory Bricks and Linings (not accessible).*

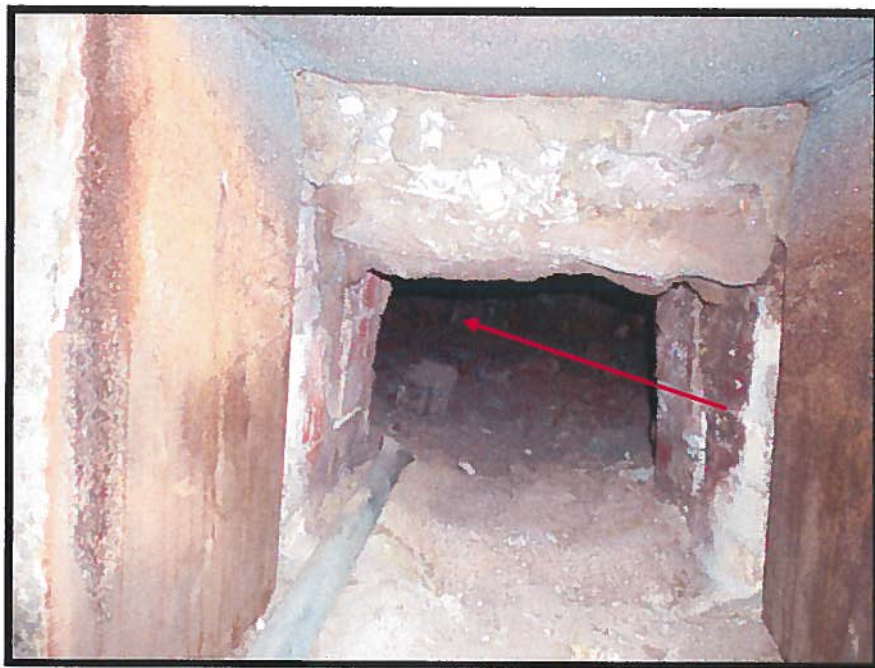
*Photograph 18: Suspect Asbestos-Containing Refractory Bricks and Linings (not accessible).*

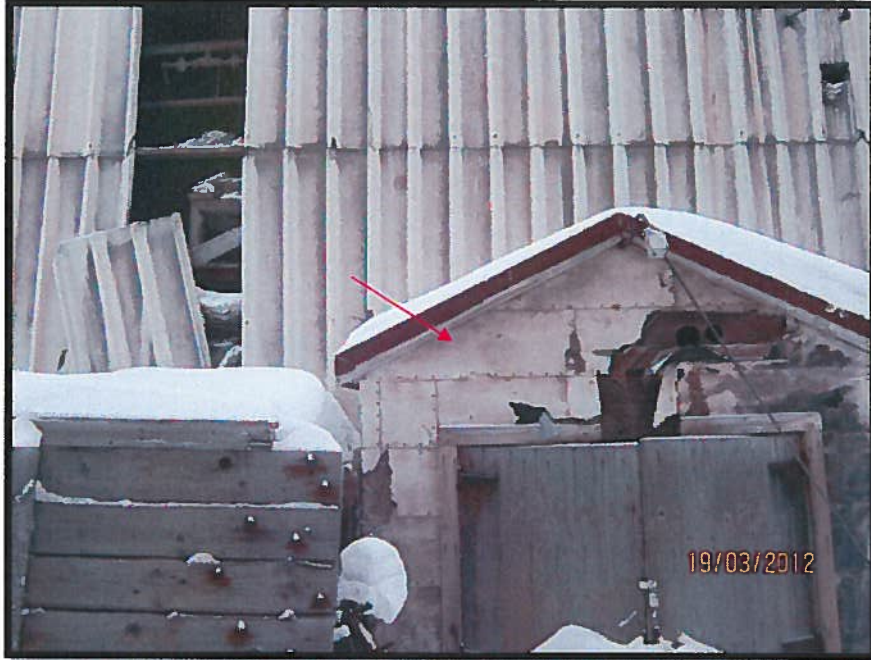
*Photograph 21: Asbestos-Containing Paper Siding and Cement Panels Located on the South Wall of the Building (Visually Referenced).*

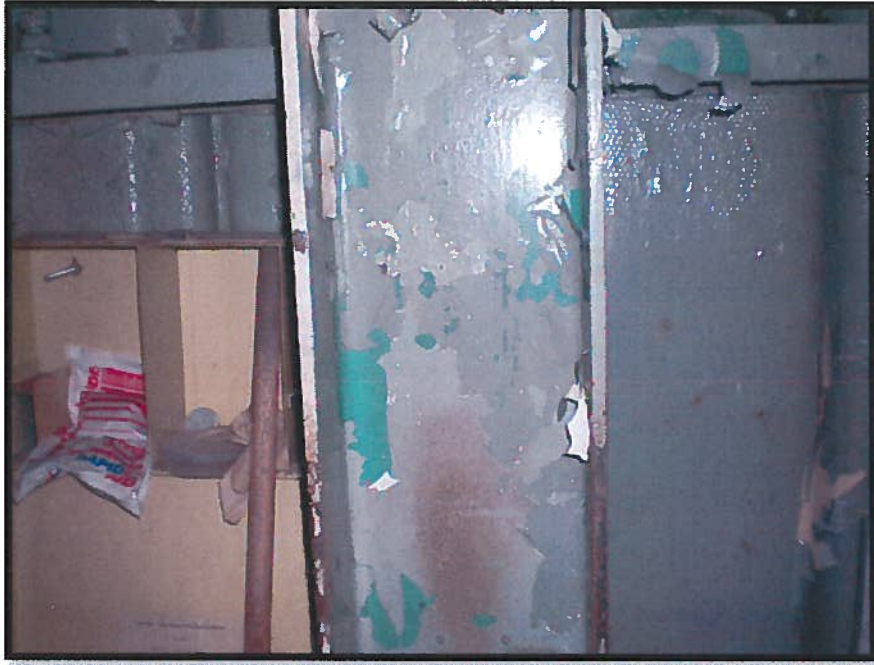
*Photograph 23: Grey Paint in Control Room (Sample 17-Pb).*

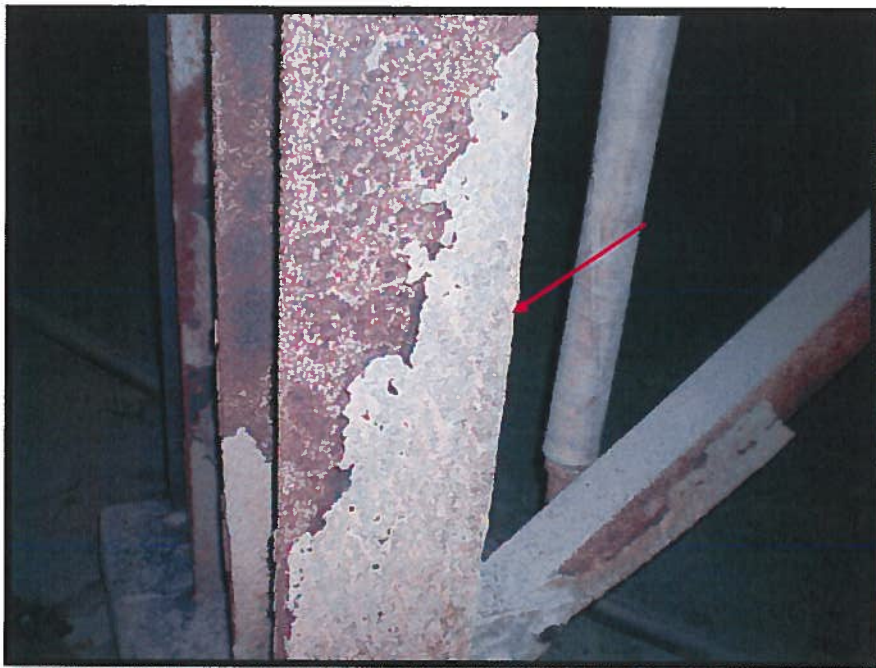
*Photograph 28: Grey Paint on Structural Steel (Sample 22-Pb).*

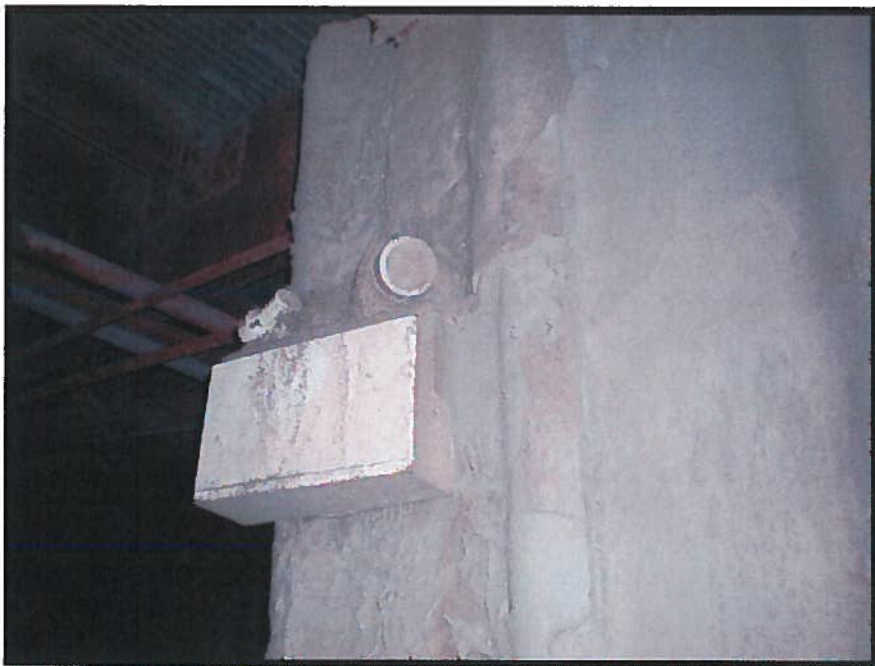
*Photograph 30: Emergency Light Fixture with Lead-Acid Batteries.*

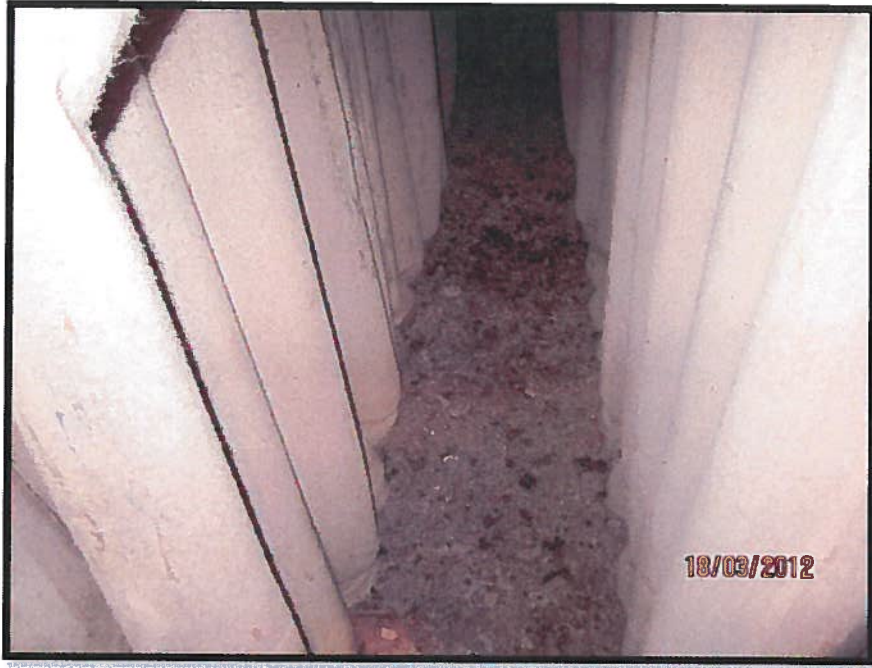
*Photograph 5: Inside Baghouse Compartments (Suspect Arsenic Contaminated Debris and Filter Bags).*

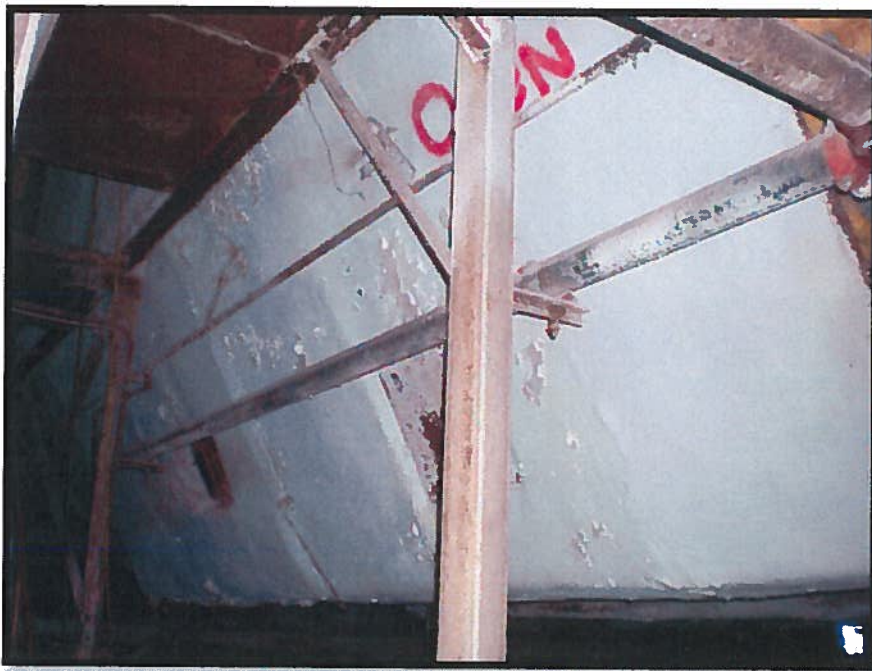
*Photograph 6: Asbestos-Containing Insulation on Hoppers (Sample 1 and 2).*

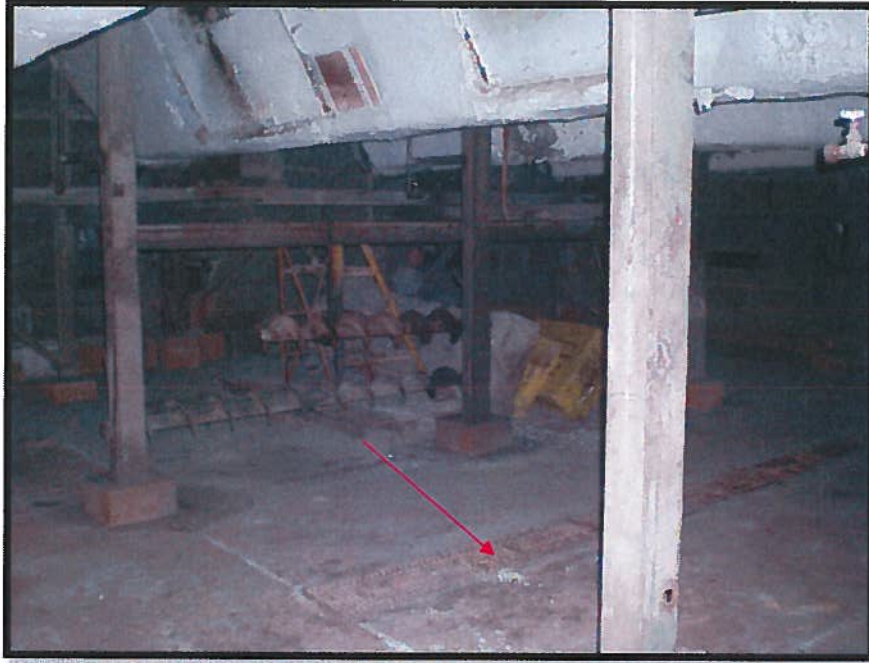
*Photograph 7: Asbestos-Containing Insulation on Hoppers (Samples 1 and 2) with Minor Amounts of Insulation Debris on the Ground.*

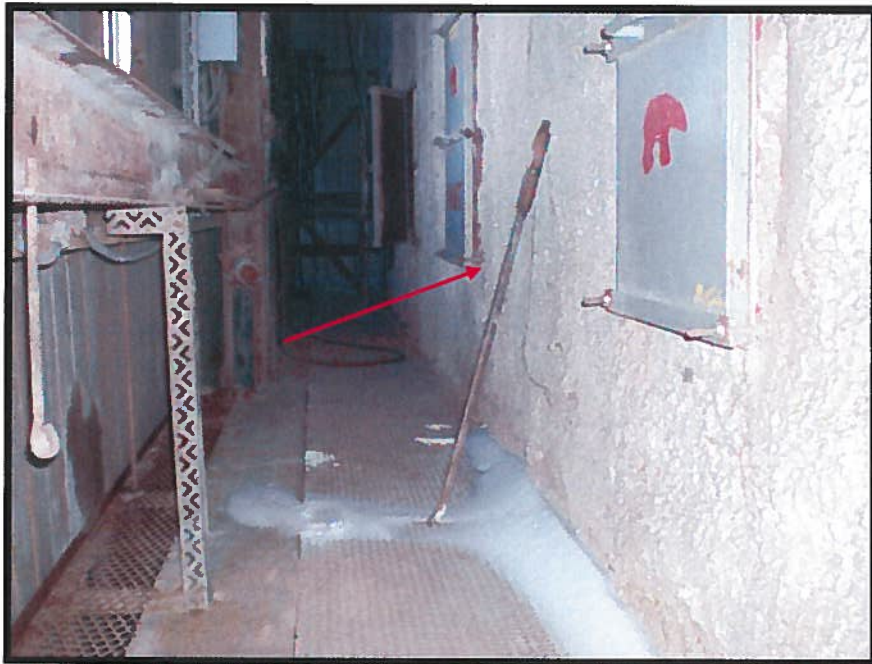
*Photograph 8: Asbestos-Containing Insulation on Bag Compartment Walls (Samples 3 and 4).*

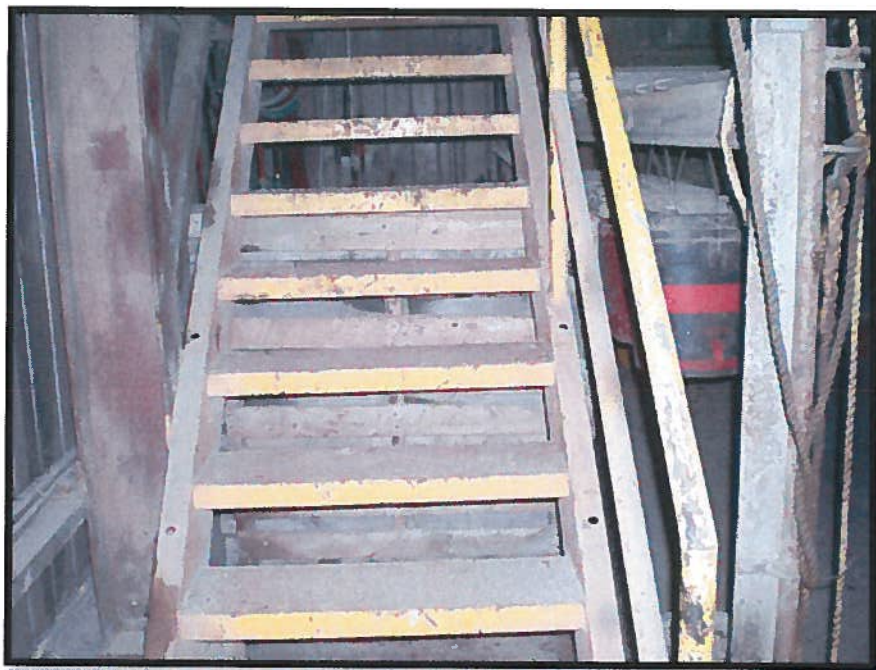
*Photograph 9: Yellow over Green Paint on Stairway (Sample 01-Pb).*

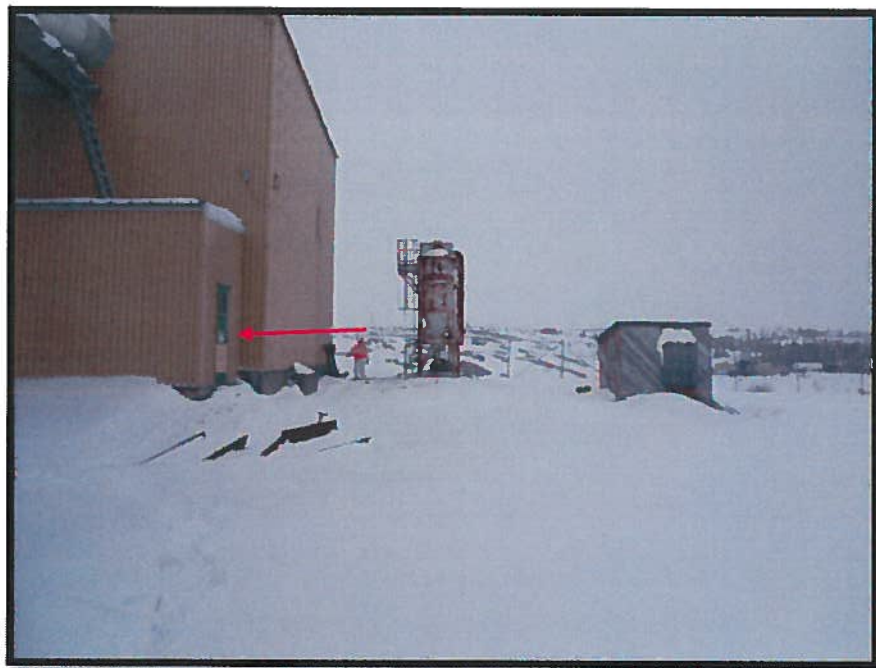
*Photograph 13: Green Paint on Door (Sample 06-Pb).*

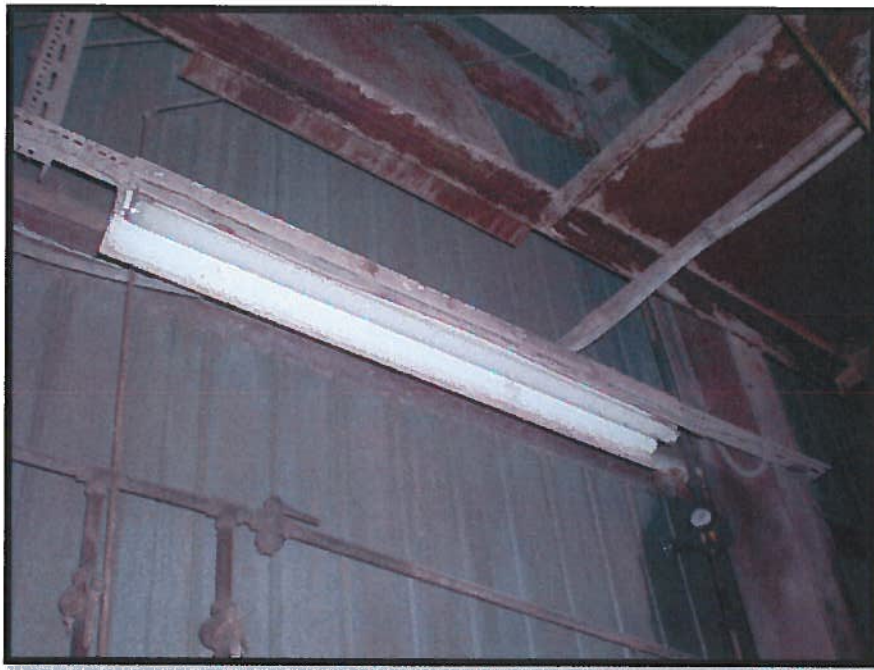
*Photograph 15: Typical Fluorescent Light Fixture with Mercury-Vapour Tubes and Suspect PCB-Containing Ballasts.*

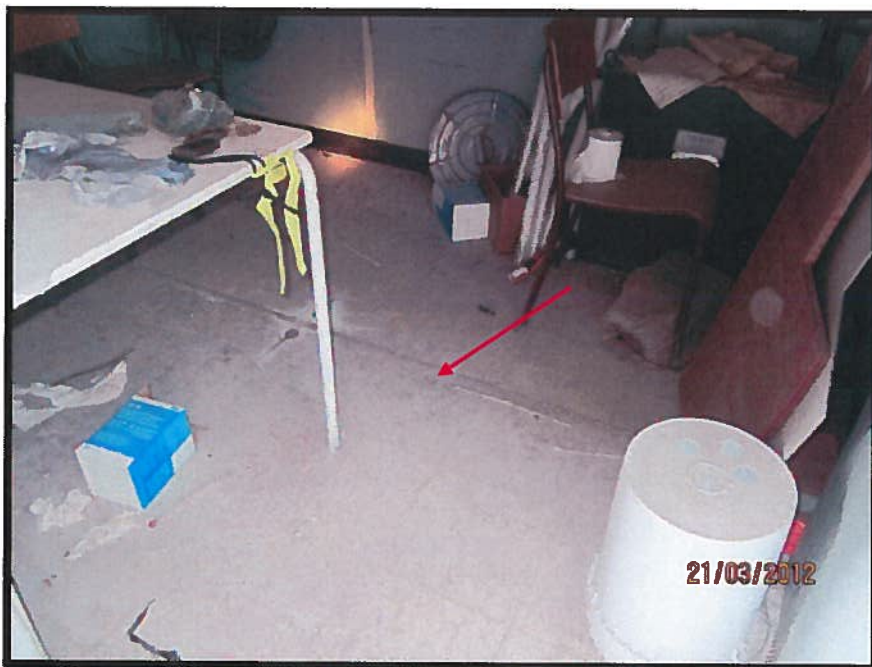
*Photograph 4: Asbestos-Containing Floor Tiles in Office (Sample 54).*

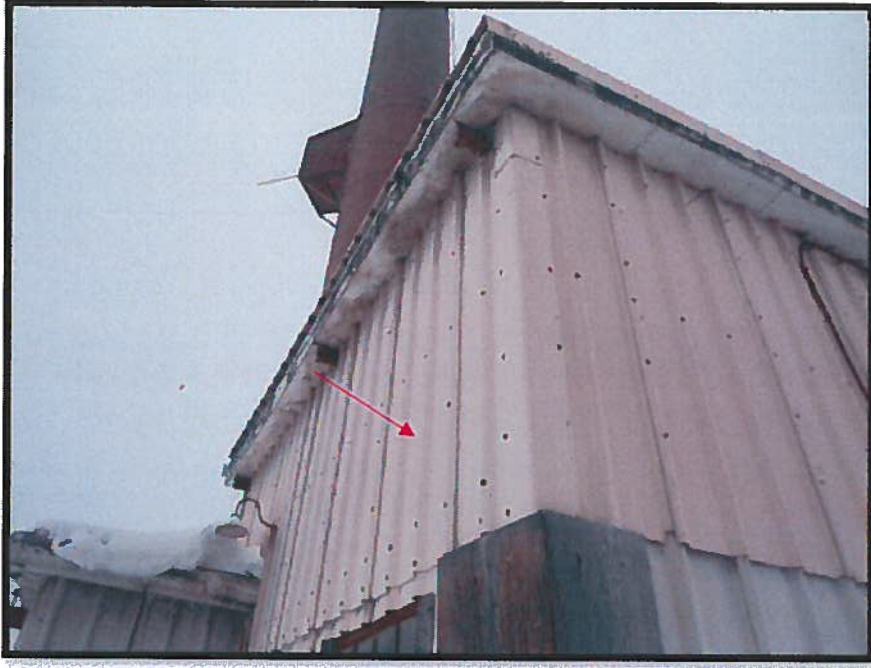
*Photograph 1: Asbestos-Containing Cement Board Panels On Building Exterior (Visually Referenced).*

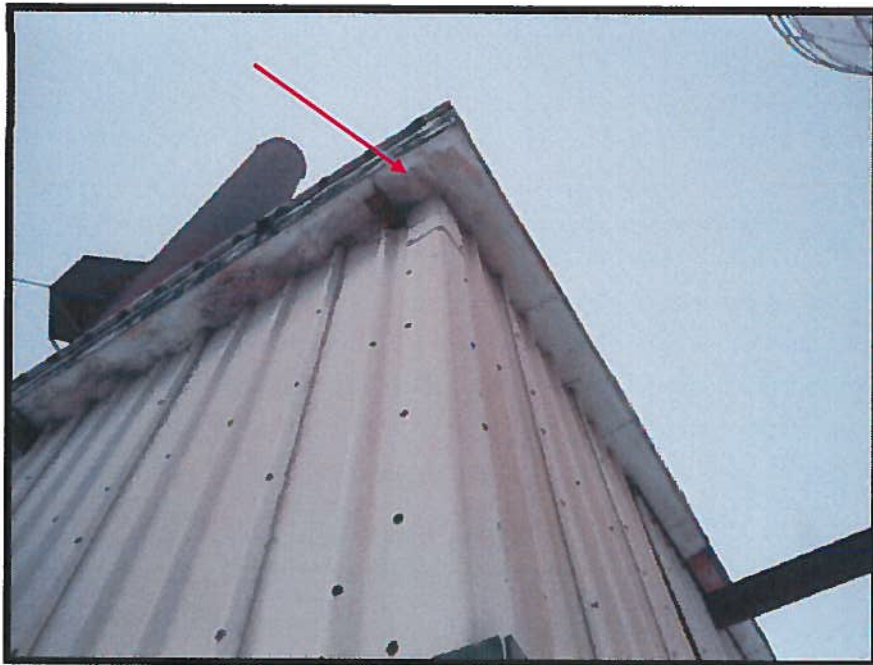
*Photograph 2: Asbestos-Containing Exterior Siding Paper (Visually Referenced).*

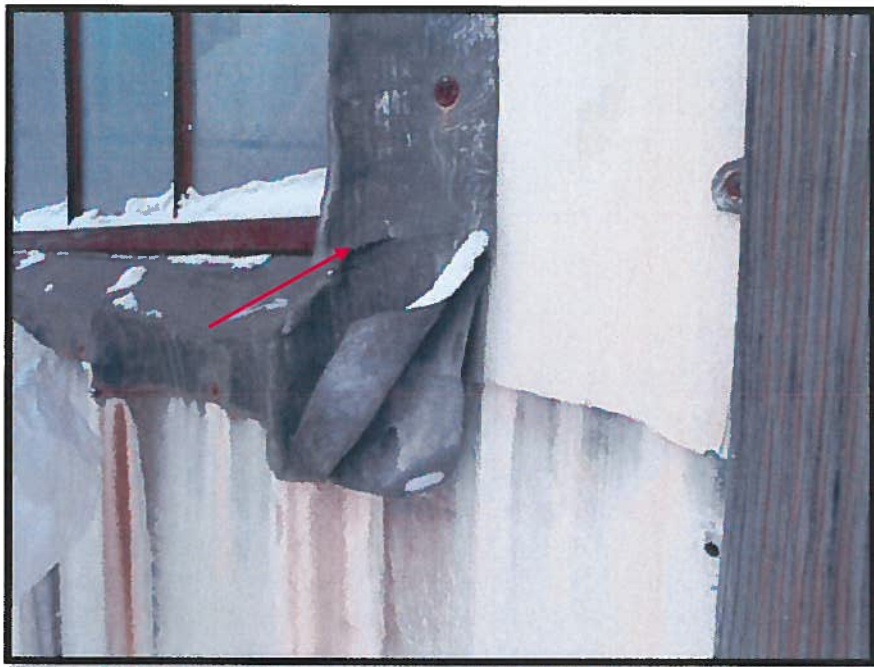
*Photograph 3: Lead Sheeting around Exterior Window Frames.*

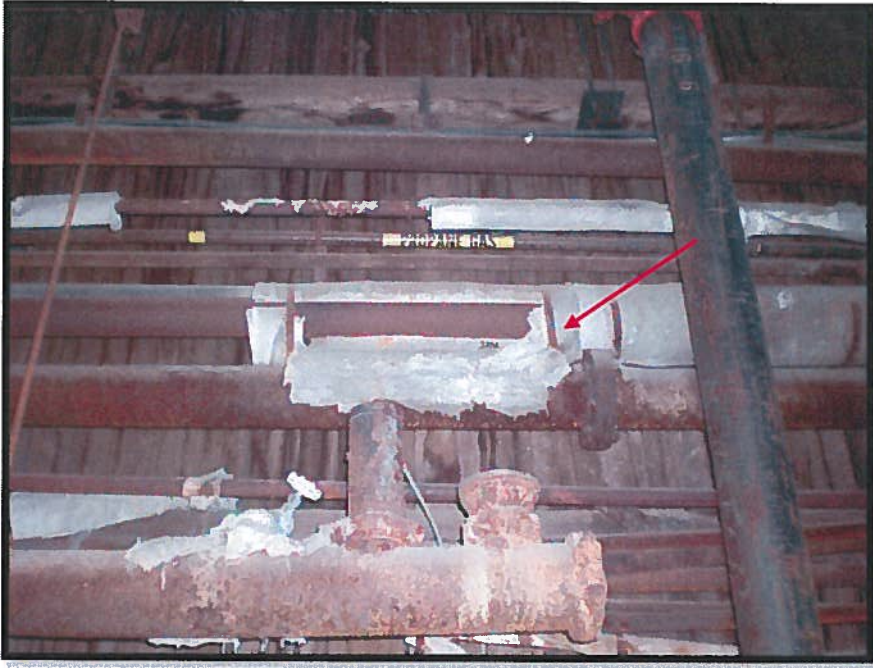
*Photograph 9: Asbestos-Containing Pipe-Run Insulation along Perimeter Walls (Sample 31).*

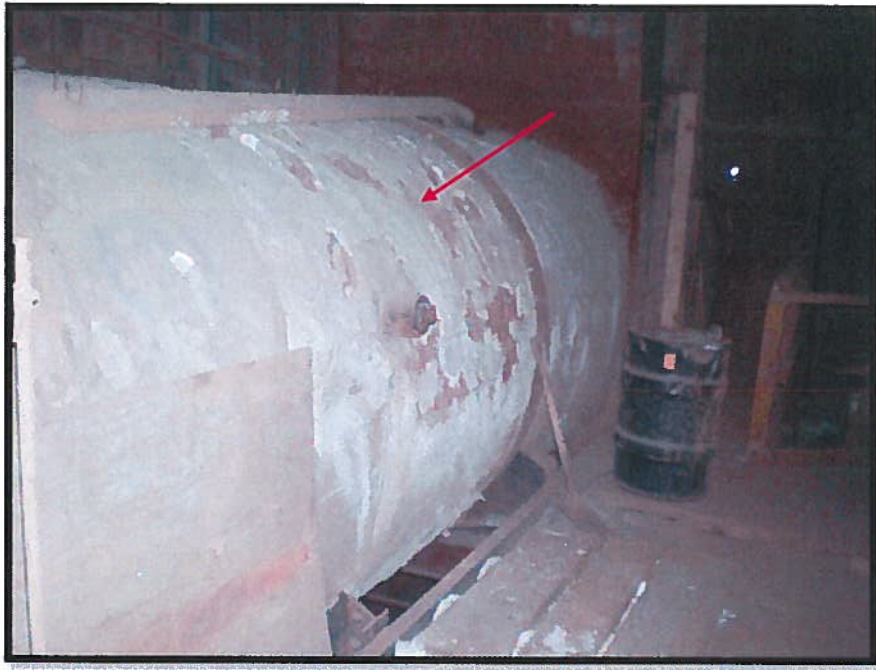
*Photograph 11: Asbestos-Containing Flue-Pipe Insulation (Sample 34).*

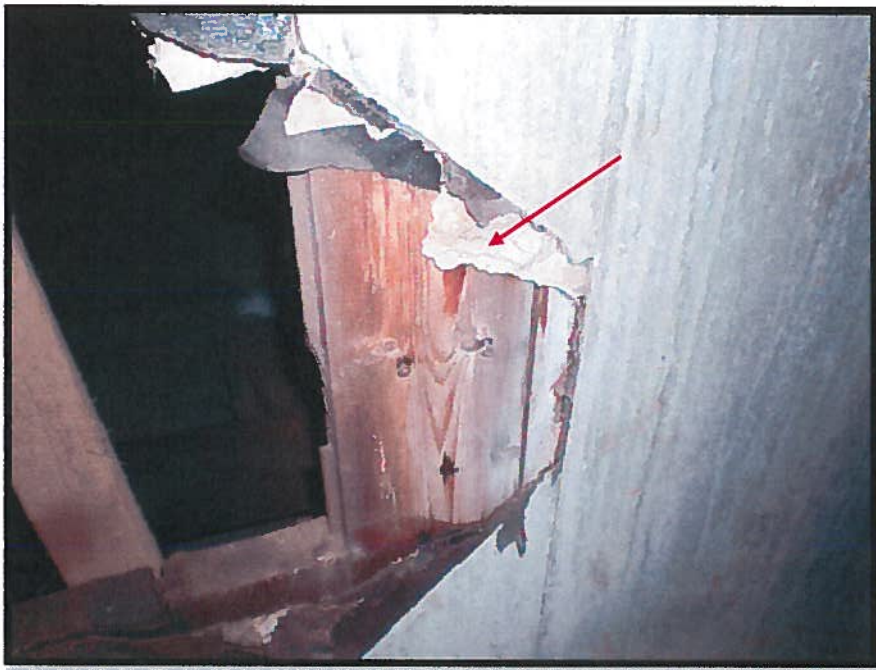
*Photograph 12: Asbestos-Containing Paper Beneath Transite Wall Panels, Generator Room (Sample 36).*

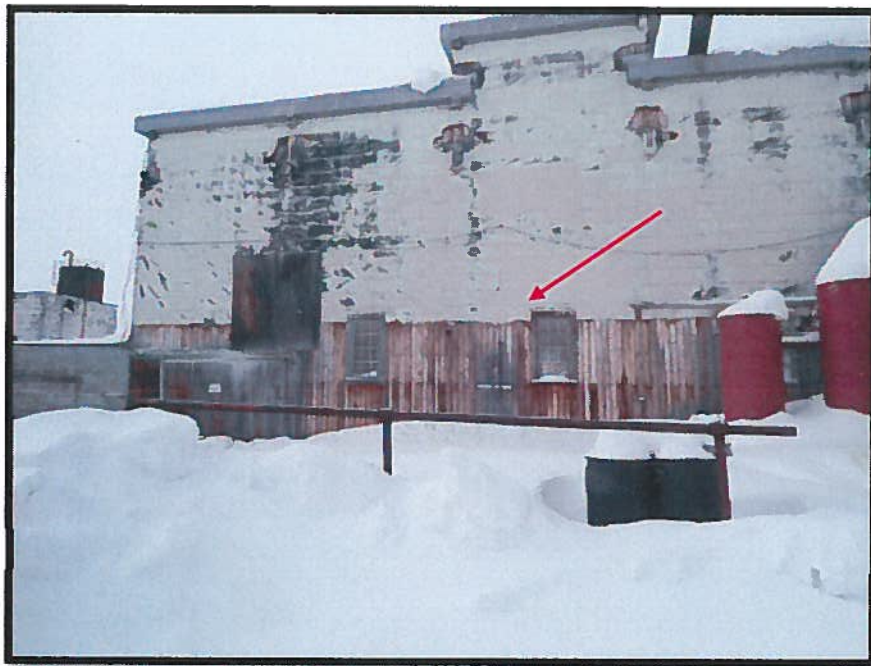
*Photograph 15: Asbestos-Containing Exterior Siding Paper (Sample 39).*

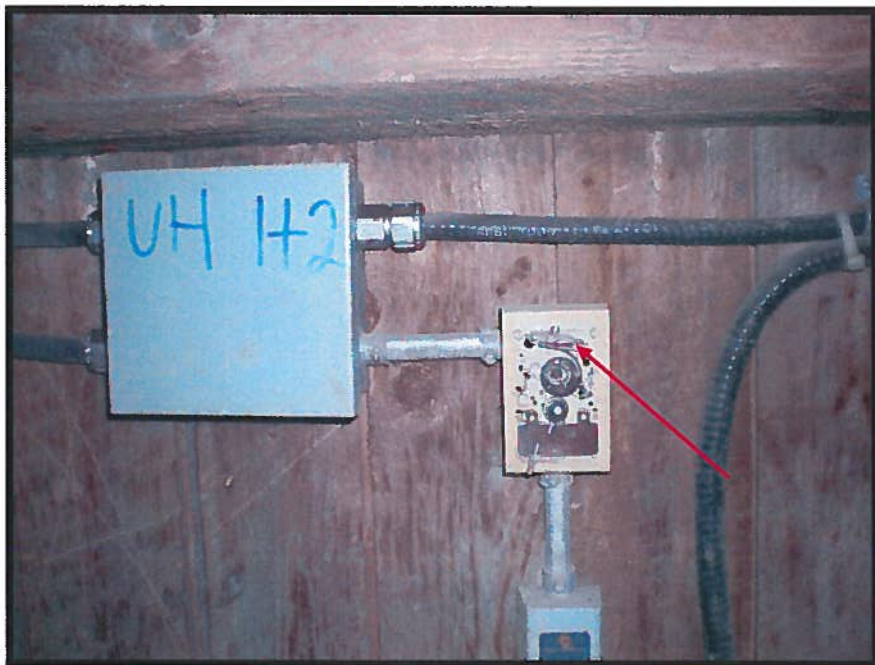
*Photograph 20: Mercury-Containing Thermostat Bulbs.*

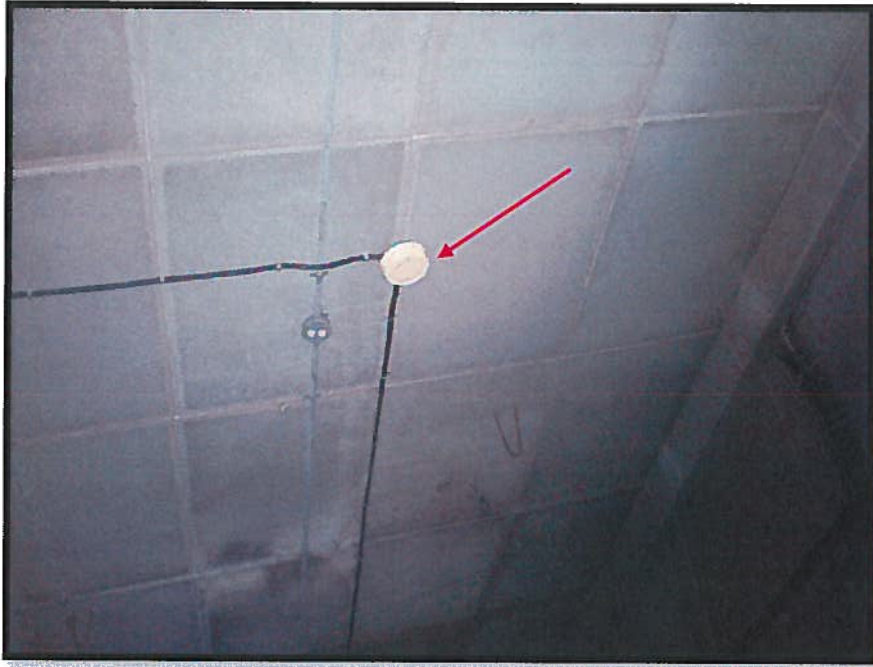
*Photograph 21: Suspect Radioactive Components within Ceiling Smoke Detector.*
