Public Works and Government Services Canada

# **Giant Mine Roaster Complex Deconstruction Waste Audit Report-FINAL**

003-DISO Roaster Demo-DISO-RPT-0004-Rev1\_20121128-FINAL

November 28, 2012

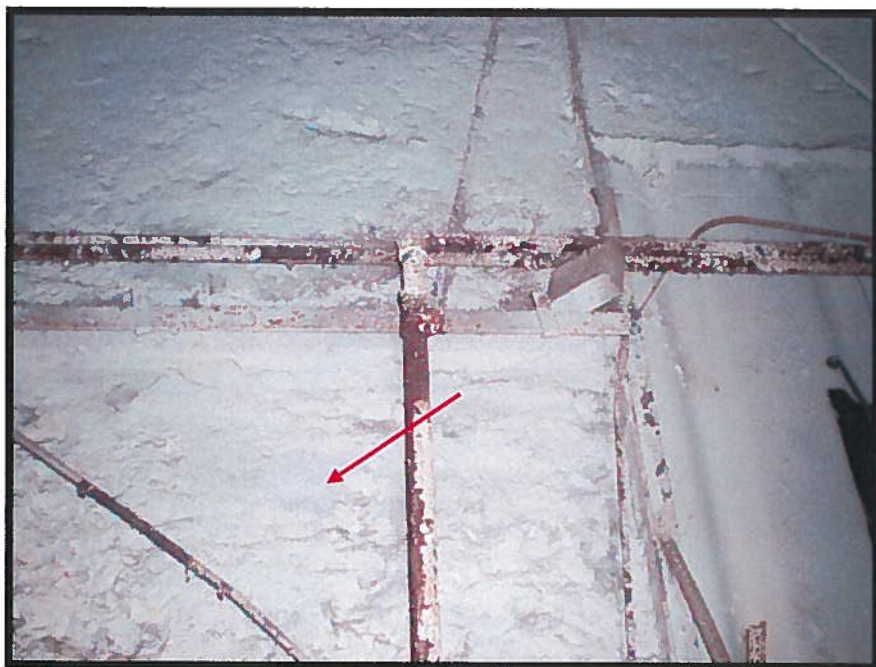
*Photograph 4: Asbestos-Containing Spray-Applied Wall Insulation, East Wall (Sample 06).*

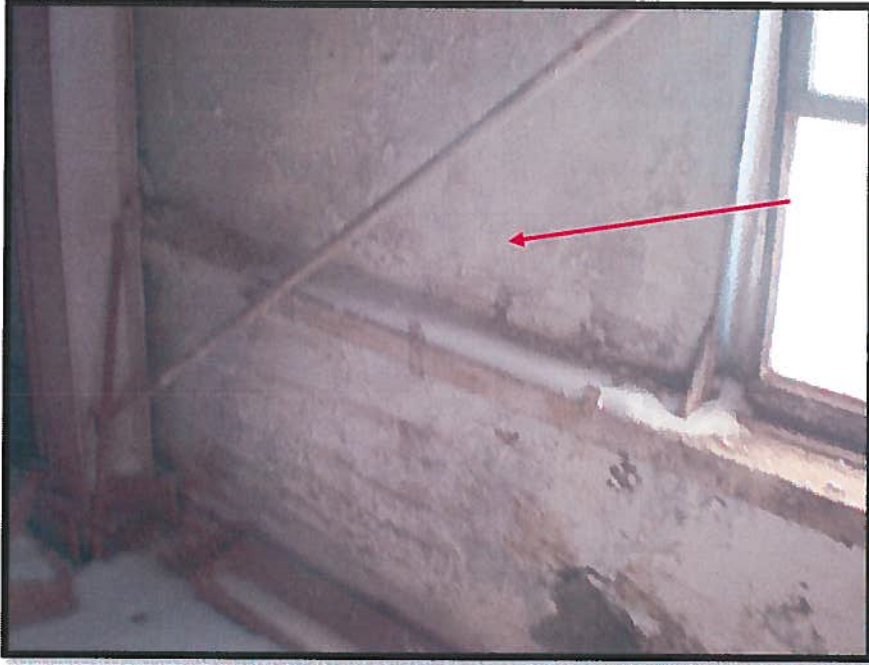
*Photograph 5: Asbestos-Containing Spray-Applied Wall Insulation, South Wall (Sample 07).*

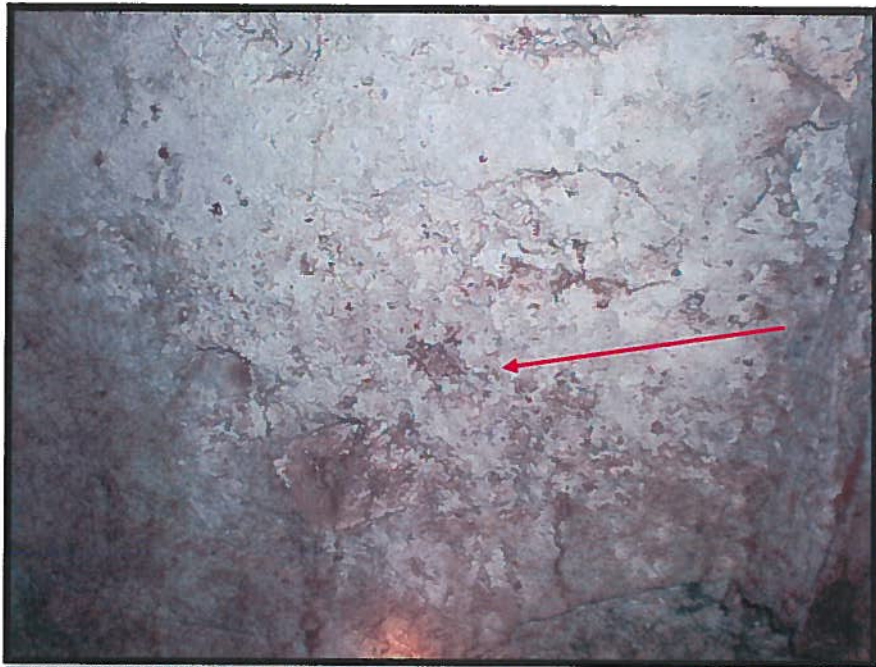
*Photograph 6: Asbestos-Containing Spray-Applied Wall Insulation, West Wall (Sample 08).*

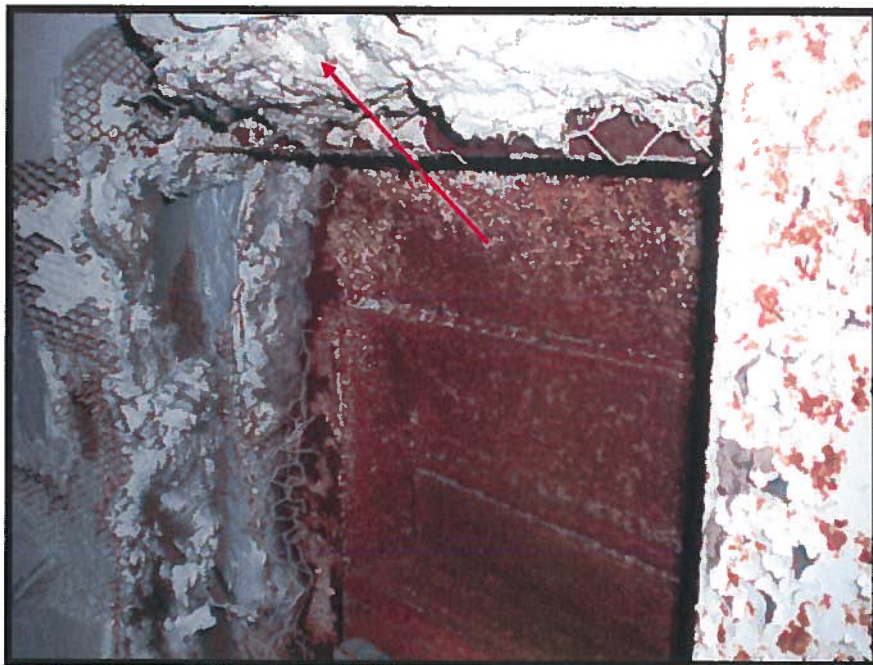
*Photograph 8: Asbestos-Containing Precipitator Vessel Insulation, South Vessel (Sample 10).*

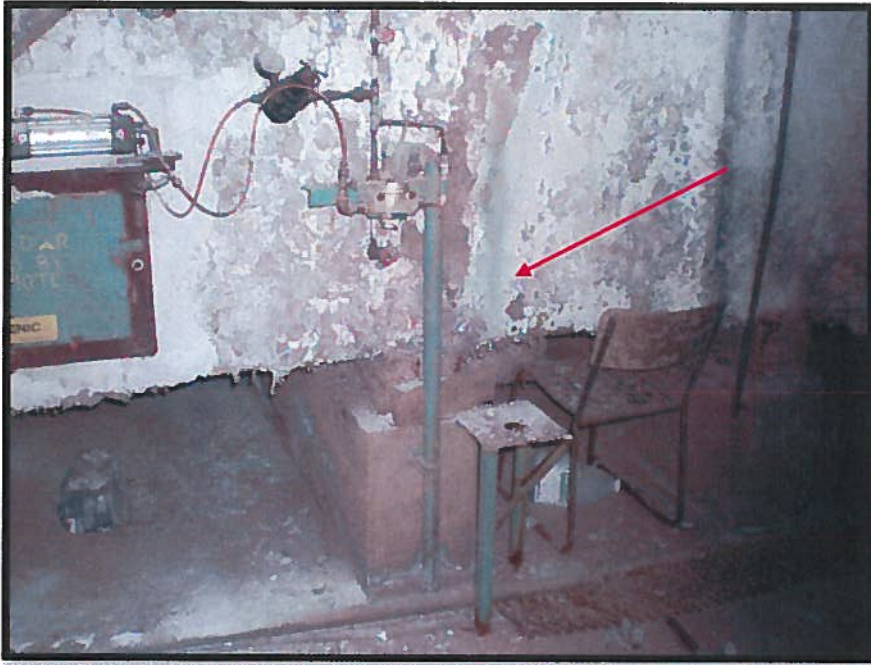
*Photograph 9: Asbestos-Containing Duct Parging Insulation (Sample 11).*

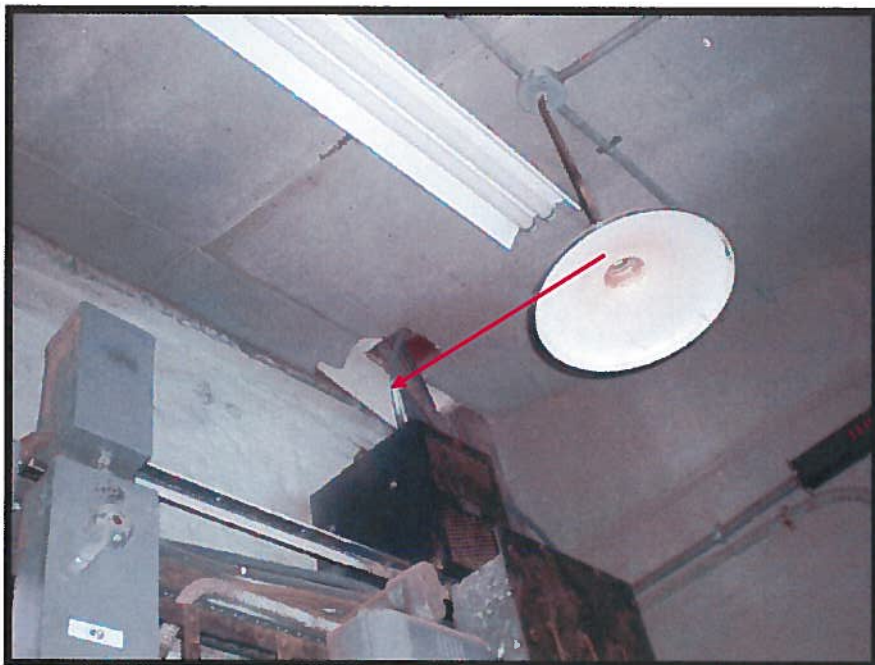
*Photograph 10: Asbestos-Containing Wall Paper behind Transite Board in Electrical Room (Sample 12).*

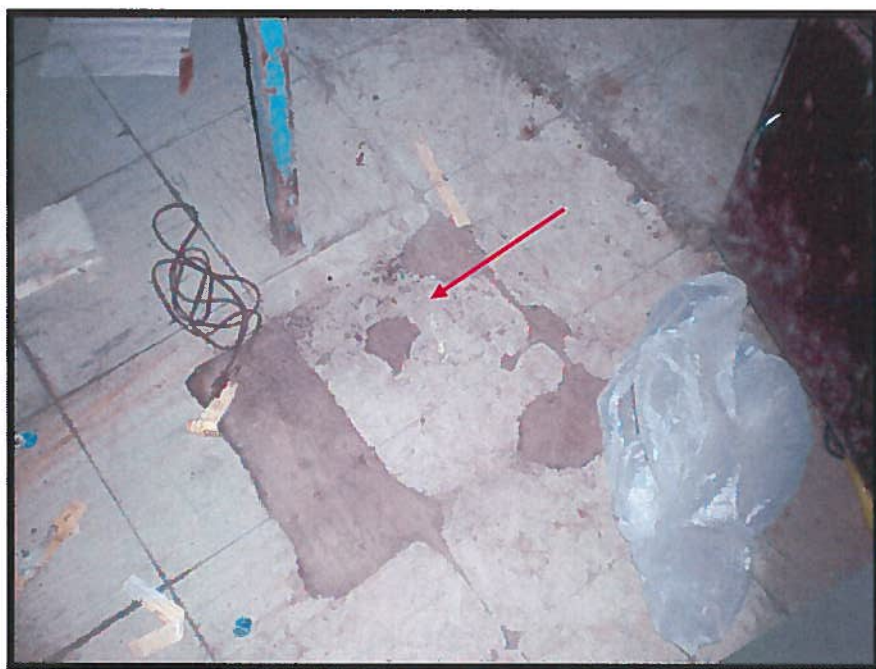
*Photograph 12: Asbestos-Containing Floor Tiles within Control Room/Office (Sample 15).*

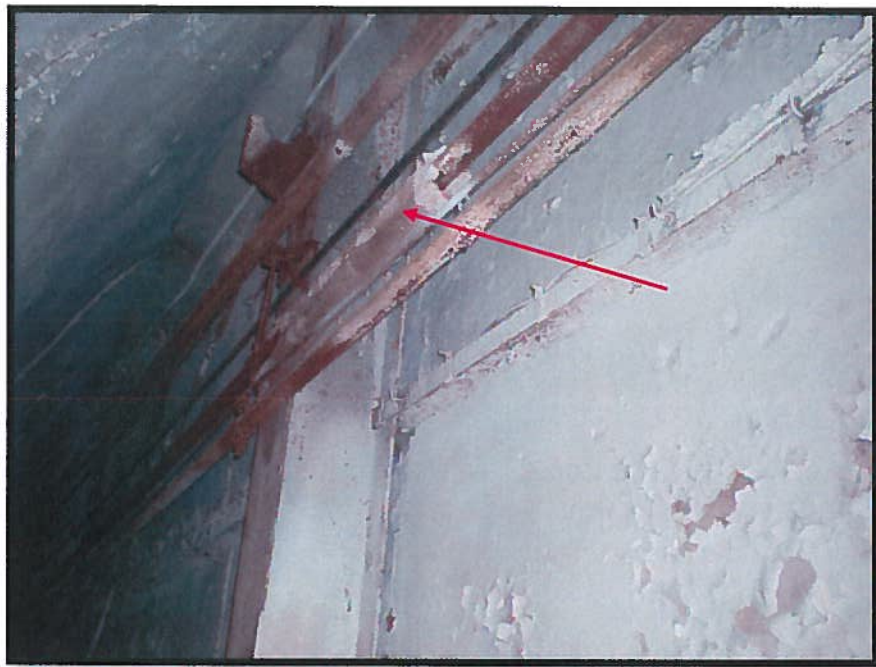
*Photograph 13: Asbestos-Containing Pipe-Run Insulation Adjacent to Stairwell (Sample 16).*

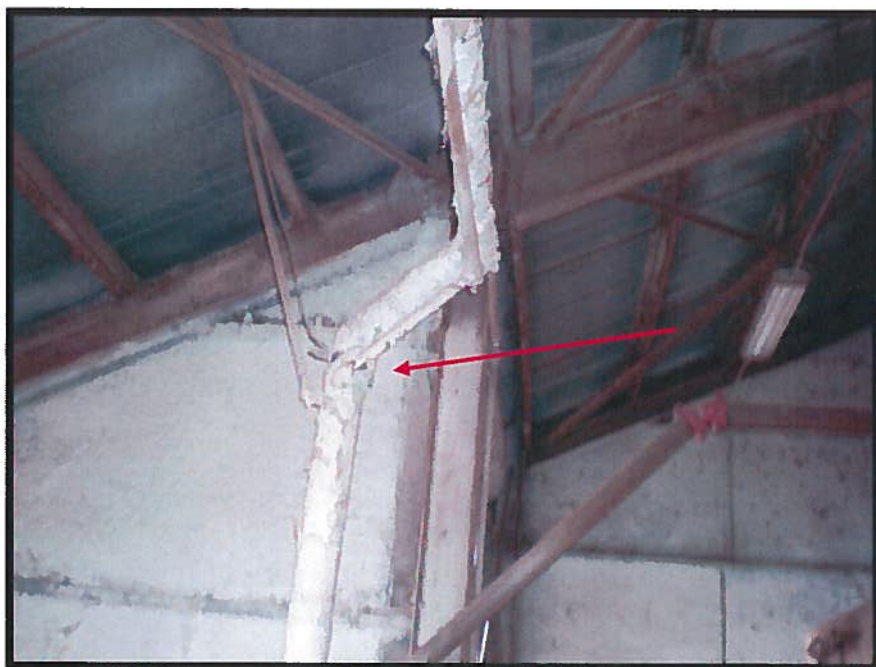
*Photograph 14: Asbestos-Containing 4" Pipe-Run Insulation (Sample 17).*

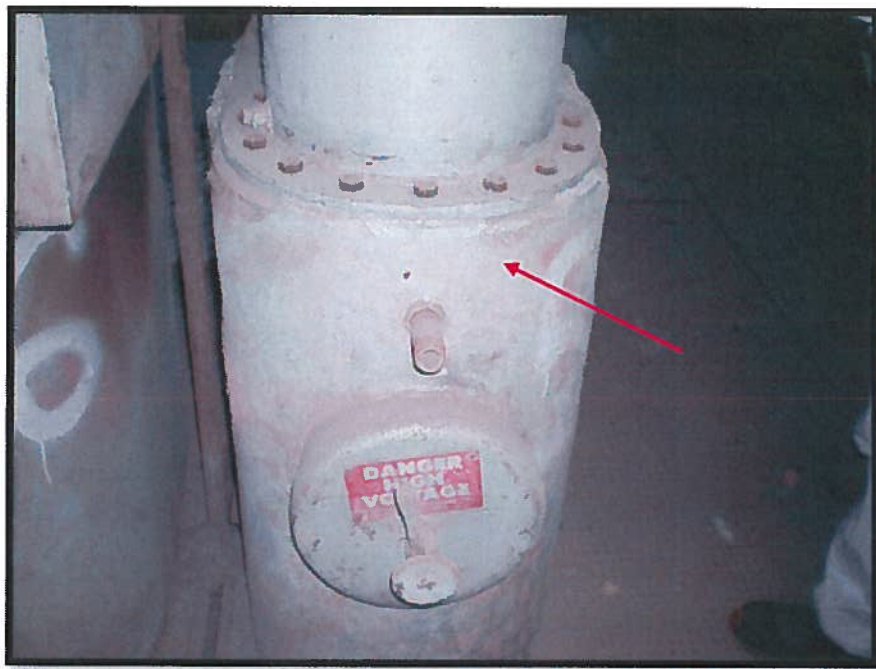
*Photograph 15: Asbestos-Containing Pipe-Insulation on North Precipitator Unit Header (Sample 18).*

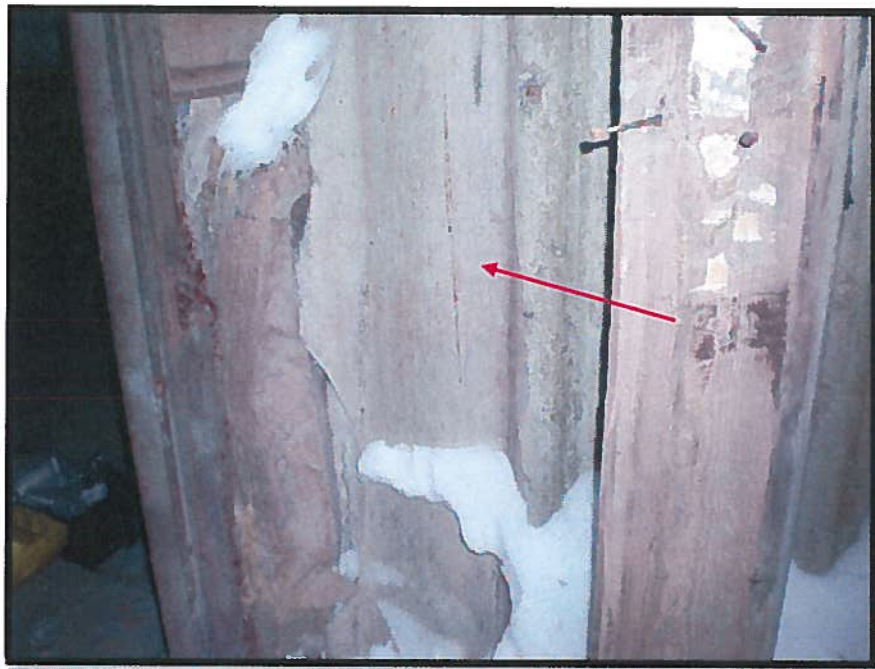
*Photograph 17: Asbestos-Containing Exterior Transite Wall Panelling (Sample 20).*

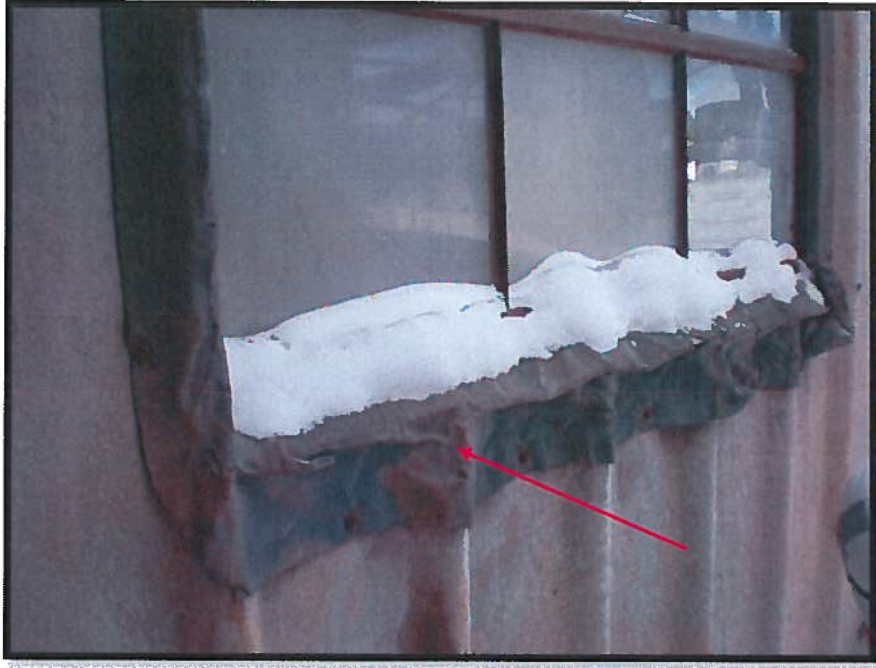
*Photograph 19: Lead Sheeting around Exterior Windows.*

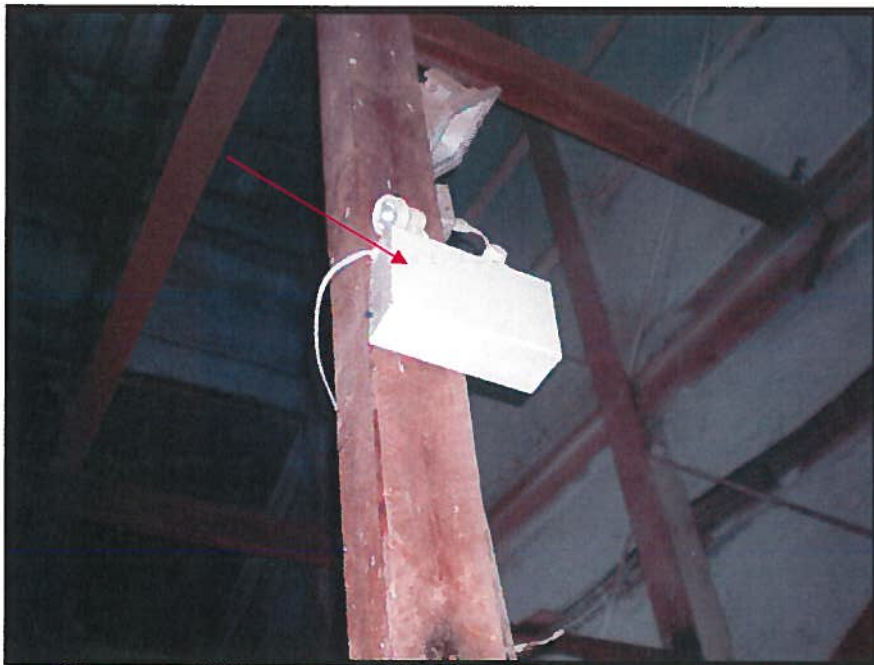
*Photograph 20: Suspect Lead-Acid Batteries within Emergency Light Fixtures.*

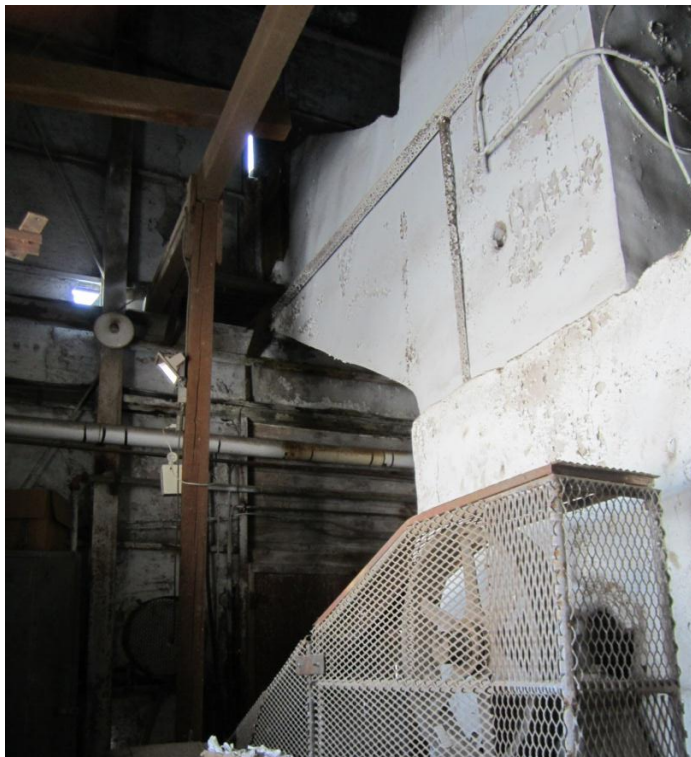
Cottrell Precipitator Building

Interior insulated duct work and exterior asbestos insulated wall panels coated with a spray applied asbestos insulation on the interior surfaces, encapsulant coating on some wall surfaces.

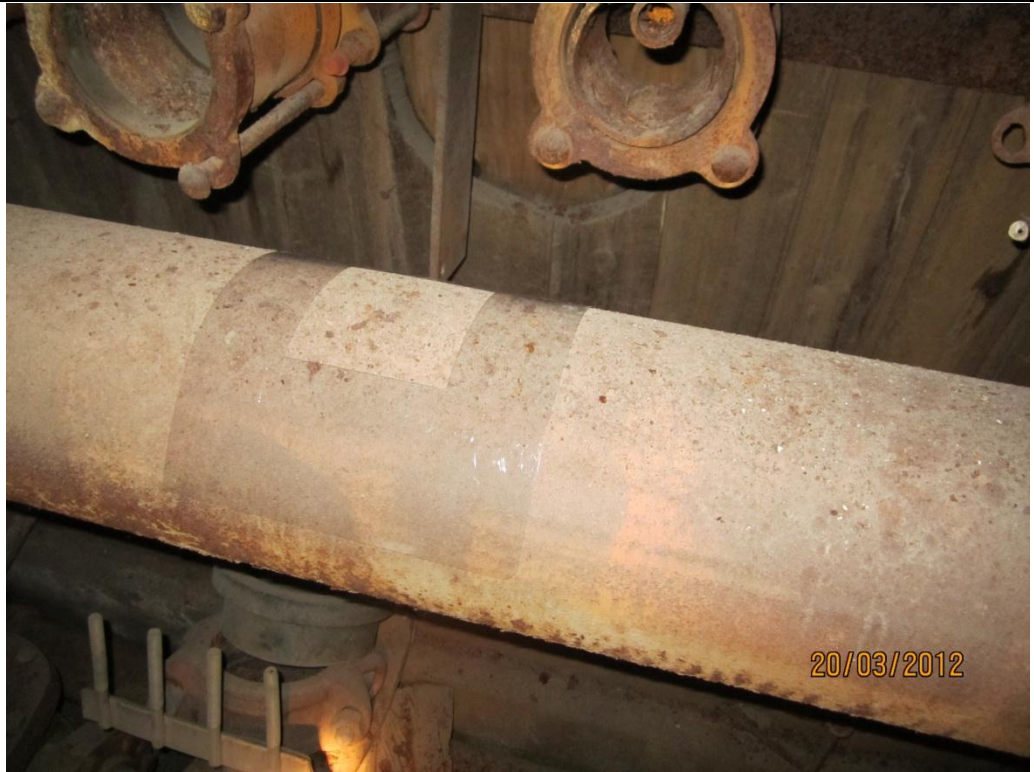
AC Roaster Building

Cleaning of dust of steel process piping

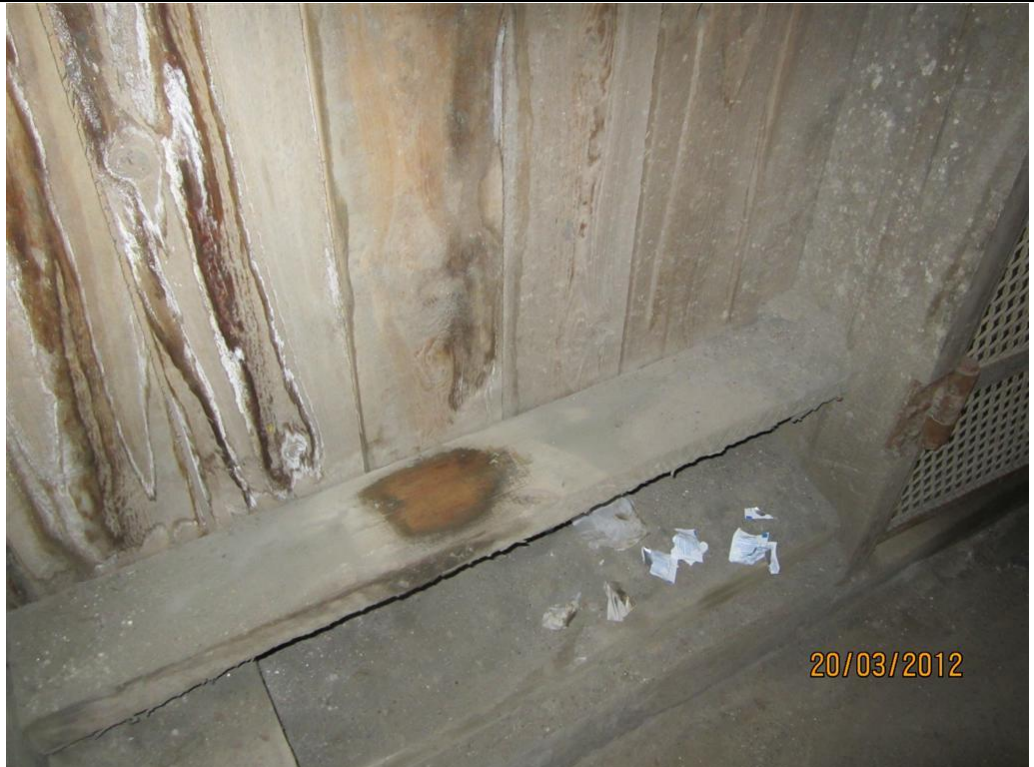
AC Roaster Building

Cleaning of dust off exterior walls

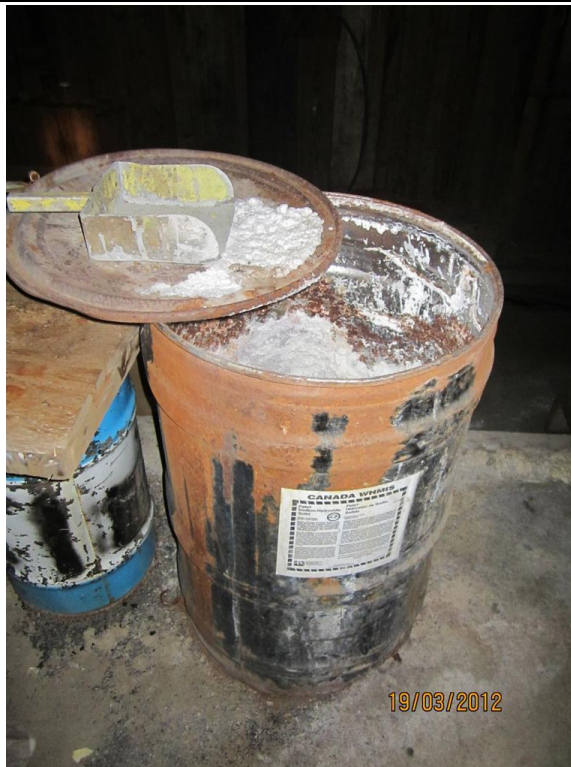
AC Roaster Building

Open barrel of sodium hydroxide

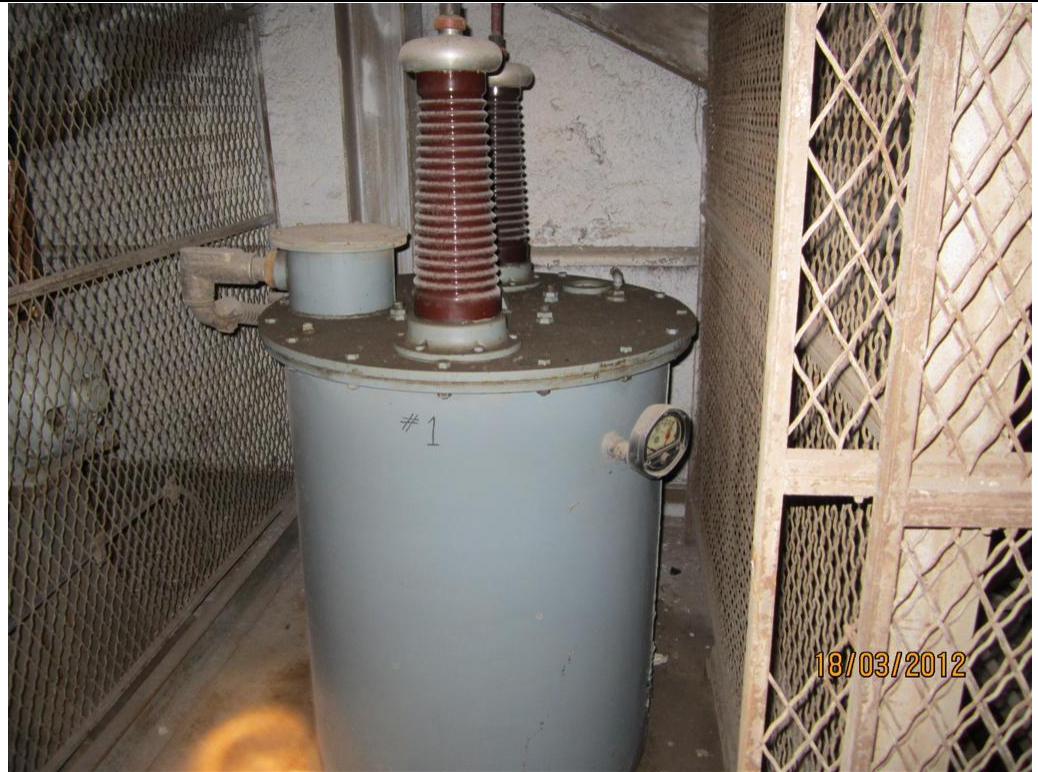
Cottrell Precipitator Building

Electrical Transformer –  
3rd floor level

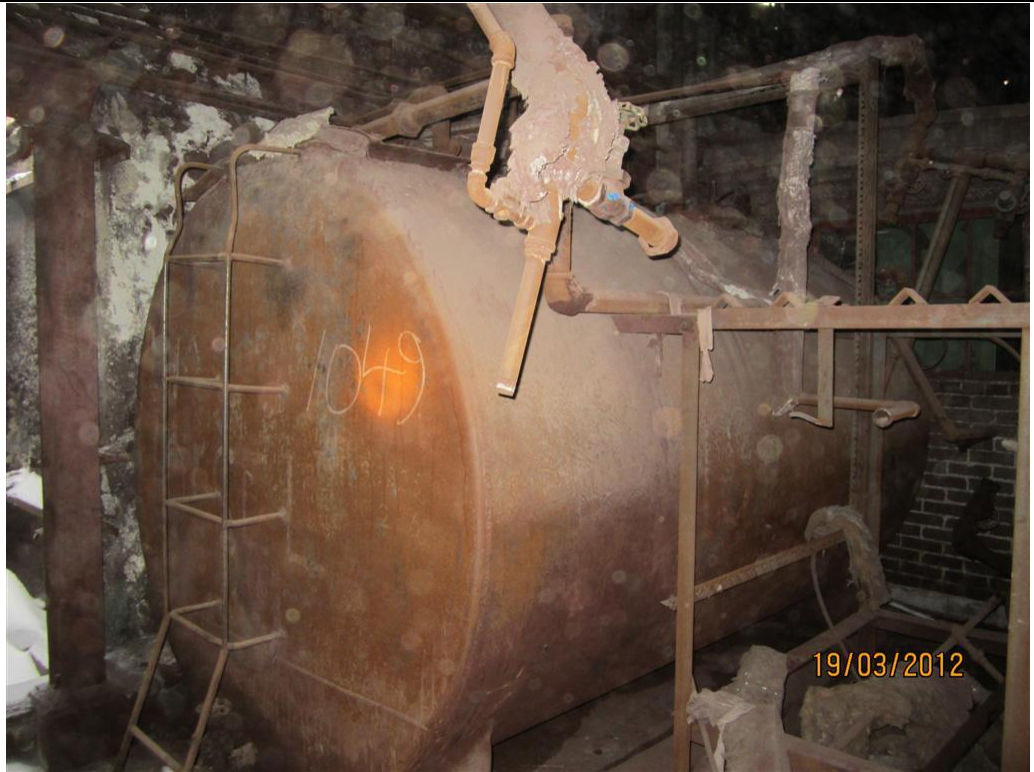
Calcine Plant

Interior fuel storage tank

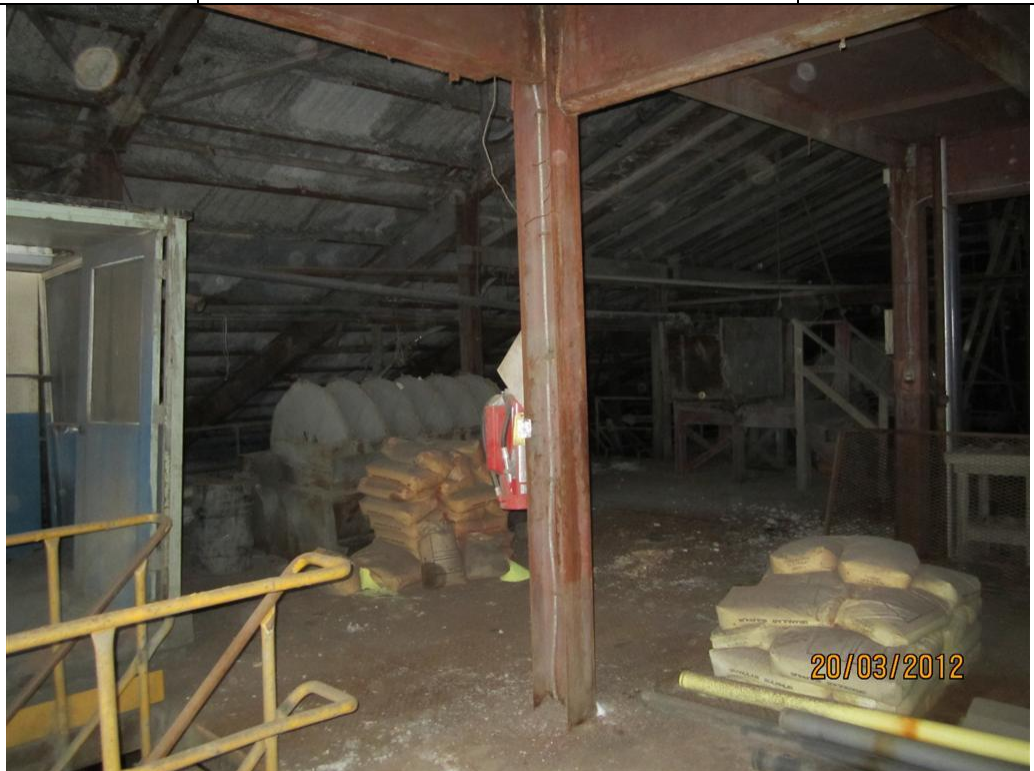
Dorrco Roaster

Storage of granular sulphur
