Final Abandonment and Restoration Plan Miramar Giant Mine Ltd.

VOLUME III OF III

APPENDIX A-9
ANNUAL DAM INSPECTION 2001

**2001 GEOTECHNICAL INSPECTION OF
GIANT MINE TAILINGS DAMS
YELLOWKNIFE, NT**

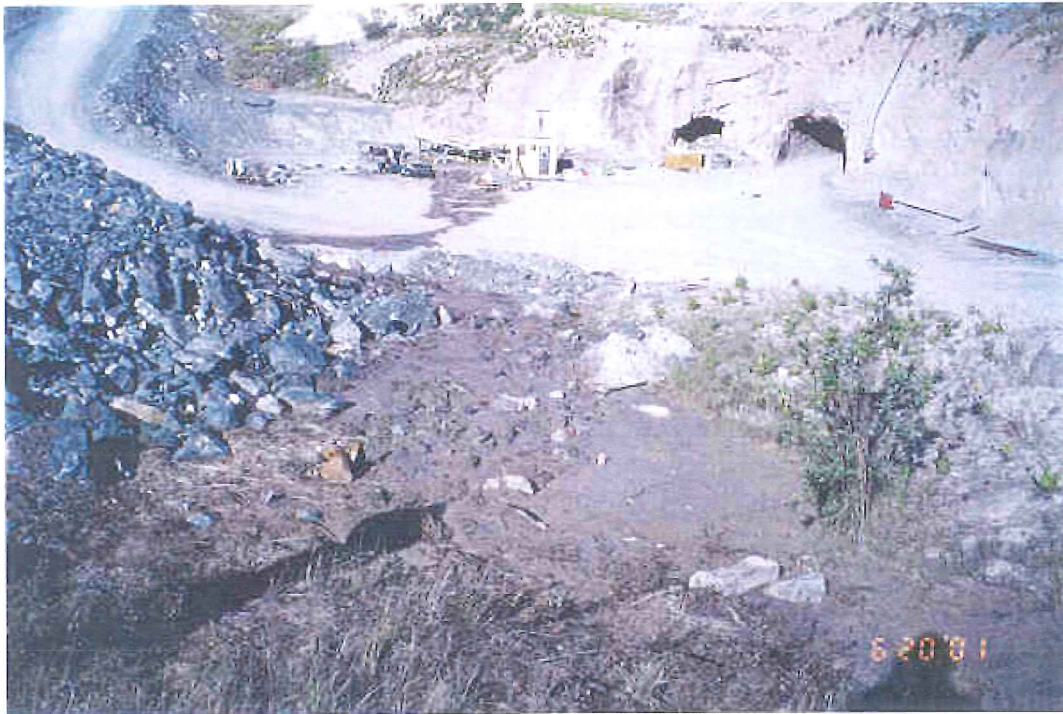
PHOTOGRAPH 1

Seepage was observed through the overburden material near the central part of the downstream toe. The seepage observed was clear. This seepage was also observed along the north side of the access road adjacent to the B3 Pit from the Ingraham Trail.

Downstream toe area of Dam 1.
Area is wet from seepage through dam foundation

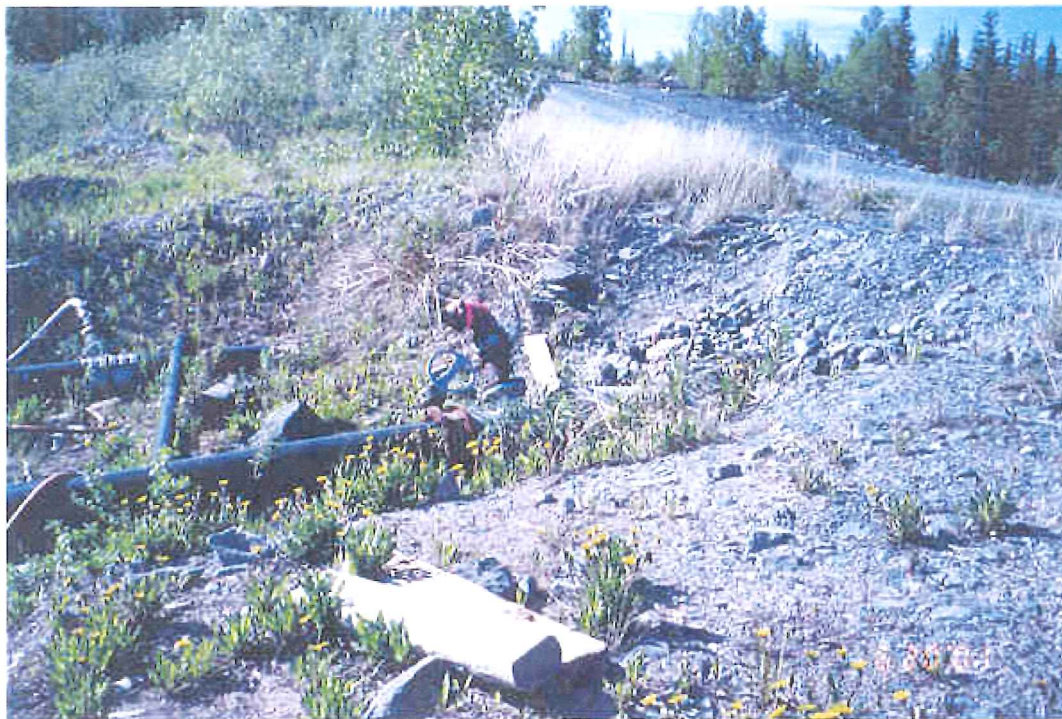
PHOTOGRAPH 2

Decant structure at Dam 1.

The decant structure through the south end of the dam is abandoned. The system should be grouted or removed in the initial stages of the final abandonment and restoration of the mine.

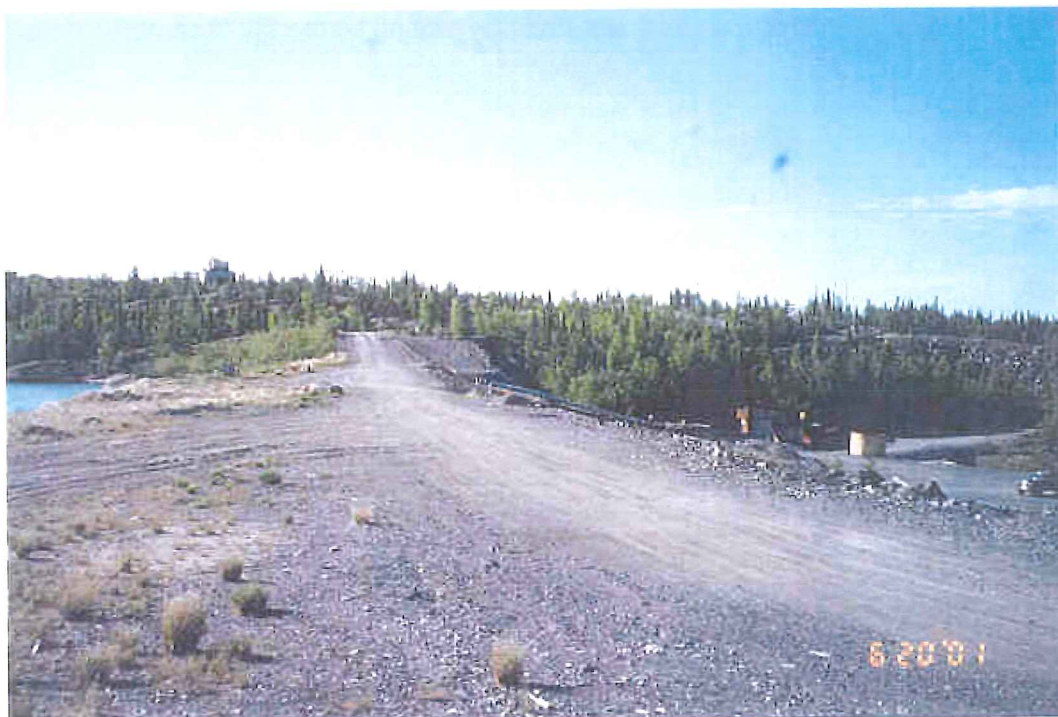
PHOTOGRAPH 3

The most important maintenance item for the dam structure, is the subsided area on the crest of the dam. This area has settled or subsided approximately 0.5 meter over the past two years. It is understood that this has reduced the efficiency of the polishing pond by reducing the volume of water that can be retained behind Dam 1. It is recommended that the clay core and associated waste rock in this area be raised by at least 0.5 meter during the post discharge season (September/October) of the 2001 operating year.

Crest of Dam 1 looking east.

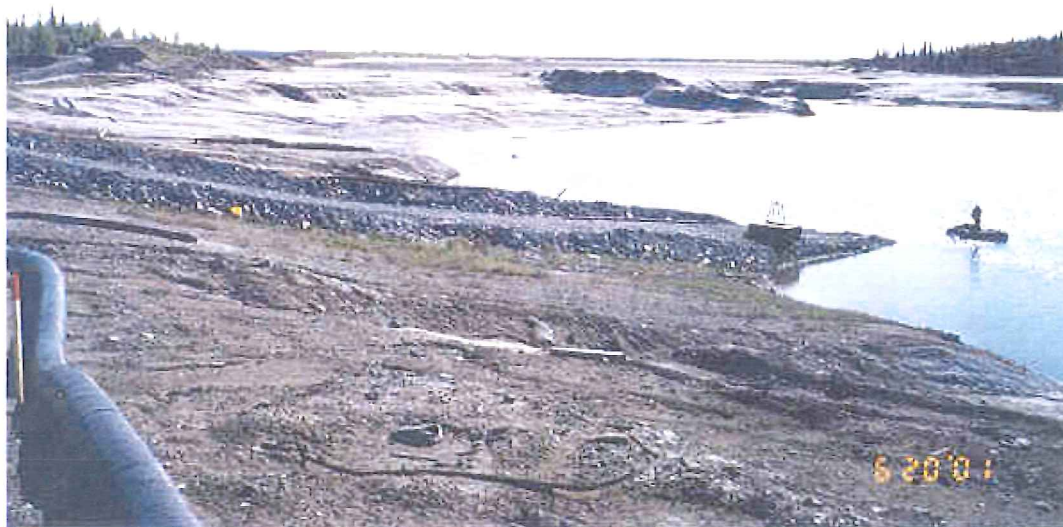
PHOTOGRAPH 4

Upstream face of dam at pump station.

The dam currently plays only a minor role and appears to stable under its current function. The gully erosion upstream should be graded.

Minewater should not be discharged on to the upstream face to minimize further erosion.

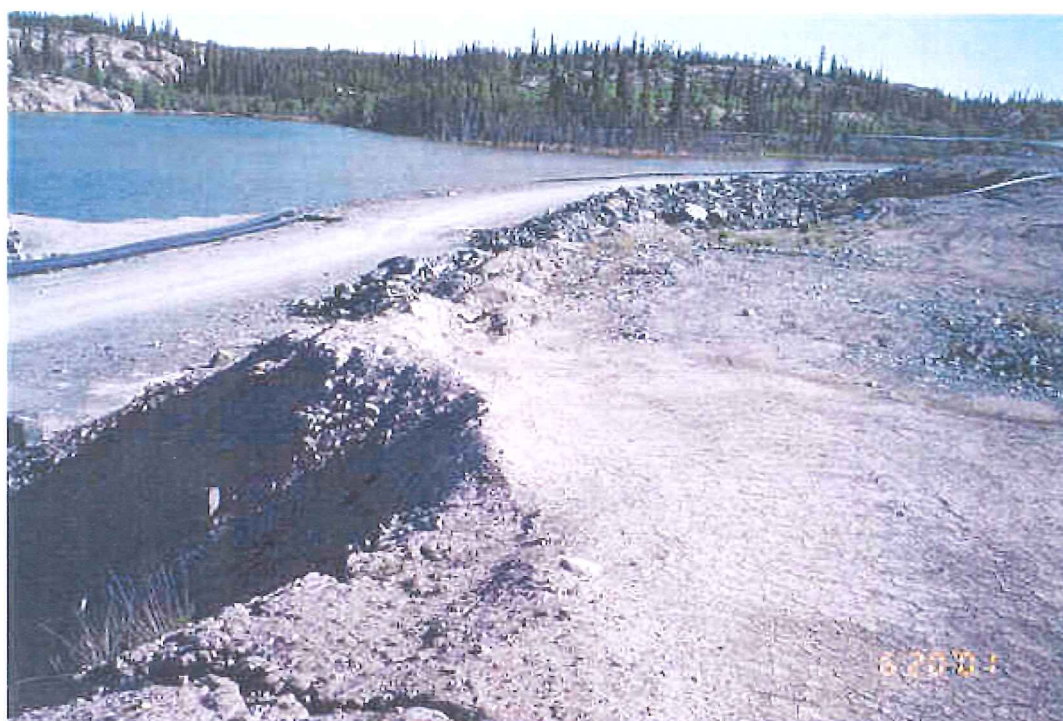
PHOTOGRAPH 5

Downstream slope of Dam 2 with settling pond in background.

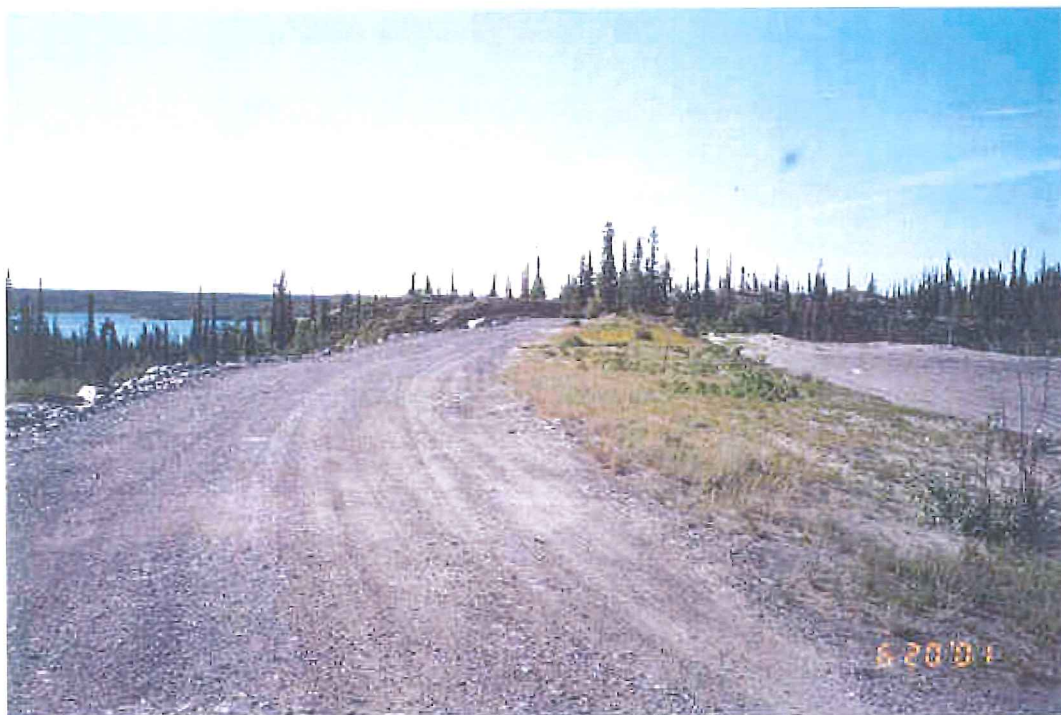
PHOTOGRAPH 6

Crest of Dam 3 looking east, old pond area on right.

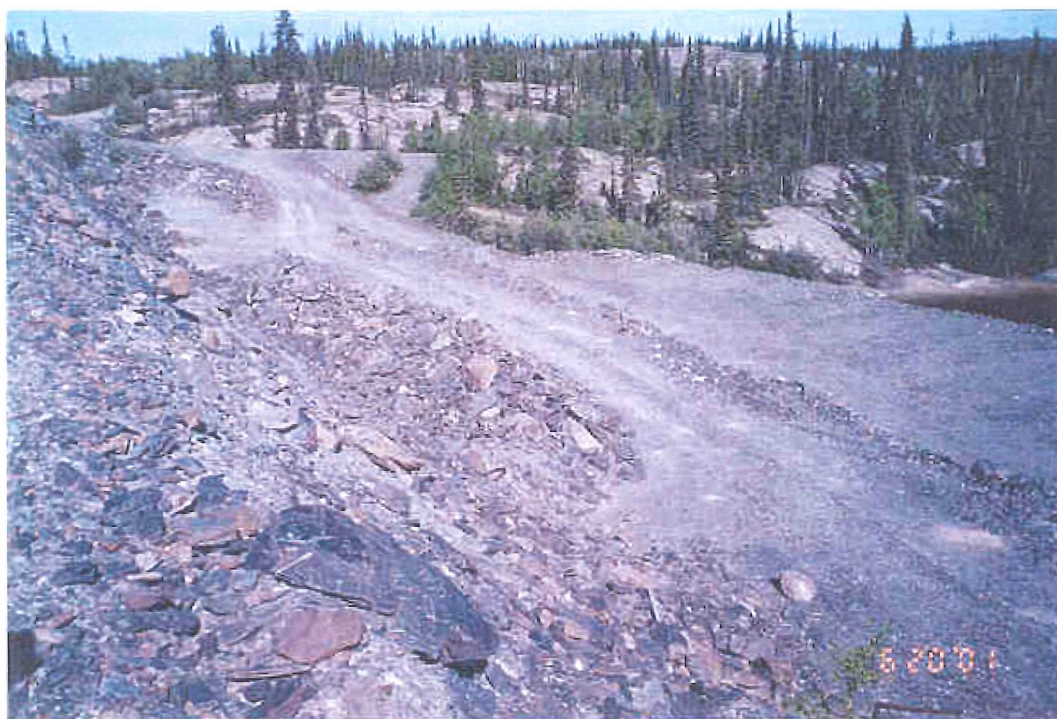
PHOTOGRAPH 7

Downstream area of west end of Dam 3.
Pond at Dam 3C at right of photo.

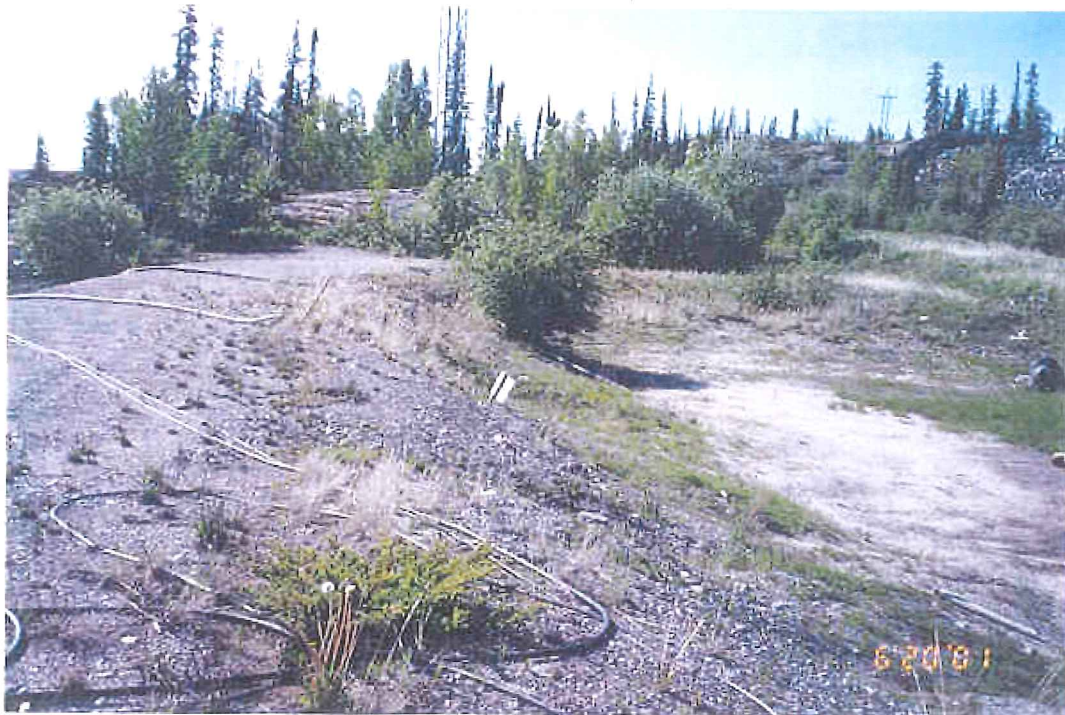
PHOTOGRAPH 8

Dam 3D looking east, Dam 3 on right.

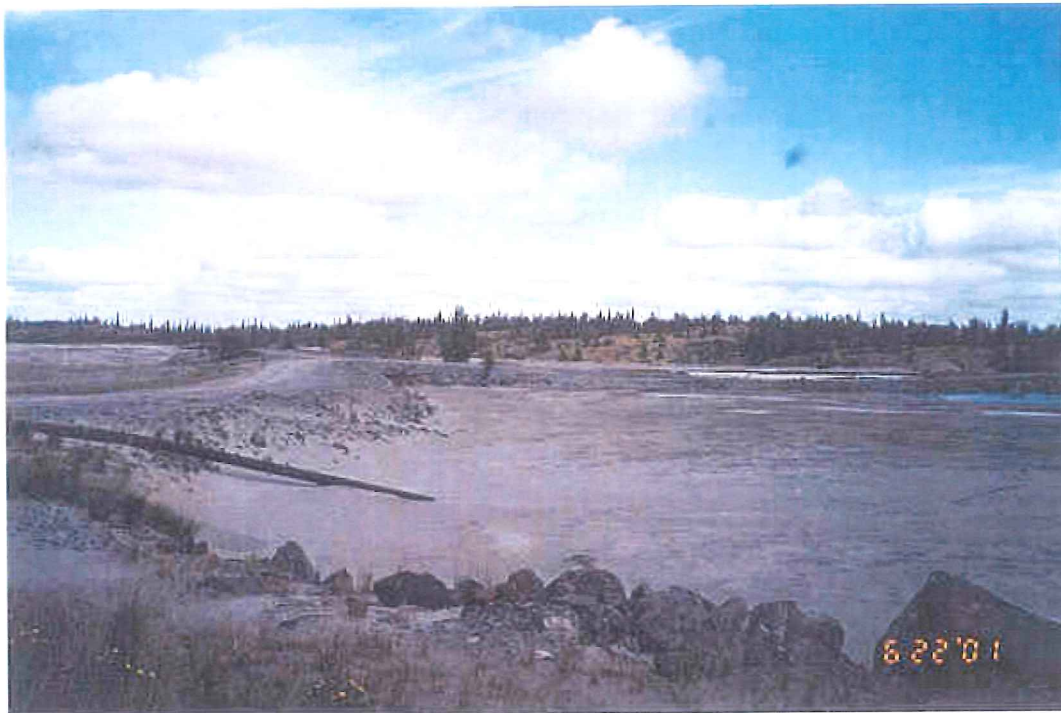
PHOTOGRAPH 10

Dyke 4 looking east. South pond on right.

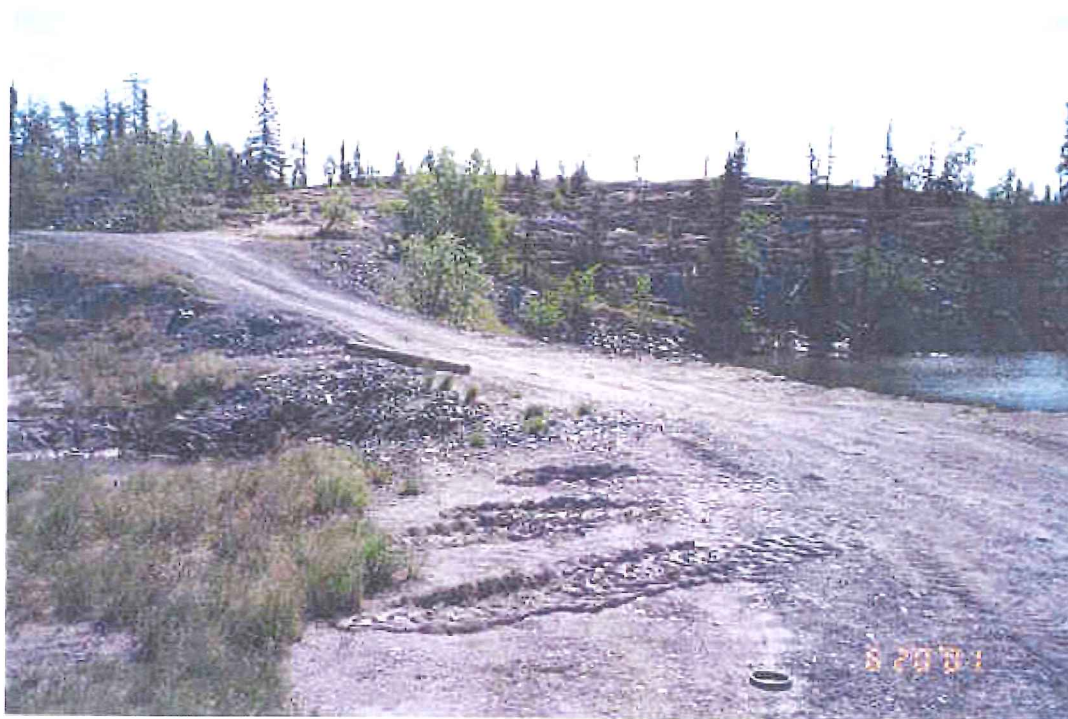
PHOTOGRAPH 11

Dyke 5 with water from south pond on right.

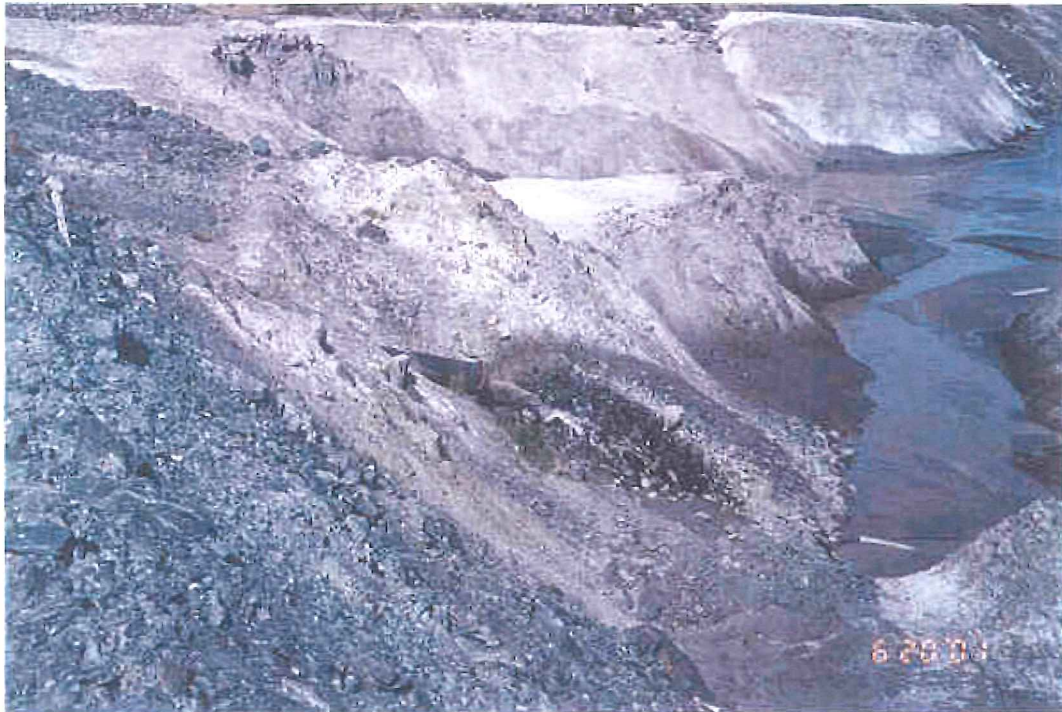
PHOTOGRAPH 12

Gully erosion was observed in the tailing on the downstream slope near the west abutment at the discharge pipe location.

The dyke has undergone some sloughing and erosion on its downstream face and crest. Since the majority of the tailing in the Central Pond are probably in a dry or frozen state, failure of this structure will only result of sloughing of tailing into the North Pond.

Decant discharge line from the central pond. Slope should be monitored and if needed, more rock added at toe of slope.

To reduce the potential for additional sloughing, the tailing area around the discharge pipe should be flattened or more rock should be added. In addition, the freeboard on the inlet end of the decant should be improved. Ultimately, a proper spillway could be constructed to direct runoff over the crest and downstream face or the north face of the Central Pond should be graded to allow for sheet flow to the North Pond from the Central Pond.

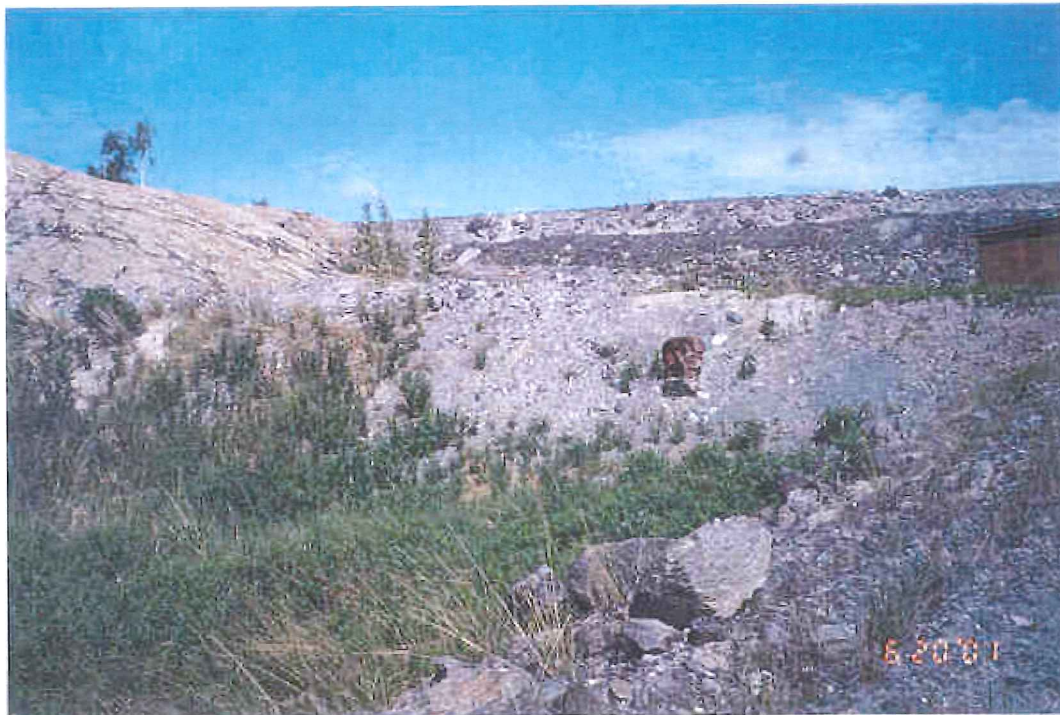
PHOTOGRAPH 13

Downstream face of dam.

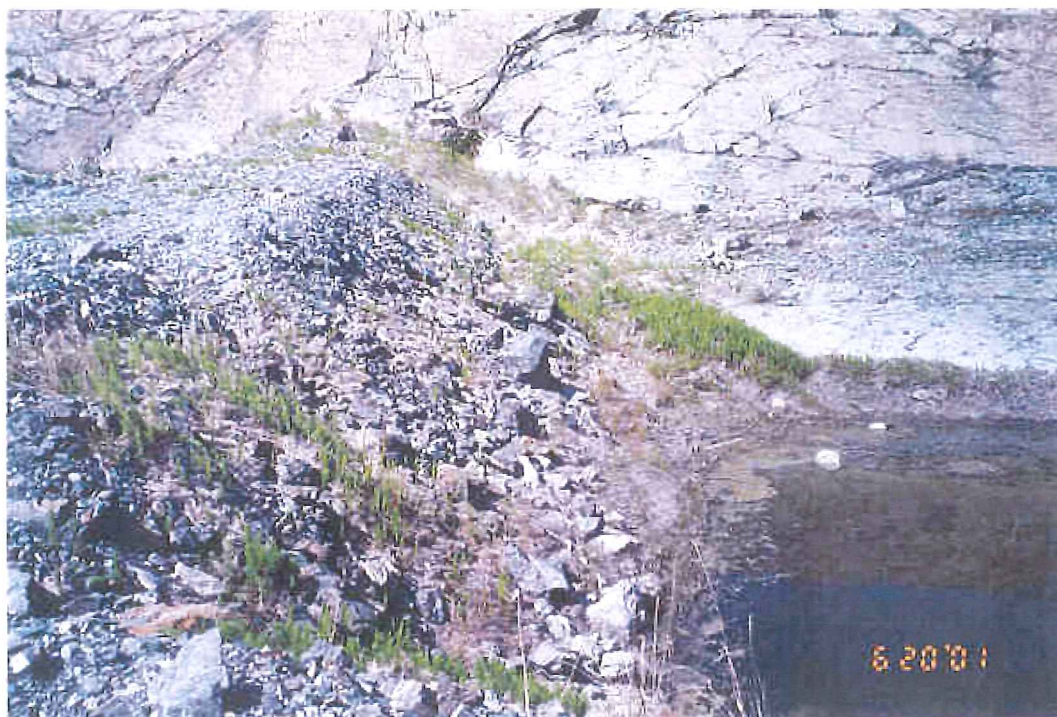
PHOTOGRAPH 14

Upstream face of dam.

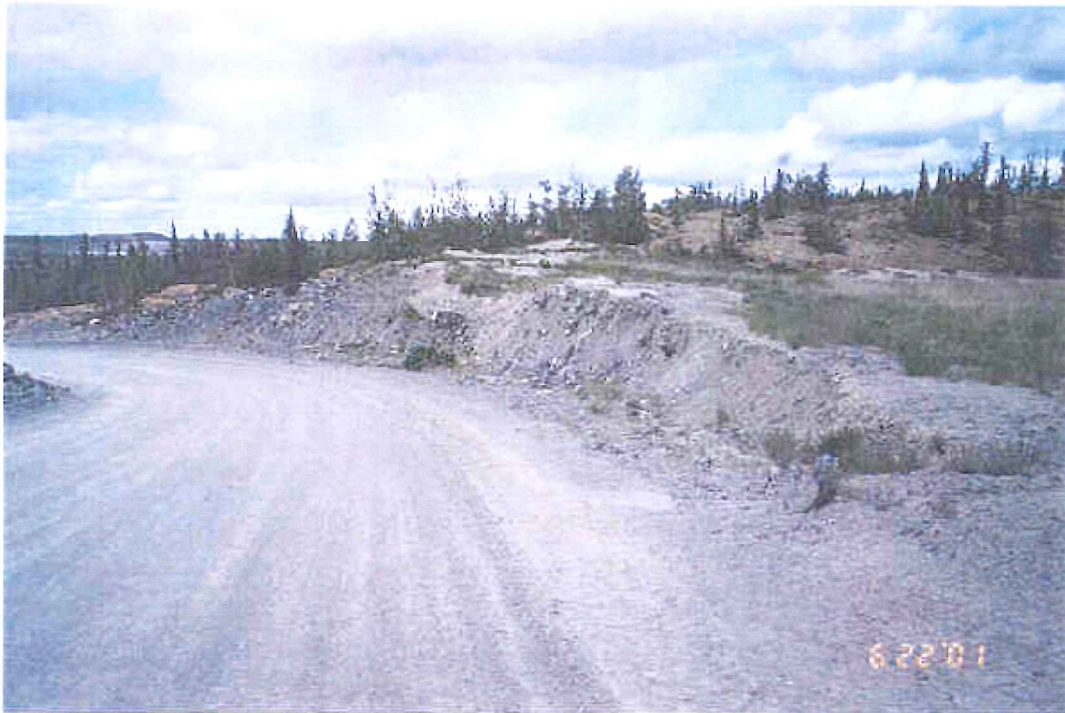
PHOTOGRAPH 15

The downstream slope was uneven and near vertical in some places. Previous inspection reports recommended placing additional fill on the backslope ramp. This recommendation does not appear to have been implemented.

Downstream slope should be flattened.

Dam 8 appears to be performing adequately under its current function. However, the downstream slope should be graded to prevent sloughing and erosion, as recommended in previous inspection reports.

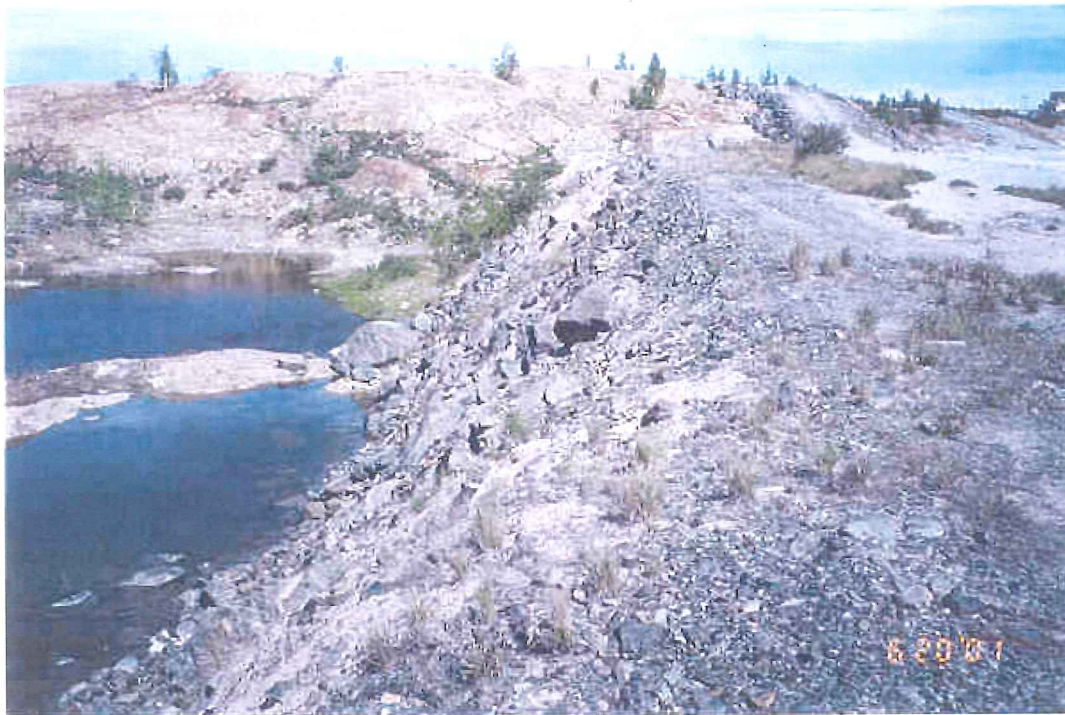
PHOTOGRAPH 16

West end of dam with water ponded at toe of dam.

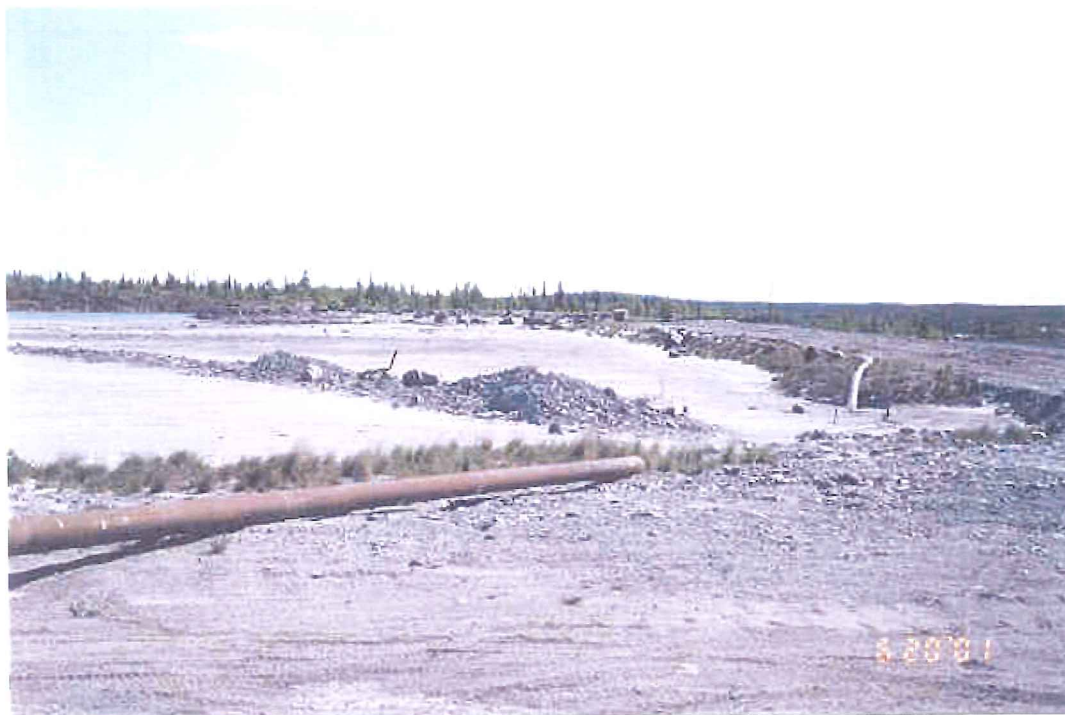
PHOTOGRAPH 17

Crest of Dam 11 looking east.

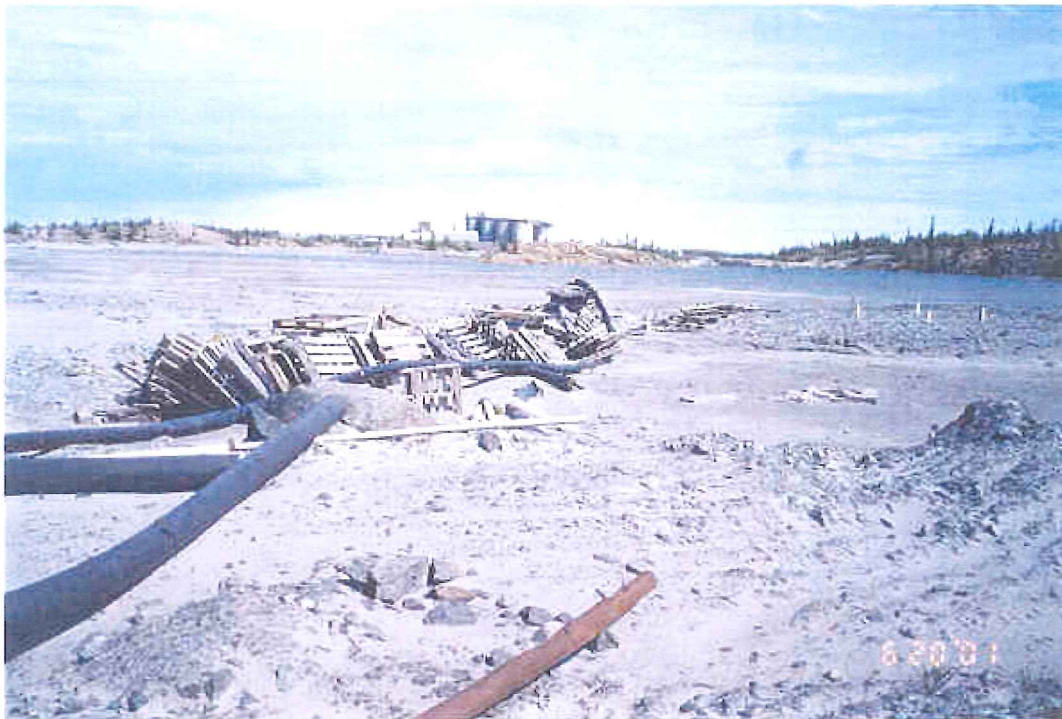
PHOTOGRAPH 19

Crest of Dam 11, with seepage water return pie from Dam 7. Supports for
pipe should be rebuilt.

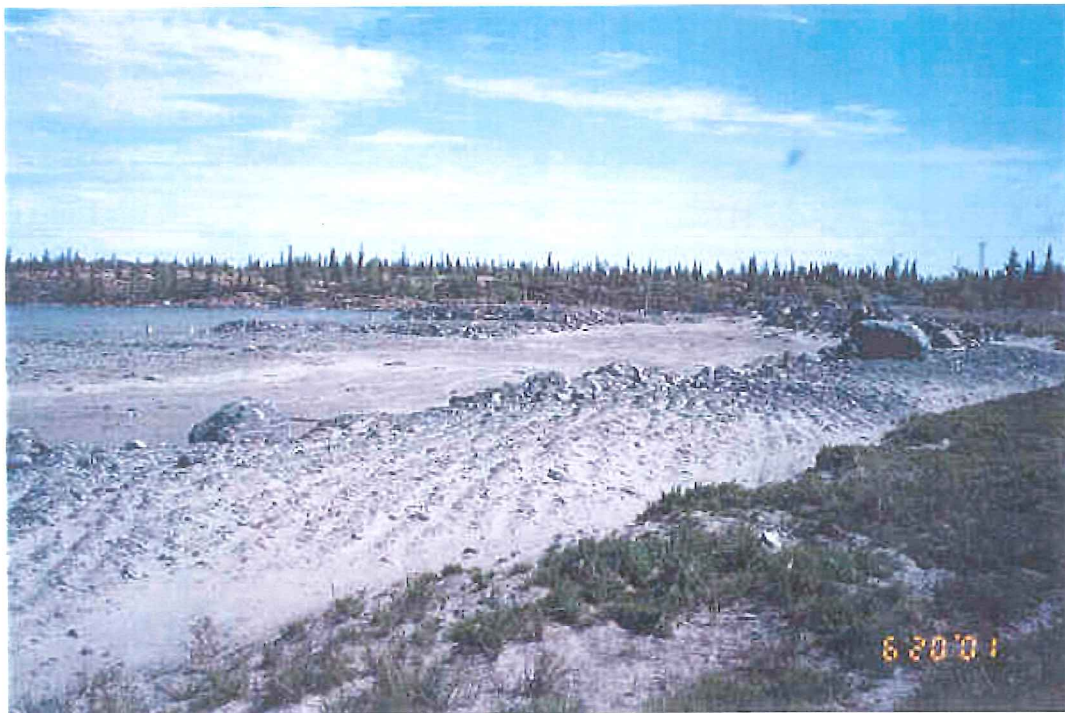
PHOTOGRAPH 20

East end of dam with water from Dam 7 to the left.

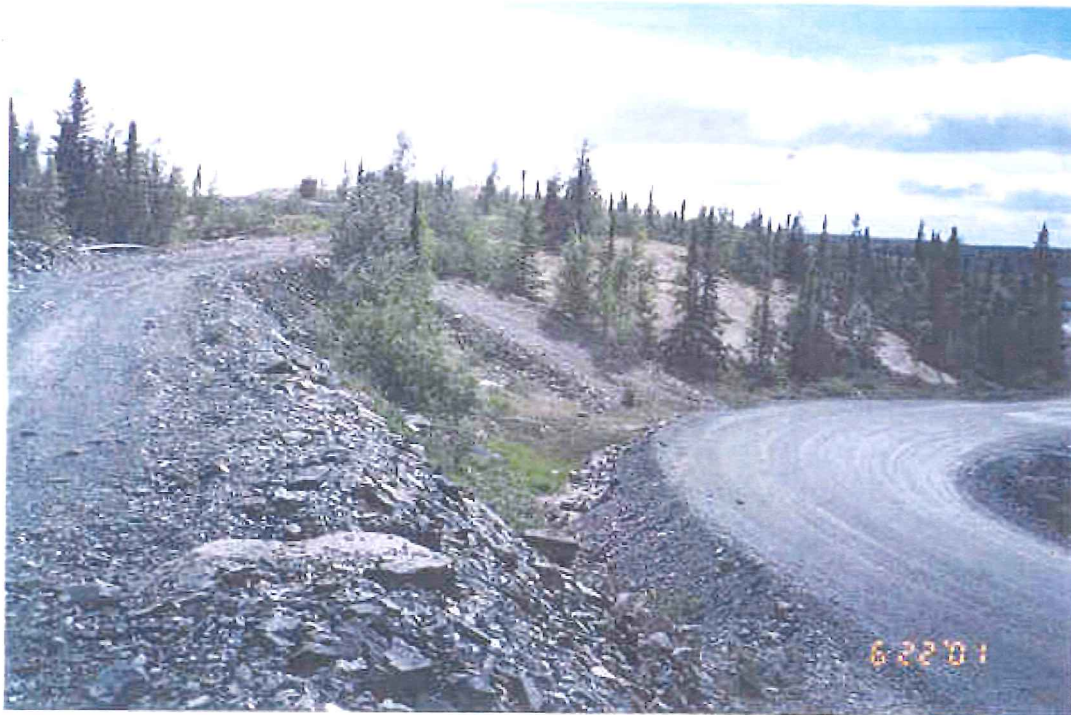
PHOTOGRAPH 21

Dam 12 with access road at toe of dam

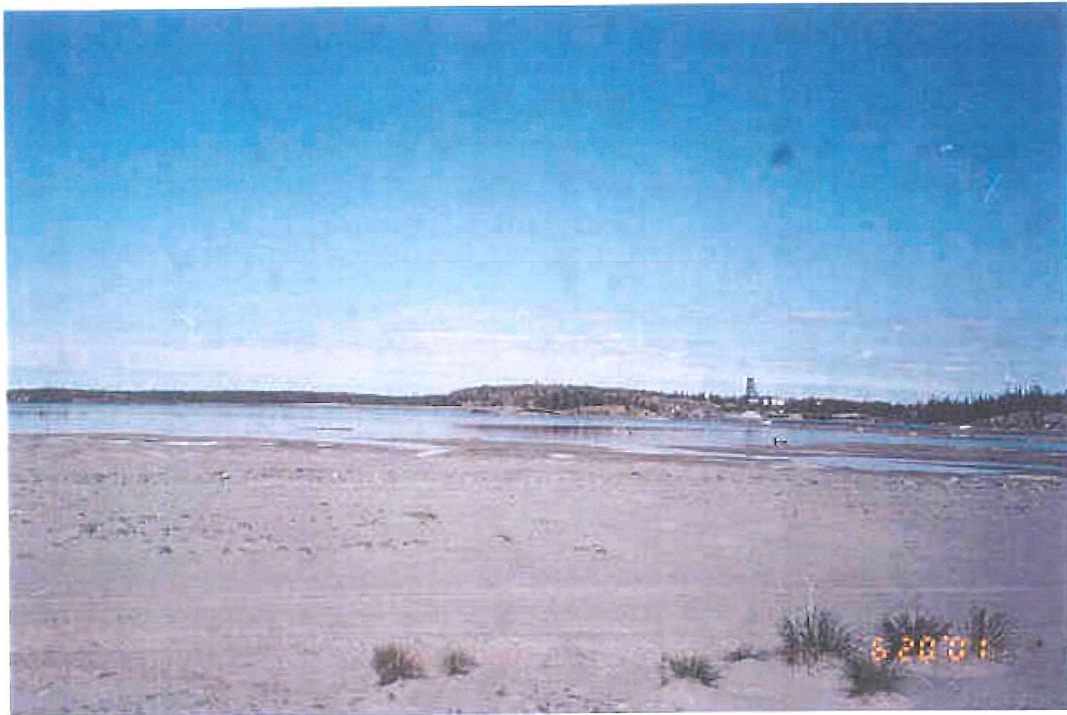
PHOTOGRAPH 22

Beach in front of Dam 21A. Water should not be discharged in this area.

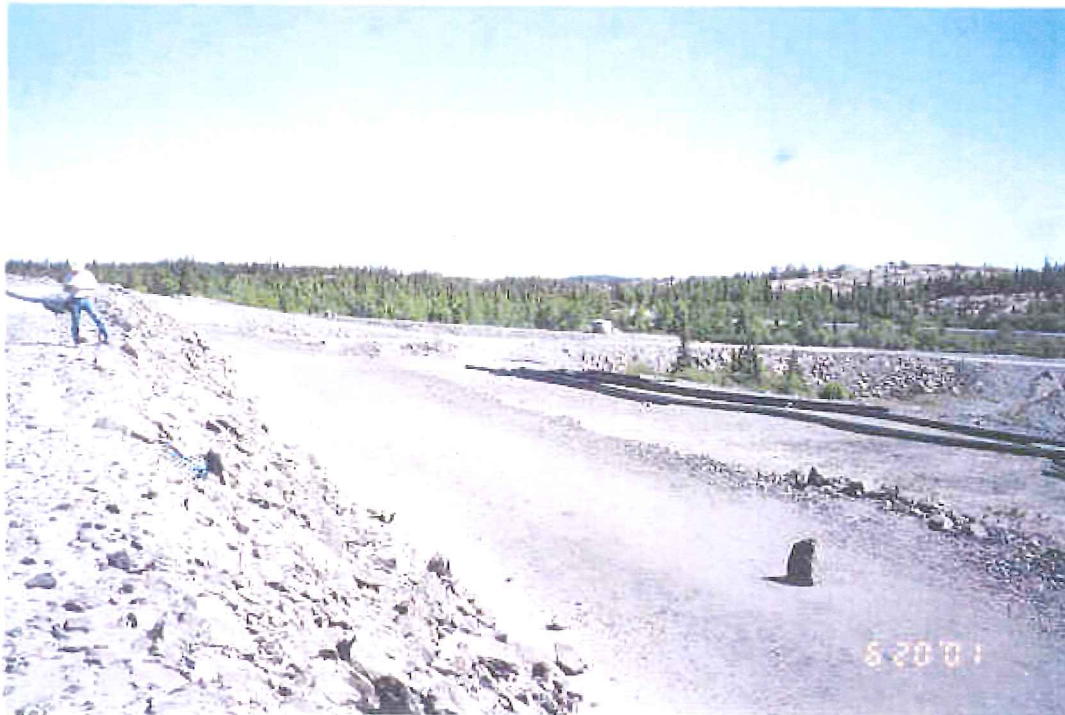
PHOTOGRAPH 23

Dam 21B, lower bench with wind blown tailing on bench.

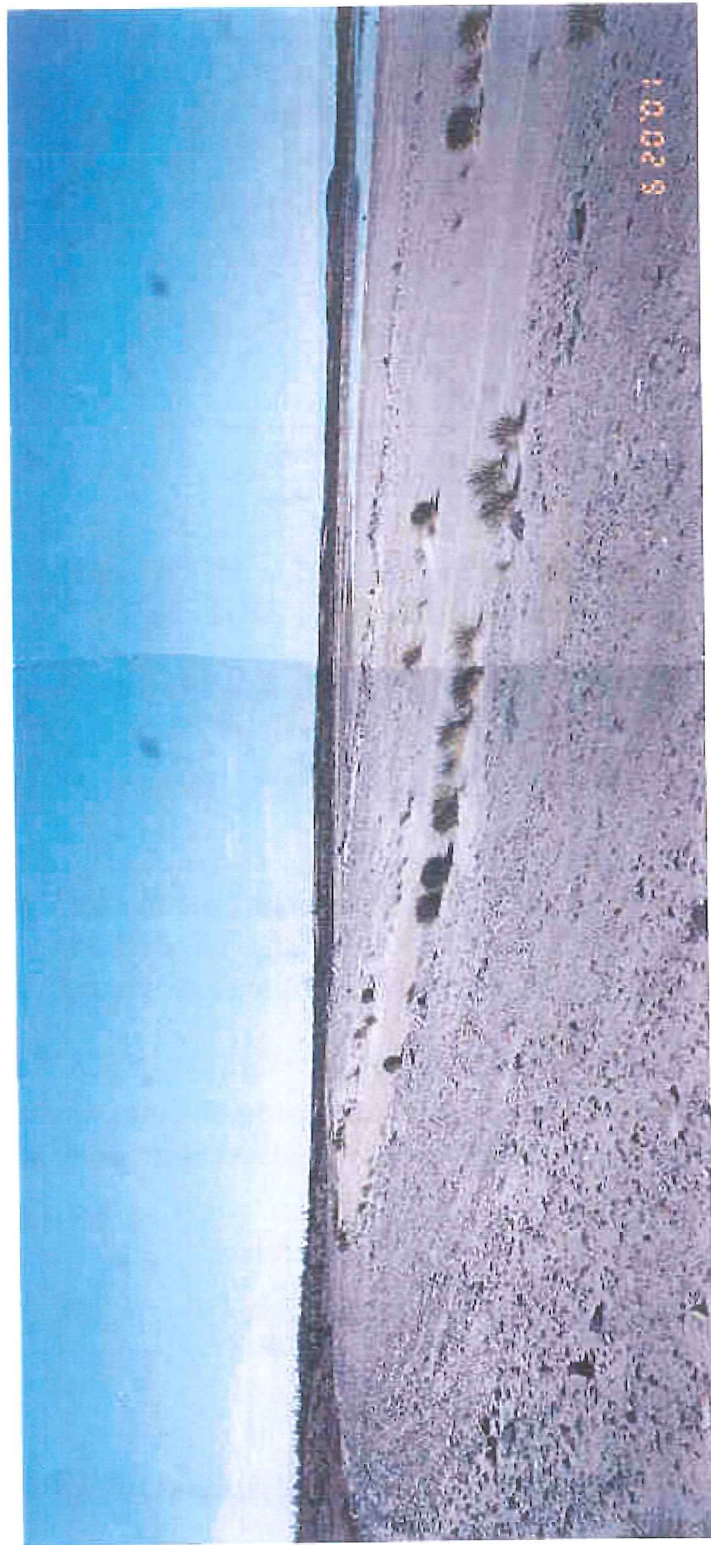
PHOTOGRAPH 24

Beach in front of Dam 21C.

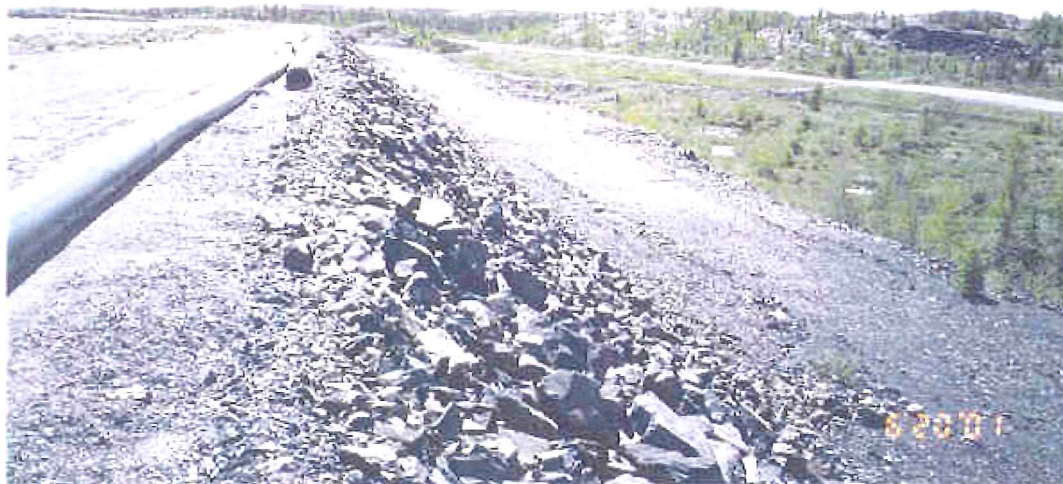
PHOTOGRAPH 25

Downstream tow area of Dam 21D.
Trapper Creek in background adjacent to Vee Lake Road.

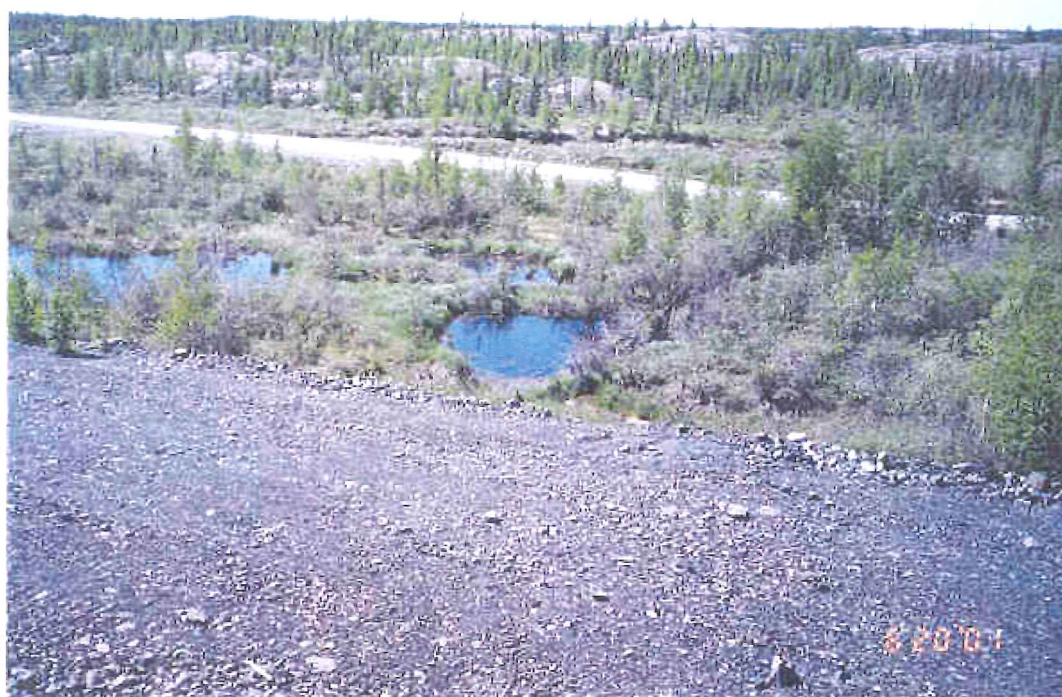
PHOTOGRAPH 26

Bench in area of minor cracks on front edge of slope.
Overall bench is stable

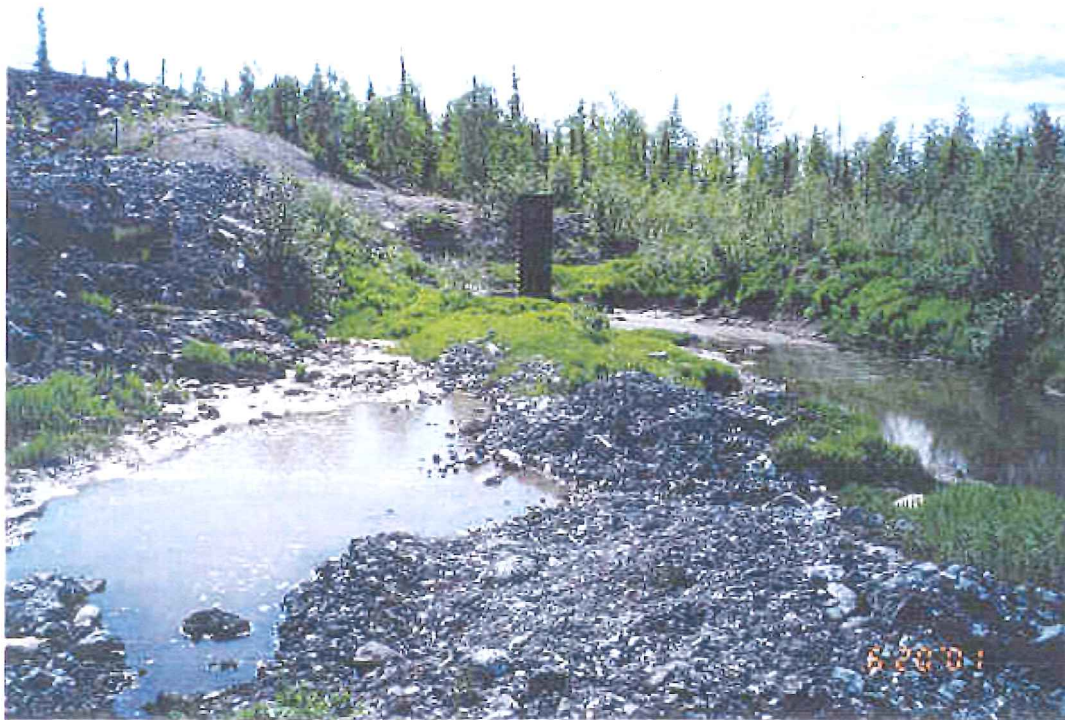
PHOTOGRAPH 27

Seepage area at toe of Dam 22B west abutment.

To reduce seepage through this dam, it is recommended that the tailing pond area upstream of the dam be further isolated from the rest of the Northwest Pond.

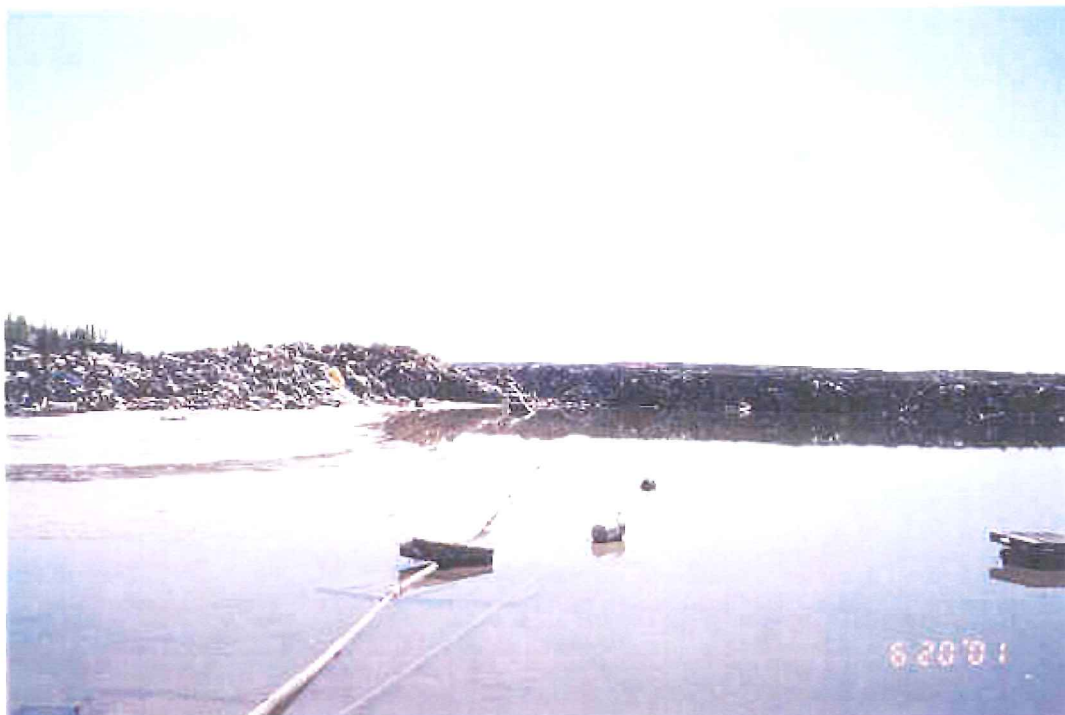
PHOTOGRAPH 28

Berm in front of Dam 22B to help reduce seepage at toe of dam.

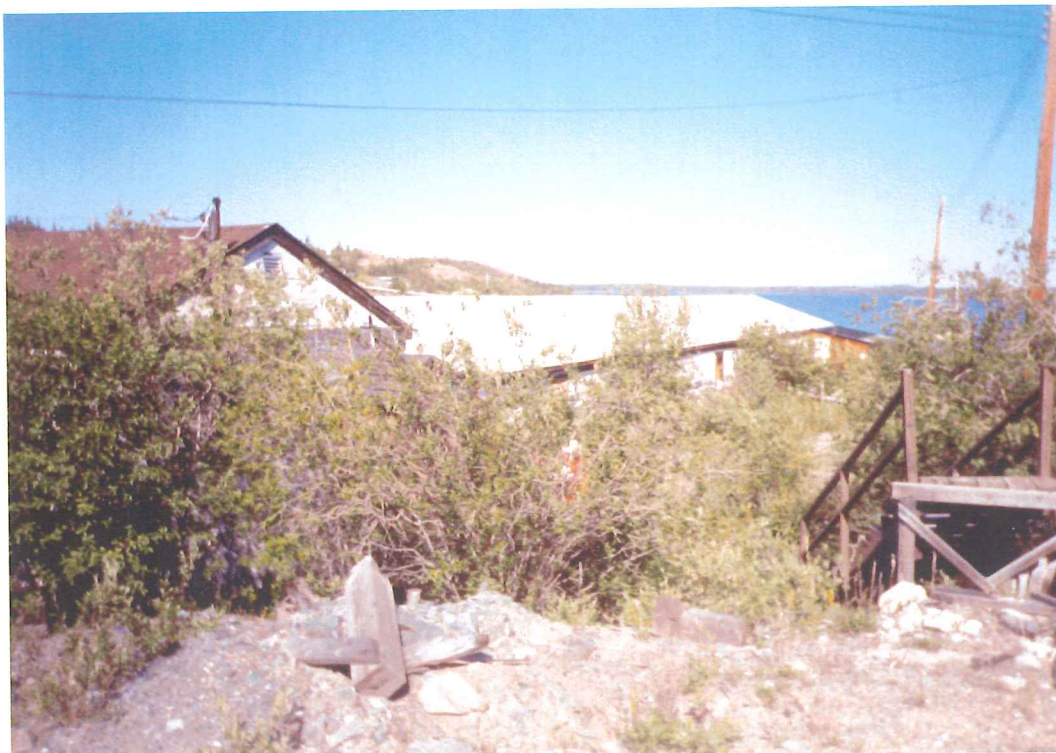
Curling Club Looking Northeast (Note Asbestos Roof Panels)

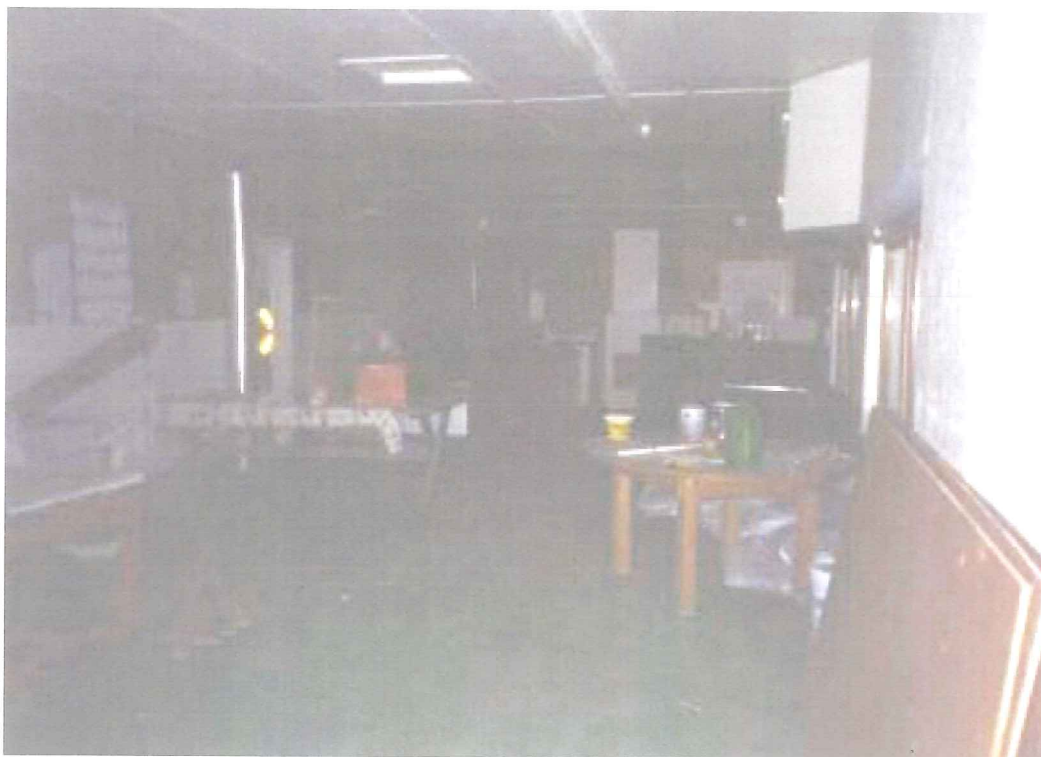
Interior Common Room (Note Asbestos Panels, Walls & Ceiling)
