Final Abandonment and Restoration Plan Miramar Giant Mine Ltd.

VOLUME III OF III

APPENDIX A-9
ANNUAL DAM INSPECTION 2001

**2001 GEOTECHNICAL INSPECTION OF
GIANT MINE TAILINGS DAMS
YELLOWKNIFE, NT**

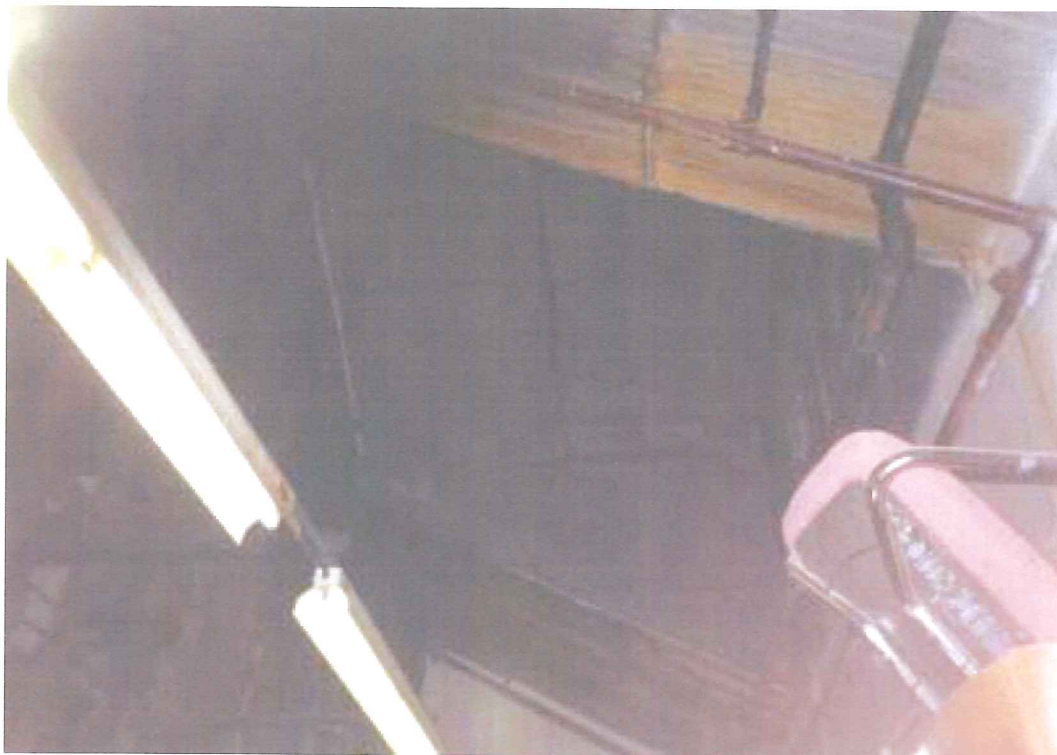
Typical Ceiling and Wall Panels Type 1 Asbestos
and Fluorescent Lights

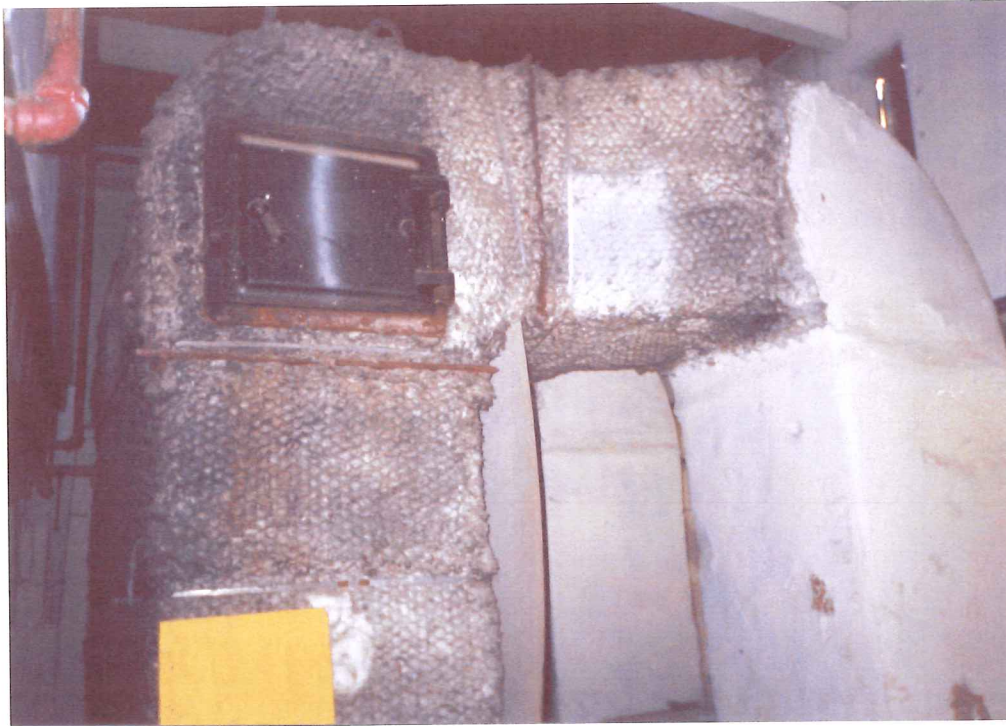
Asbestos Type 2 Pipe Insulation

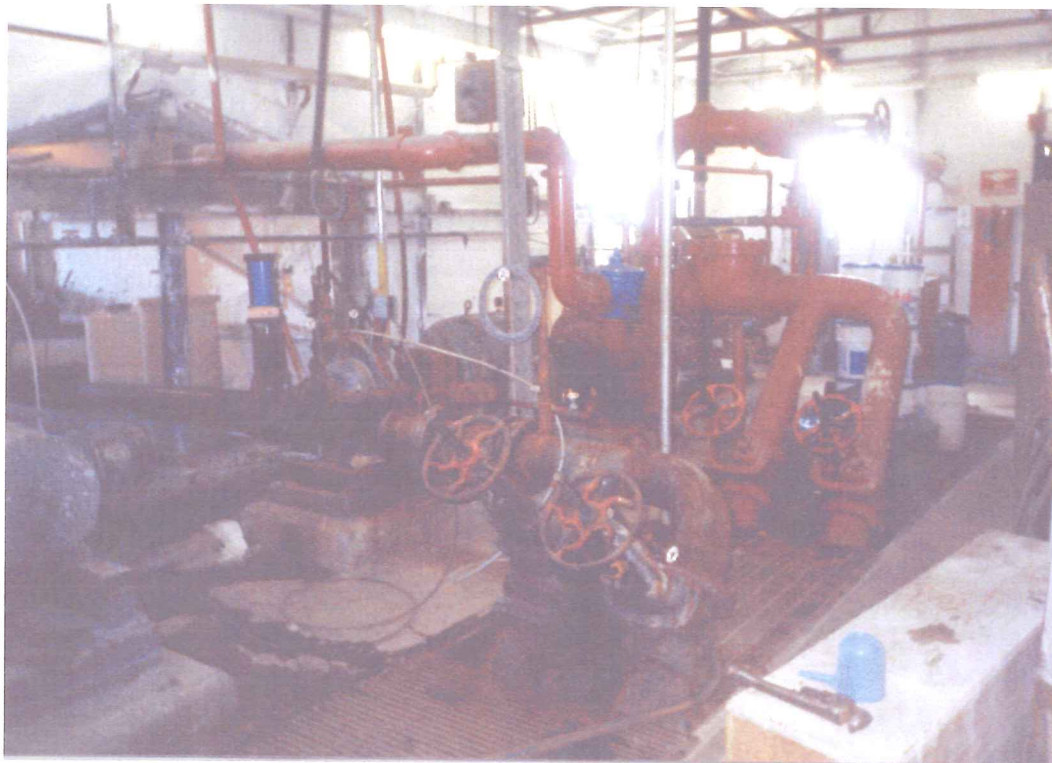
Typical Interior Piping - Asbestos Type 2 on Walls

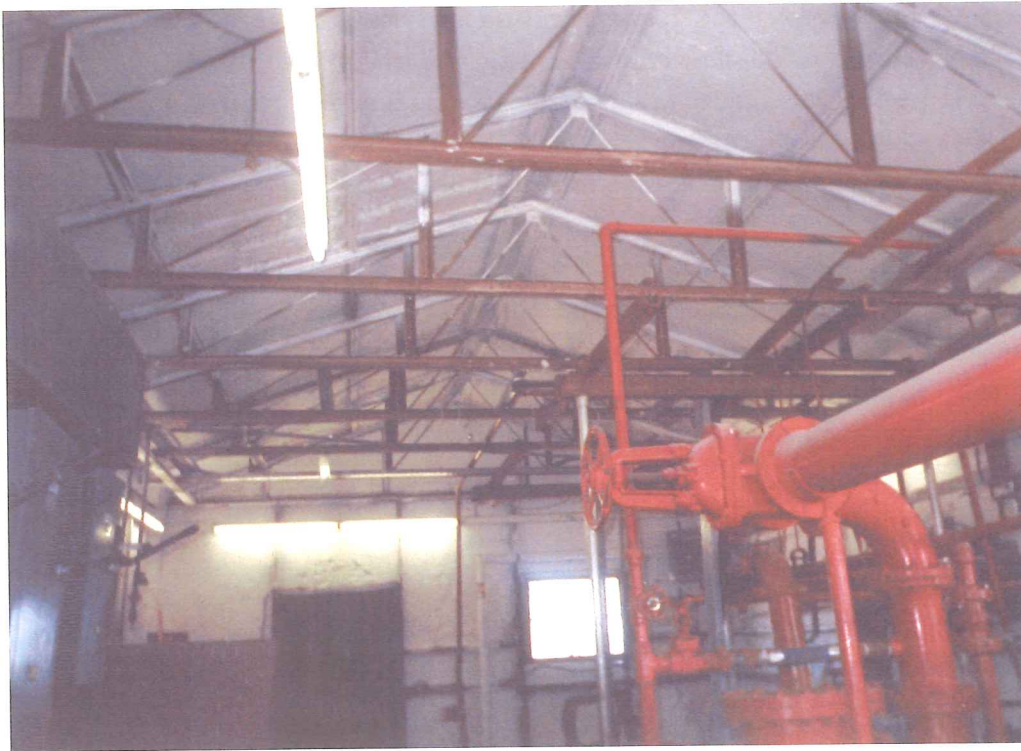
Steel Structural and Asbestos Type 2 on Ceilings and Walls

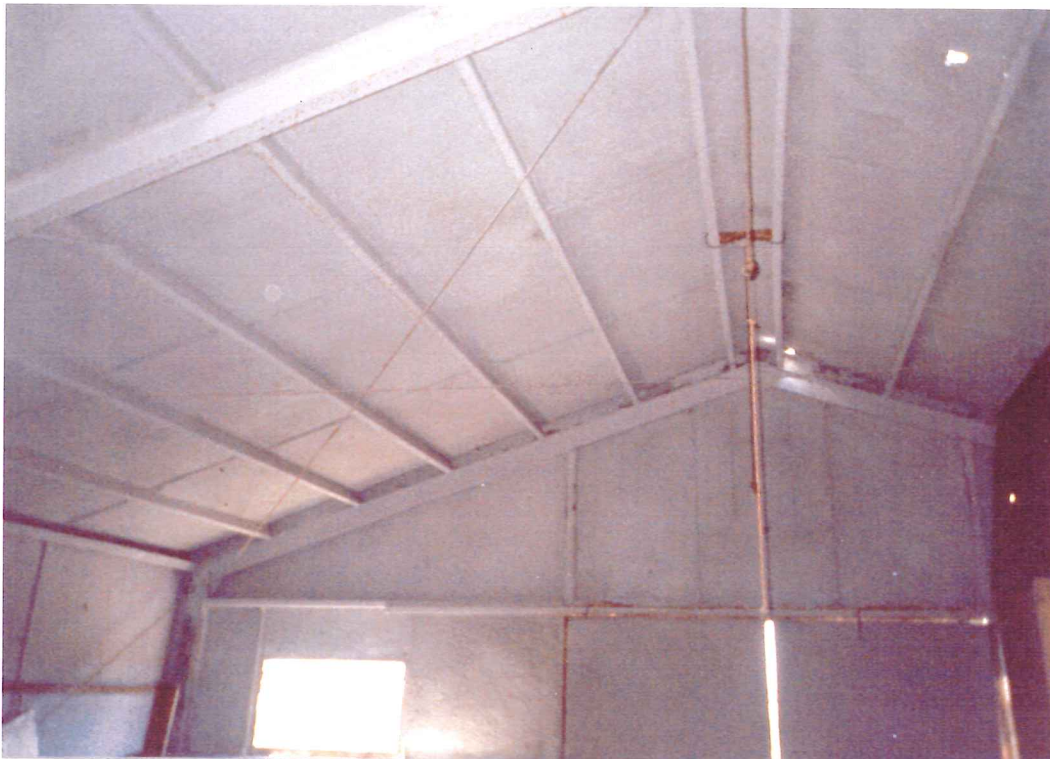
Interior Asbestos Type 2 Steel Frame

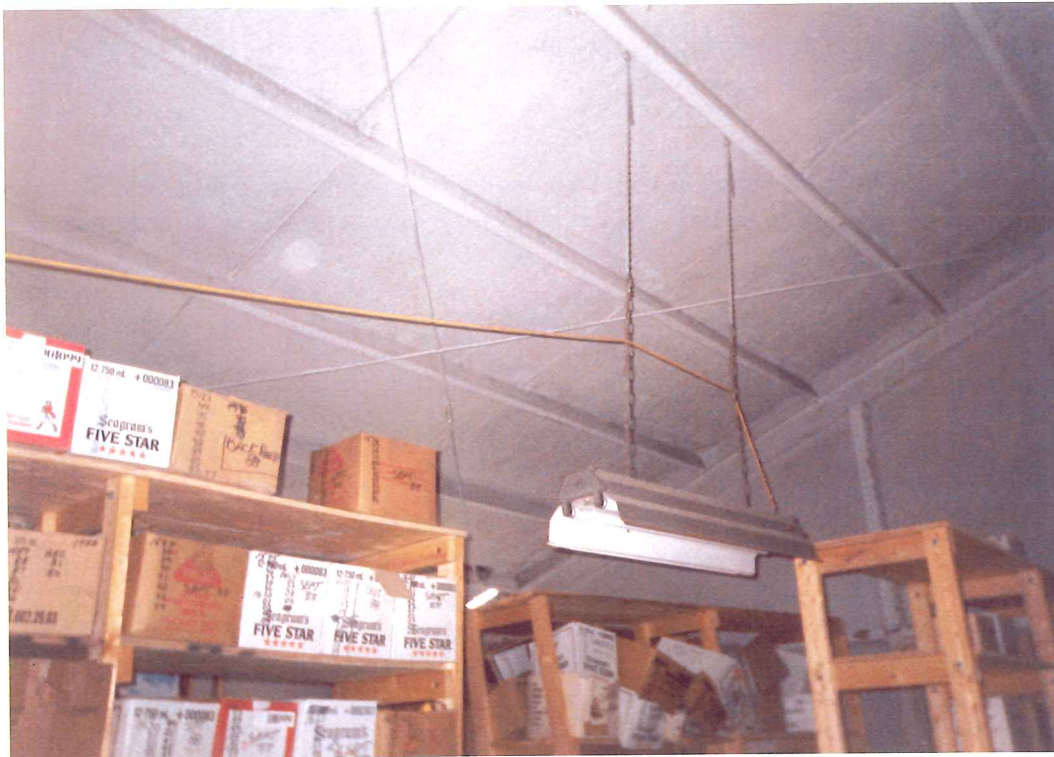
Interior Asbestos Type 2

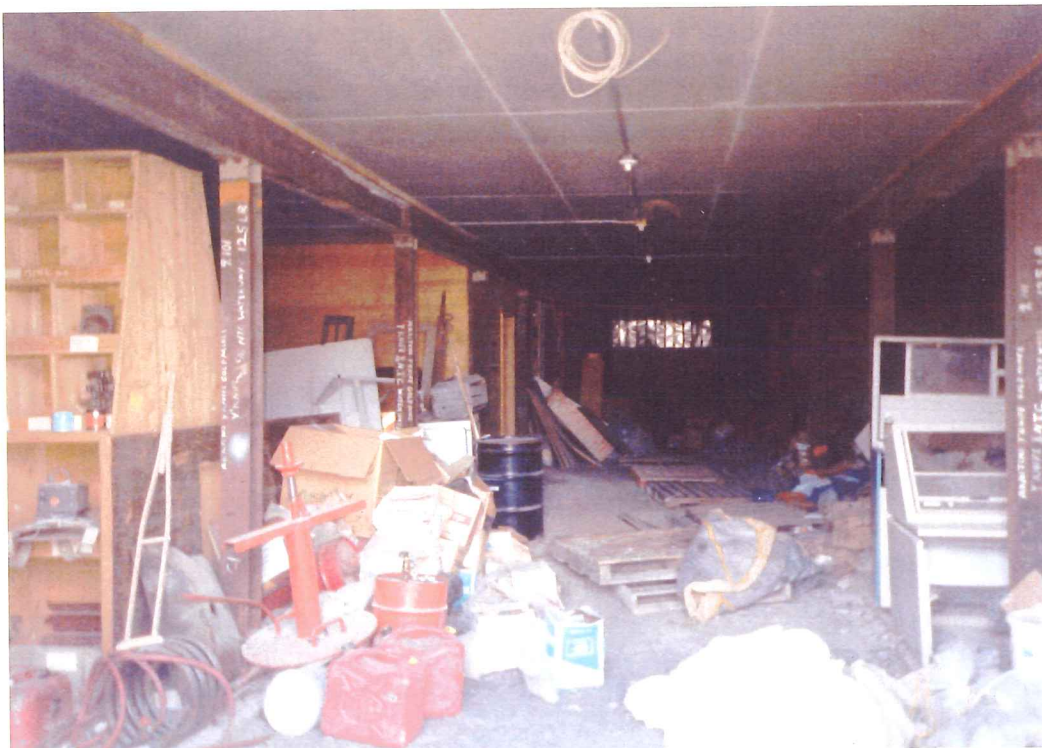
Lower Level Showing Storage Items and
Asbestos Type 1 on Ceiling

- all workers to wear Class "C" complete with dust particle respirators as minimum protection;
- measures must be taken to ensure that Asbestos Type 2 insulation attached to siding, roofing and steel is not allowed to escape into the environment during the demolition and transportation of same; and
- enforce safe working habits for demolition type projects.

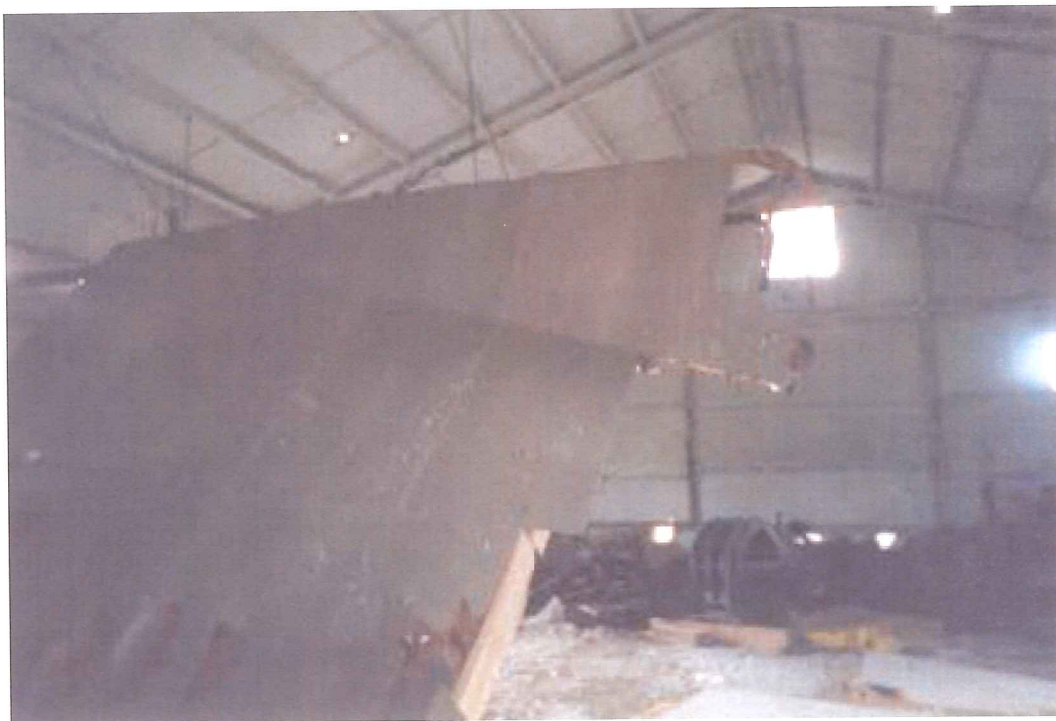
Interior Shows Asbestos Type 1 Wall Panels and
Sprayed On Asbestos Type 2 on Super Structure

- all workers to wear Class "C" complete with dust particle respirators as minimum protection;
- measures must be taken to ensure Asbestos Type 2 insulation attached to removed steel siding, roofing & steel frame is contained and not released into the environment during demolition and transportation;
- enforce safe and proper handling and storing protocol for hydrocarbons; and
- enforce safe work practices for demolition type projects.

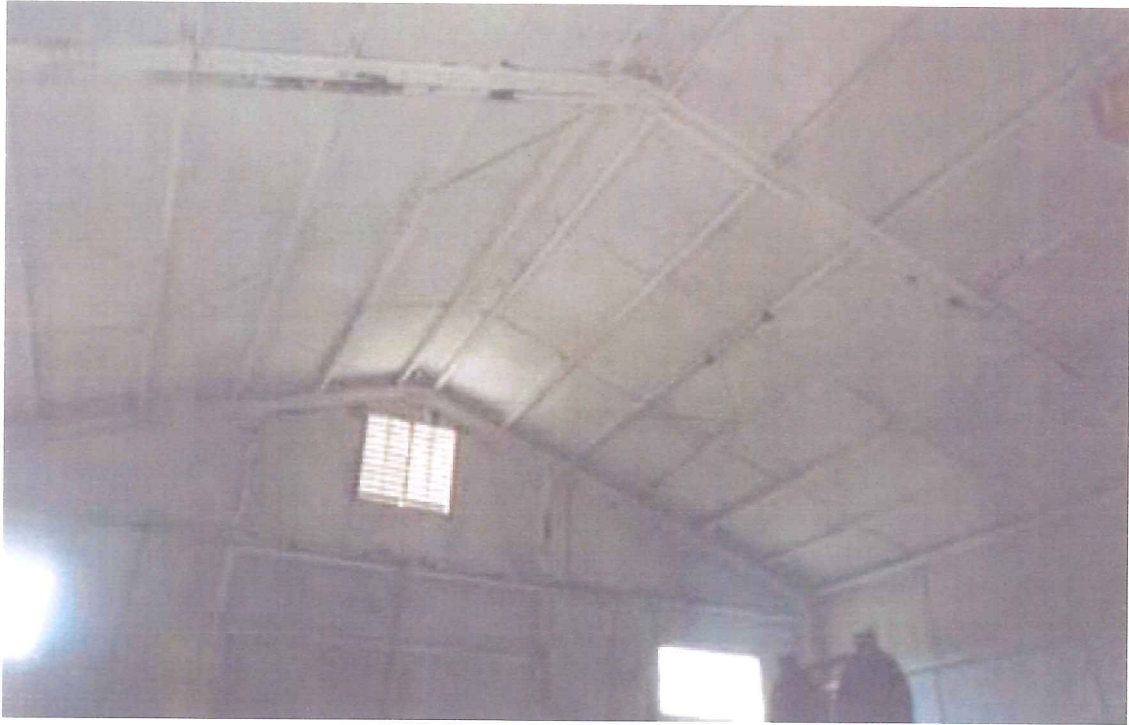
Sprayed On Asbestos Type 2 Steel Structure

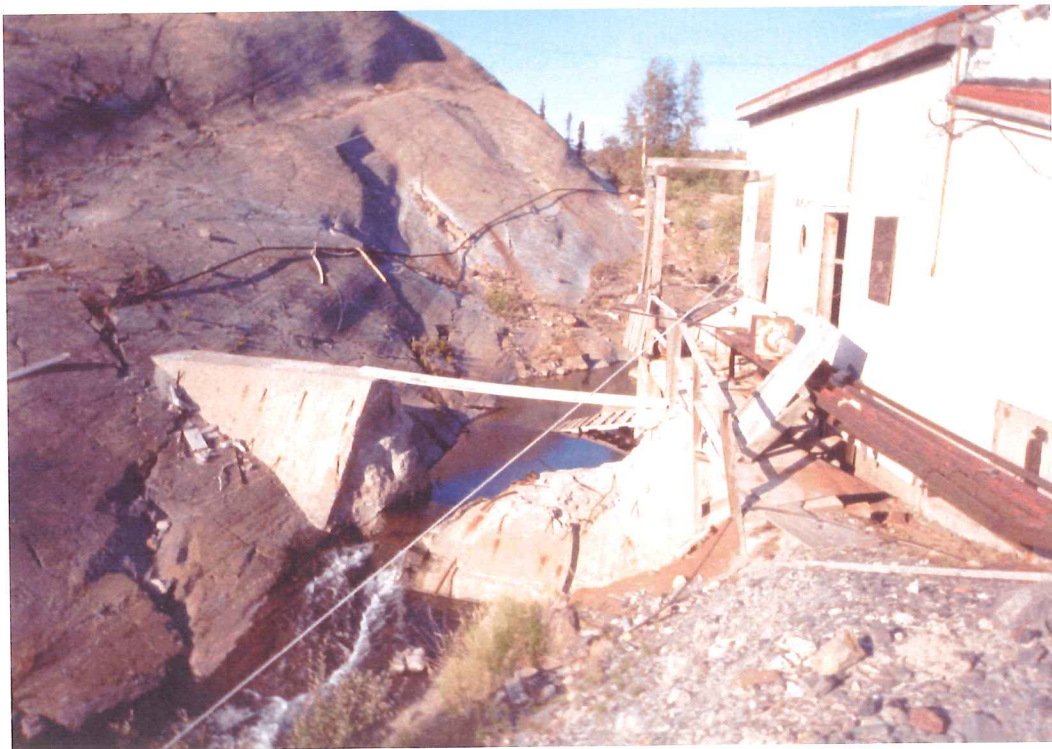
Baker Creek Adjacent to the Old Compressor Building

- all workers to wear Class "C" complete with dust particle respirators as minimum protection;
- protective measures must be taken to protect Baker Creek from any and all pollution which might result from demolition of building;
- enforce safe and proper handling and disposal practices for PCBs, mercury, Asbestos Type 1 and hydrocarbons; and
- enforce safe work practices for demolition type projects.

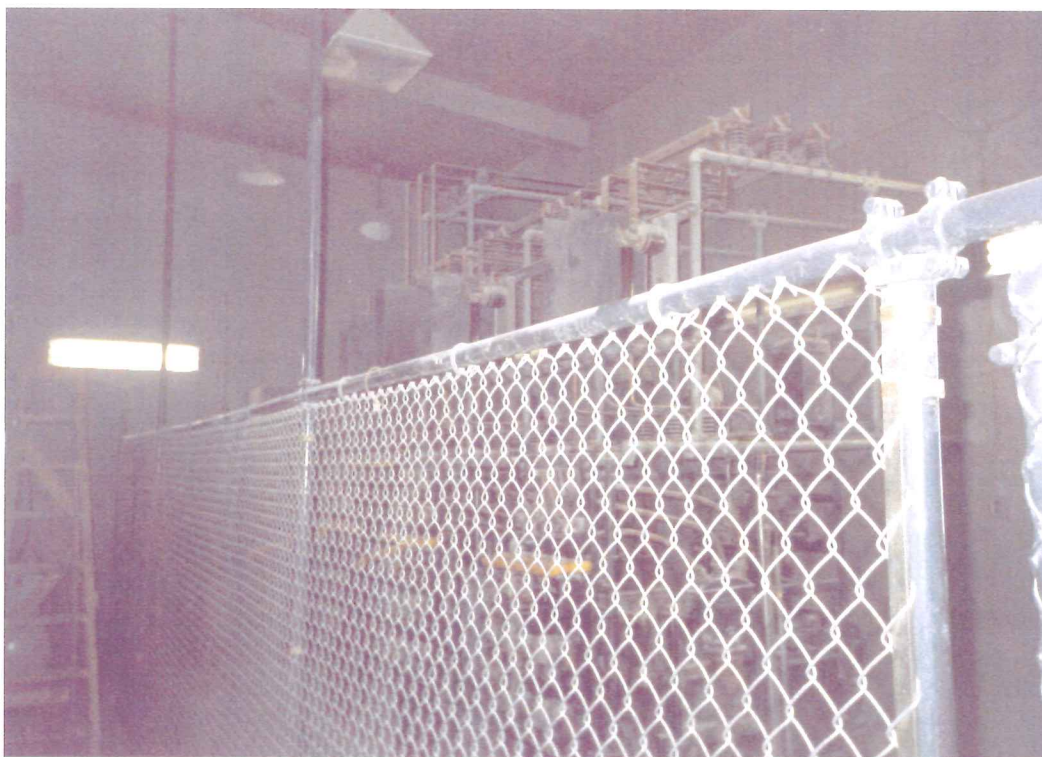
Electrical Room Showing Asbestos Type 1

- multiple level wooden structure; pitch felt roofs; concrete floor & concrete foundations; concrete pedestals for machinery; electrical equipment; Asbestos Type 1 panelling in electrical room; railway tracks and loading zone; heavy machinery & conveyor belt systems; and mezzanines & ore bins.

- all workers to wear Class “C” complete with dust particle respirators as minimum protection;
- enforce safe handling practices for asbestos, hydrocarbons, PCBs and mercury;
- enforce personal hygiene for workers handling demolition materials;
- enforce safe work practices for working around open holes; and
- enforce safe work practices for demolition type projects.

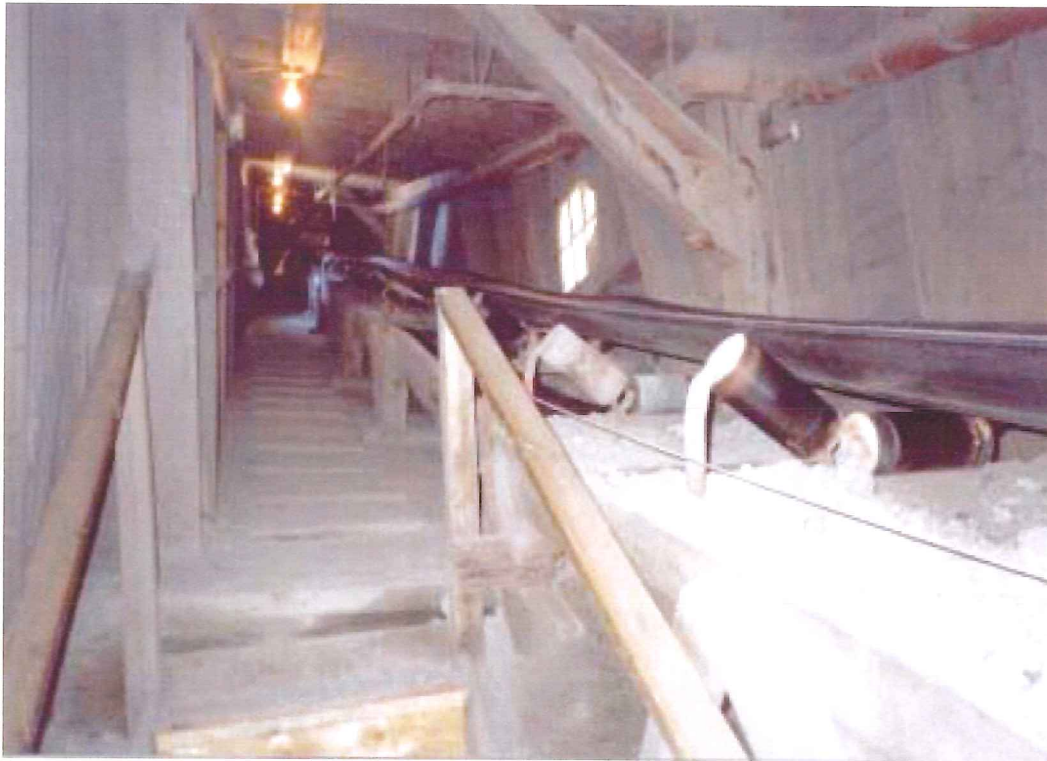
Interior Towards Screen House from Crusher House
(Note: Conveyors are made of Wood)

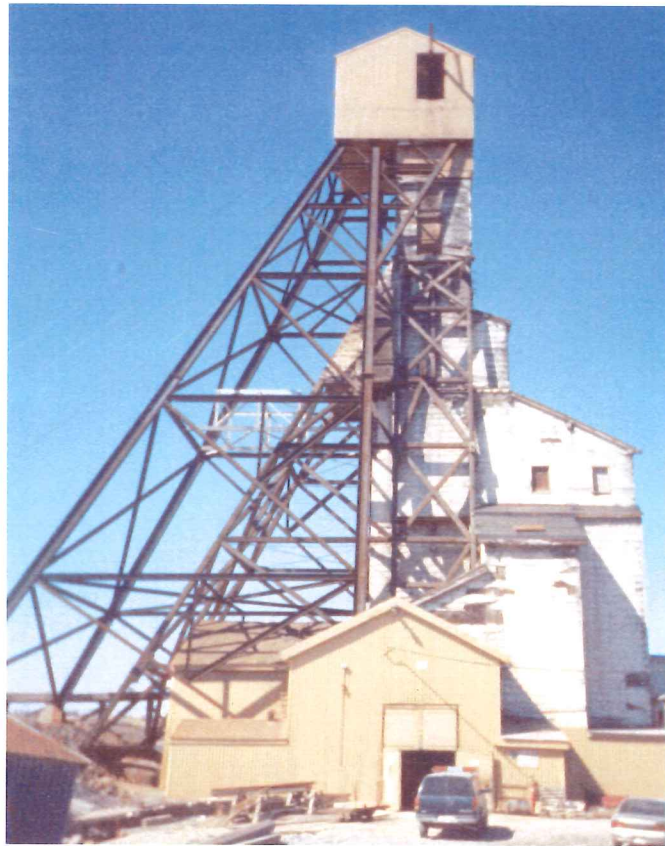
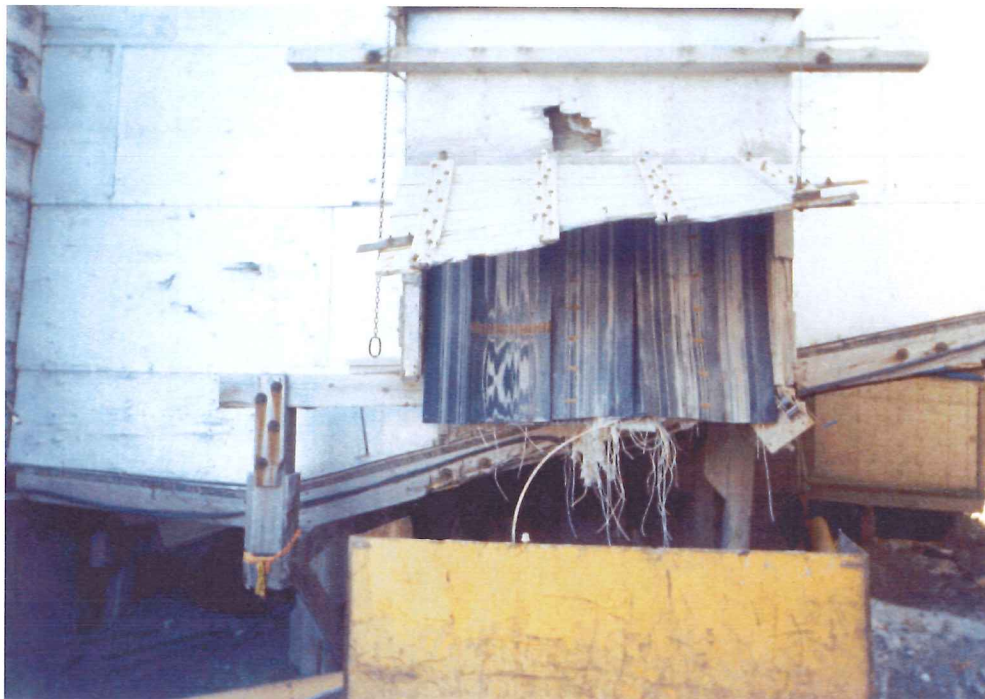
Steel Scrap Disposal off Feed Conveyor to Crusher House

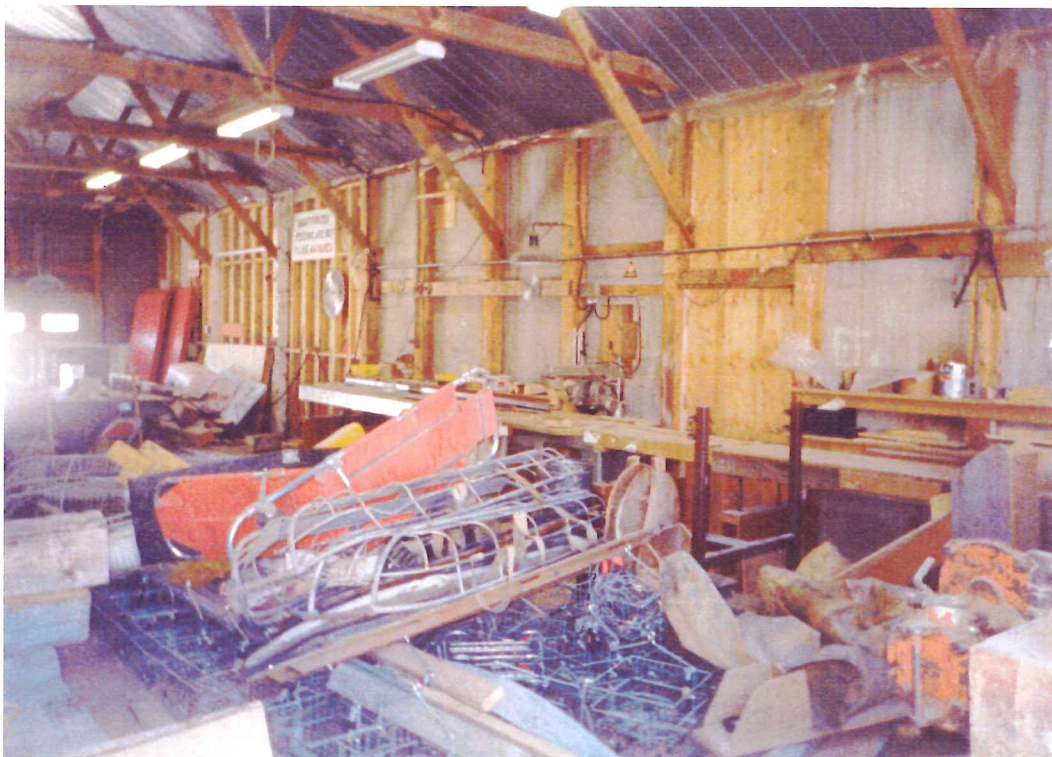
Interior – Asbestos Type 1 on Walls

Interior Asbestos Type 1 on Walls

- wood frame structure; steel roof covered with pitch felt; some exterior Asbestos Type 1 siding; interior siding of Asbestos Type 1; wood sill foundation; wood floor; light rail in floor; and adjacent saw dust bin.

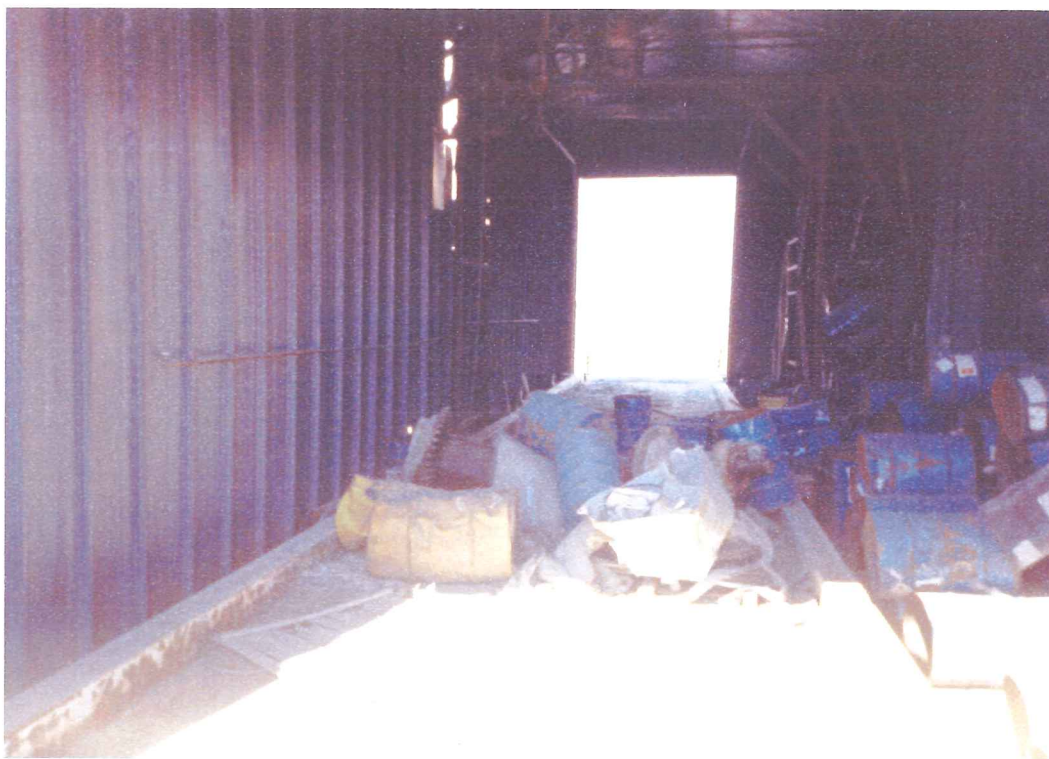
Interior Showing Truck Scale and Debris

- remove all Asbestos Type 1 panelling from Control Room, place in proper containers and dispose of same in designated landfill;
- dismantle silo and dispose of material in designated landfill;
- demolish concrete foundations and dispose of material in designated landfill;
- backfill open pit from scale removal with approved material; and
- clean up, grade site and leave in an orderly manner.

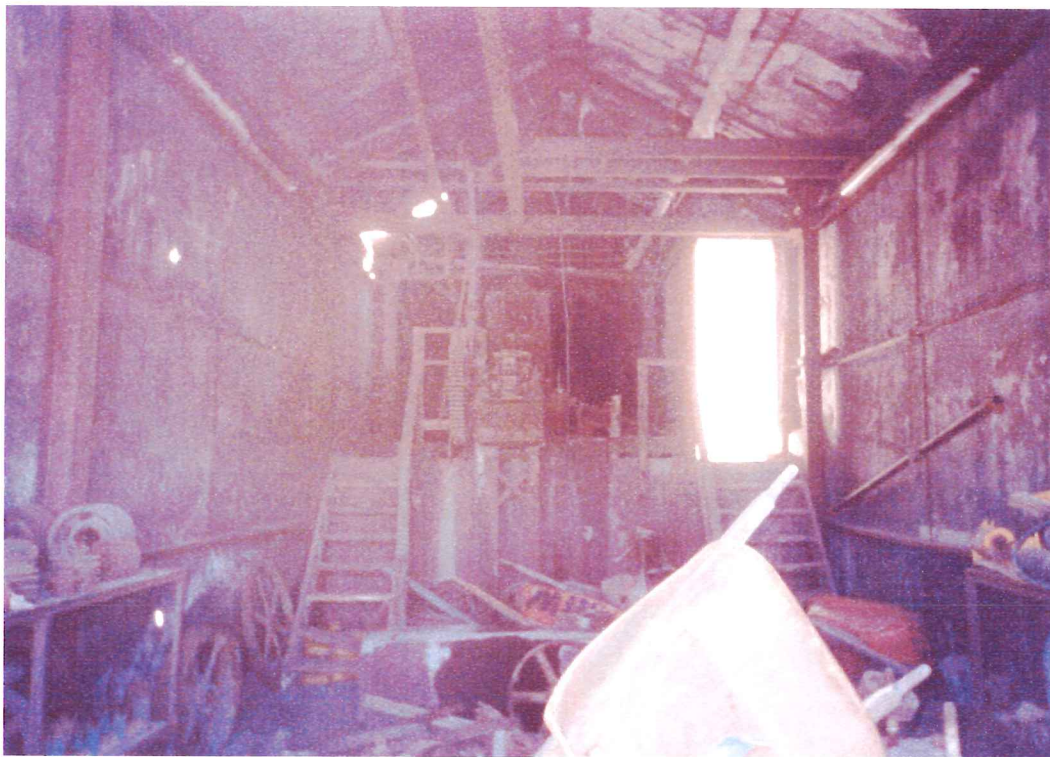
Interior Showing Asbestos Type 2 Insulation

- remove heavy machinery as demolition allows access and dispose in designated area;
- demolish all concrete foundations, footings, stairways and pedestals and dispose of all materials in designated landfill; and

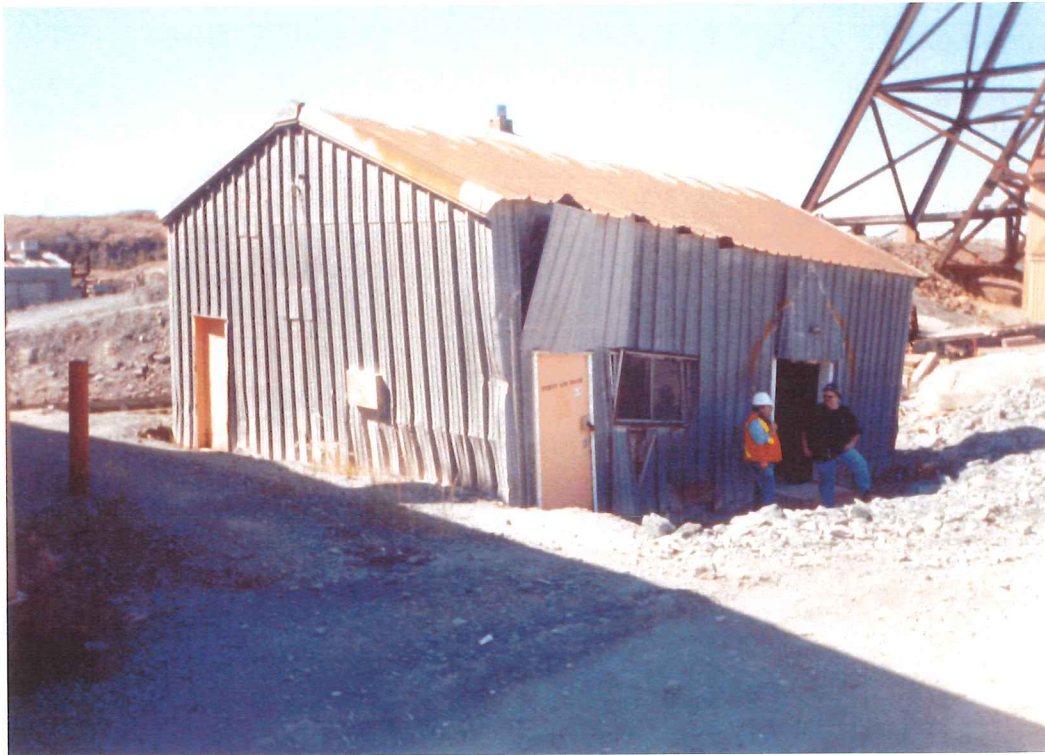
**"C" SHAFT
BUILDING #171
BUTLER BUILDING**

- Butler Style; steel frame; steel roof and siding; double walled; fiberglass insulation; sprayed on Asbestos Type 2; concrete slab foundation; and building sinking.

- demolish concrete slab foundation;
- dispose of all materials resulting from demolition in designated landfill;
- backfill excavation resulting from demolition with approved material; and
- clean up, grade site and leave in an orderly manner.

- all workers to wear Class “C” complete with dust particle respirators as minimum protection;
- take special measures to ensure that during removal and transportation of Asbestos Type 2 the dust is not allowed to escape into the environment; and
- enforce safe work practices for demolition type projects.

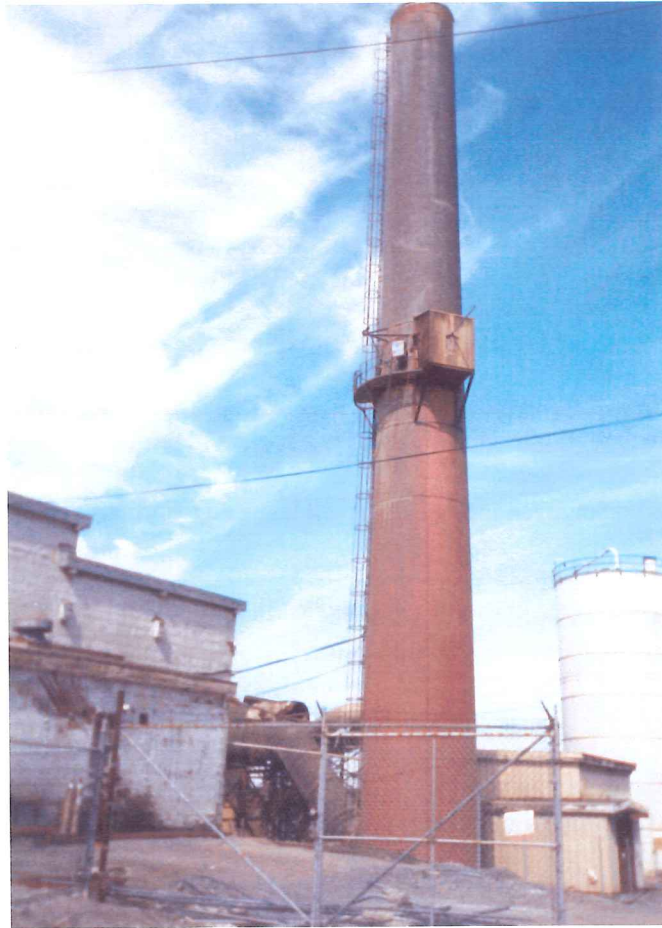
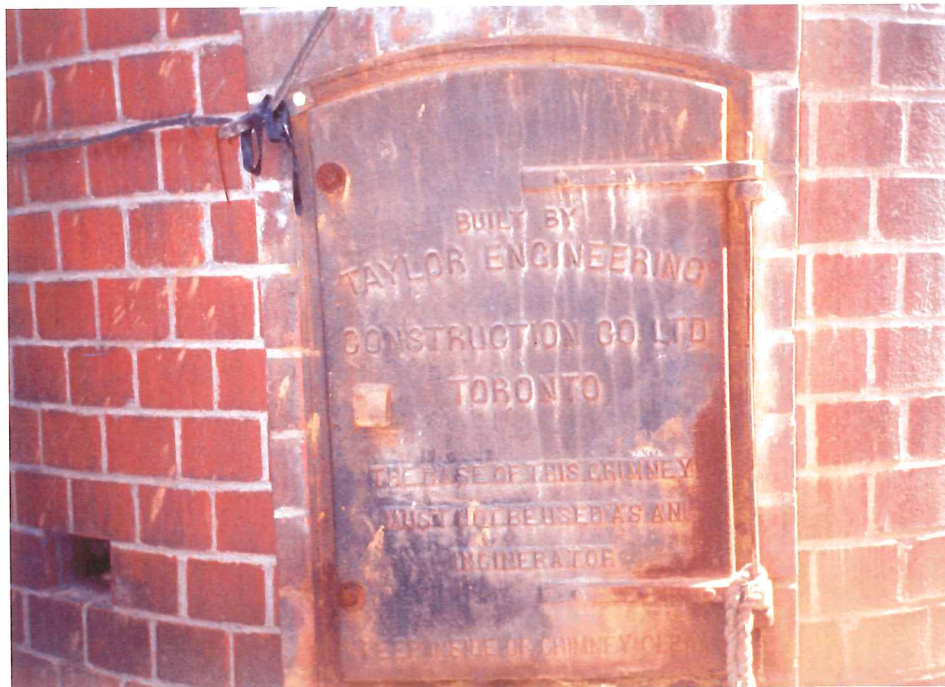
**"C" SHAFT
CHIMNEY**

- brick chimney; Asbestos Type 2 liner; and concrete foundation.

- owner shall locate and de-energize all utilities attached to structure;
- chimney demolition;
- collect, properly package and dispose of all asbestos and arsenic residue in designated landfill;
- demolish concrete foundation;
- dispose of all materials resulting from demolition in designated landfill; and
- clean up, grade site and leave in orderly manner.

- demolition to be done in best manner possible to contain dust;
- all workers to wear Class "C" complete with dust particle respirators as minimum protection;
- enforce safe work practices for demolition type projects.

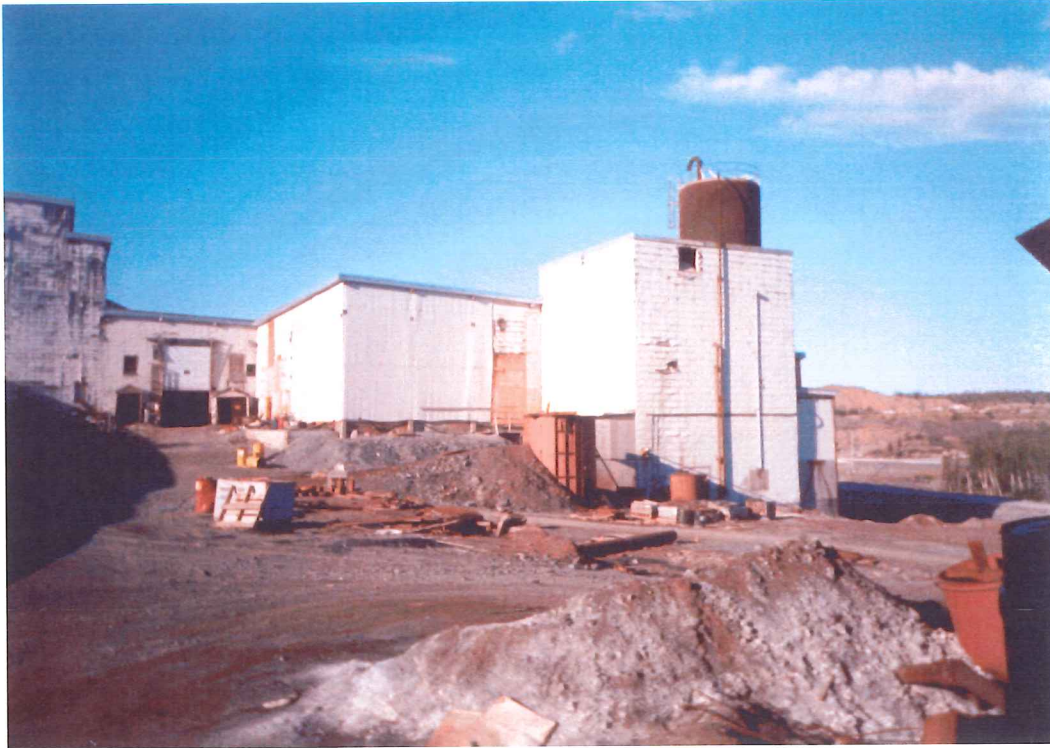
Mill Looking Southwest
Showing Exterior Asbestos Siding Type 1 and Lime Silo
